*Office of Railroad, Pipeline and
Hazardous Materials Safety*

**Collision of Metrolink Passenger
Train 111 and Union Pacific
Freight Train LOF65-12**

Signal Presentation
Chatsworth, California
September 12, 2008

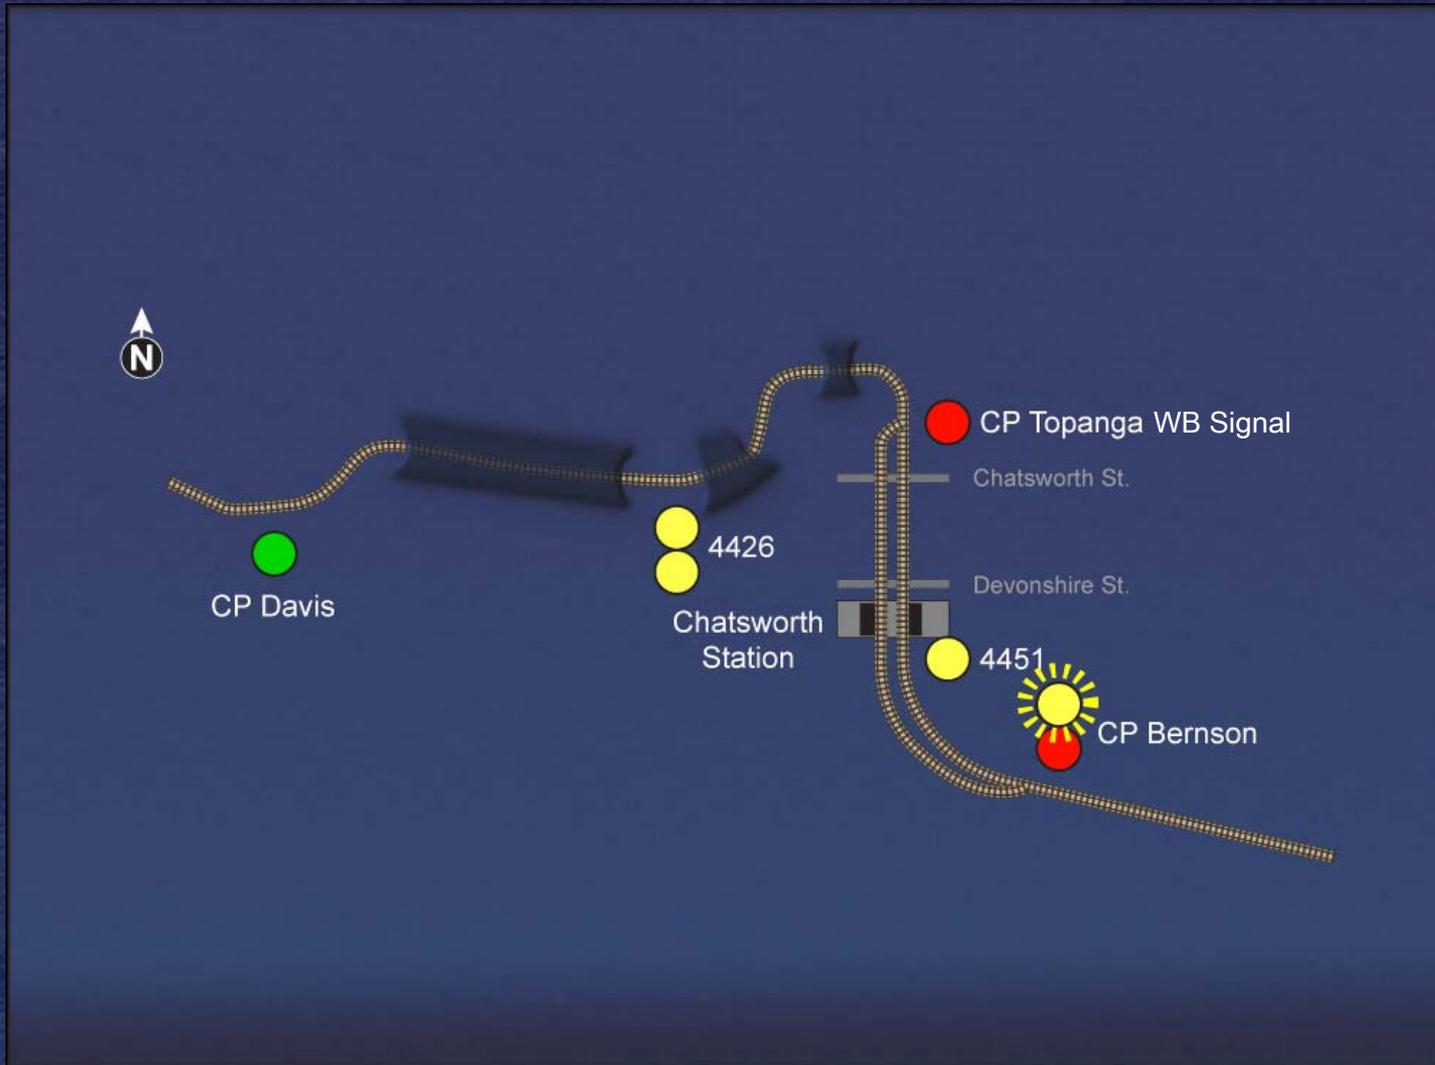
Signal Aspects from CP Bernson to CP Davis

- The dispatcher then “stacked” the route for the westbound movement of the Metrolink train to proceed west through CP Topanga once the UP train was clear of the siding.
- The dispatcher can make multiple signal routes by “stacking” signal requests. The dispatcher selects the first route, in this case for the UP train movement into the siding, followed by the second route for the Metrolink train movement into the main track.
- All stacked signal requests from the dispatcher are in a queue in the Digicon system at the Metrolink Operations Center and are acted upon, one at a time, in the order that they are requested.
- Recorded data showed that the stacked request for the CP Topanga westbound signal to clear after the UP train was in the siding, was never transmitted from the dispatch center to the field signal equipment.

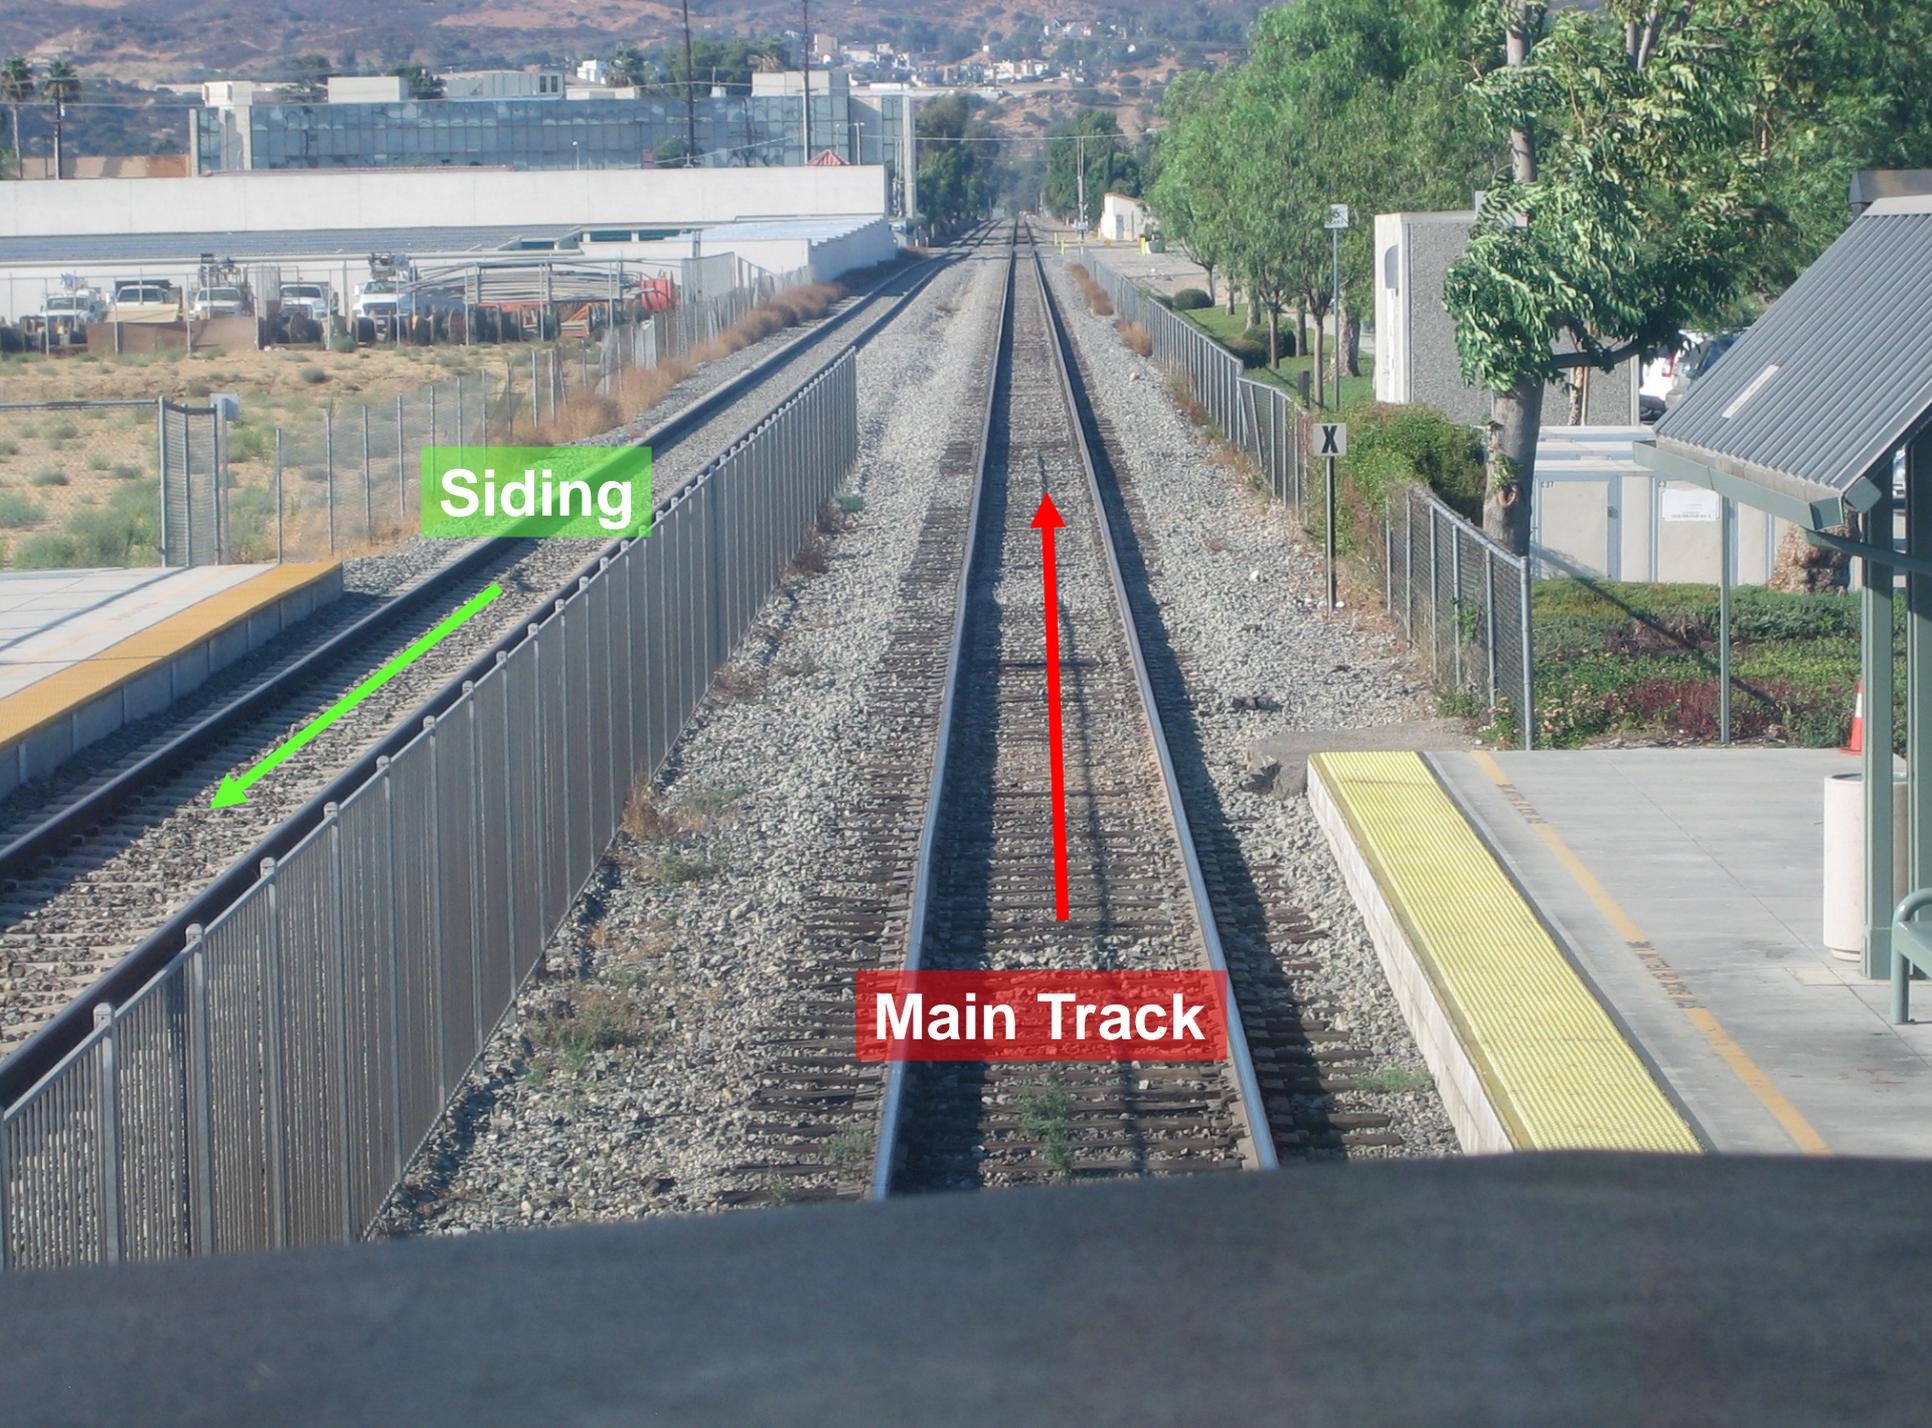
- The CP Topanga switch was lined and locked for the siding for the eastbound movement of the UP train.
- Once the switch was lined for an eastbound train to move into the siding, the system does not allow the westbound signal at CP Topanga to show any aspect other than red.
- As part of the post-accident tests, investigators sent commands to clear the westbound CP Topanga signal with the switch lined for the siding and the signal still would not clear.

The investigation determined that had these stacked commands been sent prematurely, the signal equipment would have responded as it did during postaccident testing; that is, the signal system would have discovered a potential routing conflict and changed all the control point signals, both eastbound and westbound, to red until the conflict could be resolved.
