**Survival Factors and Biomechanics Factual
In support of the General Aviation Airbag Study**

April 29, 2009

Location: Fullerton, CA
Aircraft Type: Cessna 172S
Accident Date: 9/30/08
Accident Time: 1837 PDT
Accident Number: LAX08FA301
Airbag Equipped:

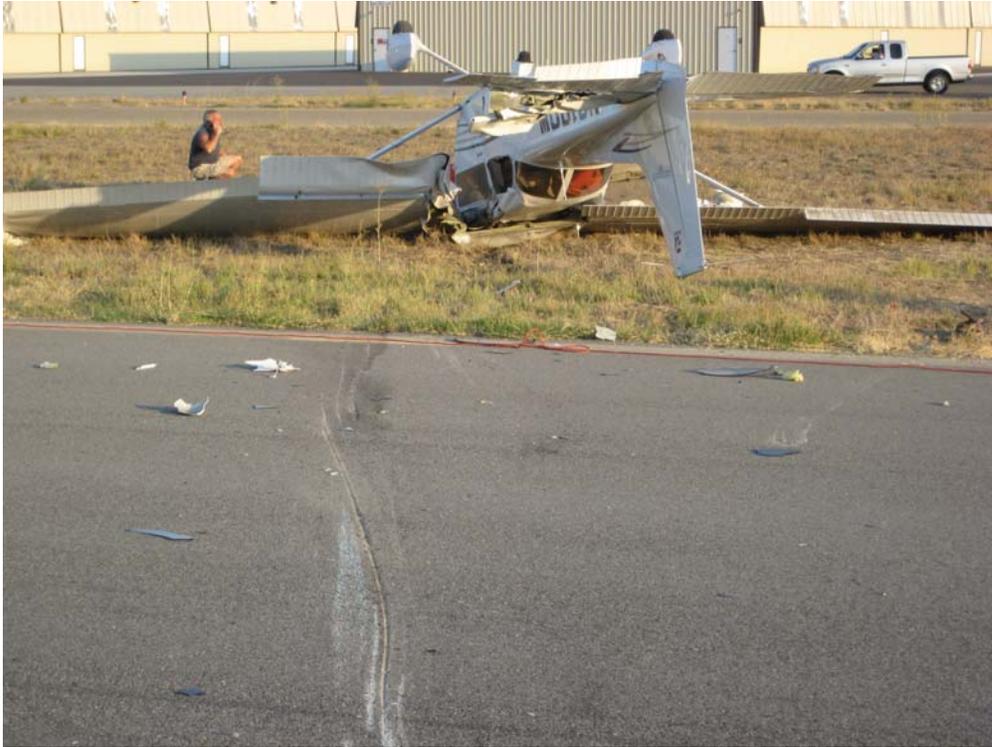
Figure 1: The aircraft's final rest position relative to the runway.

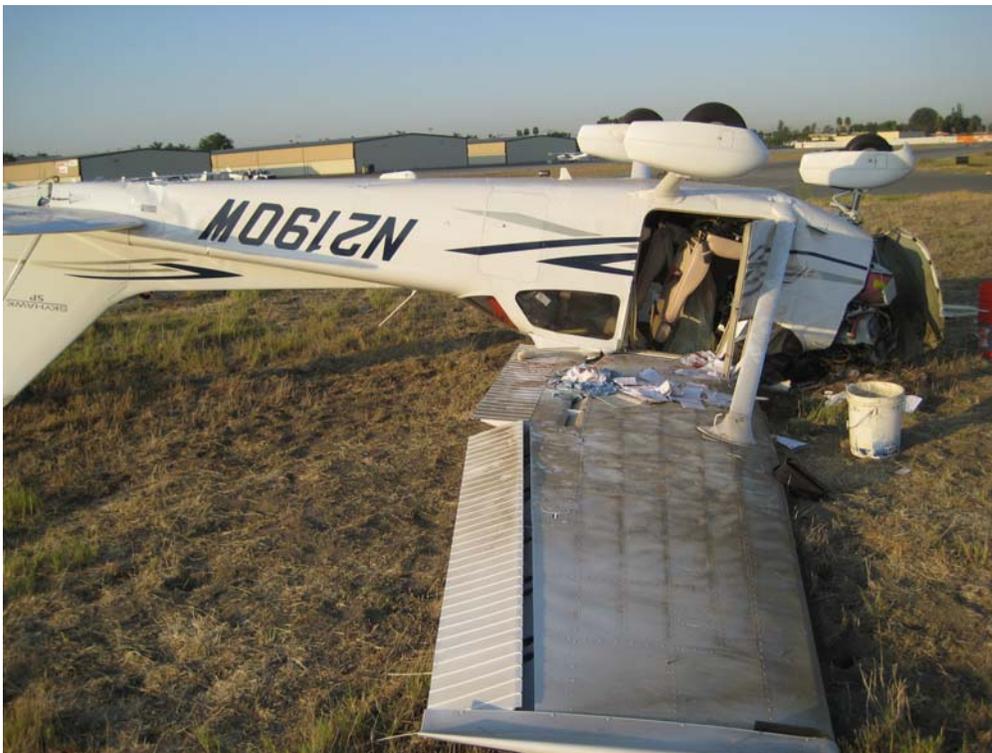
Figure 2: A photograph showing the aircraft in its final rest position. (The photo is looking toward the pilot's seat.)

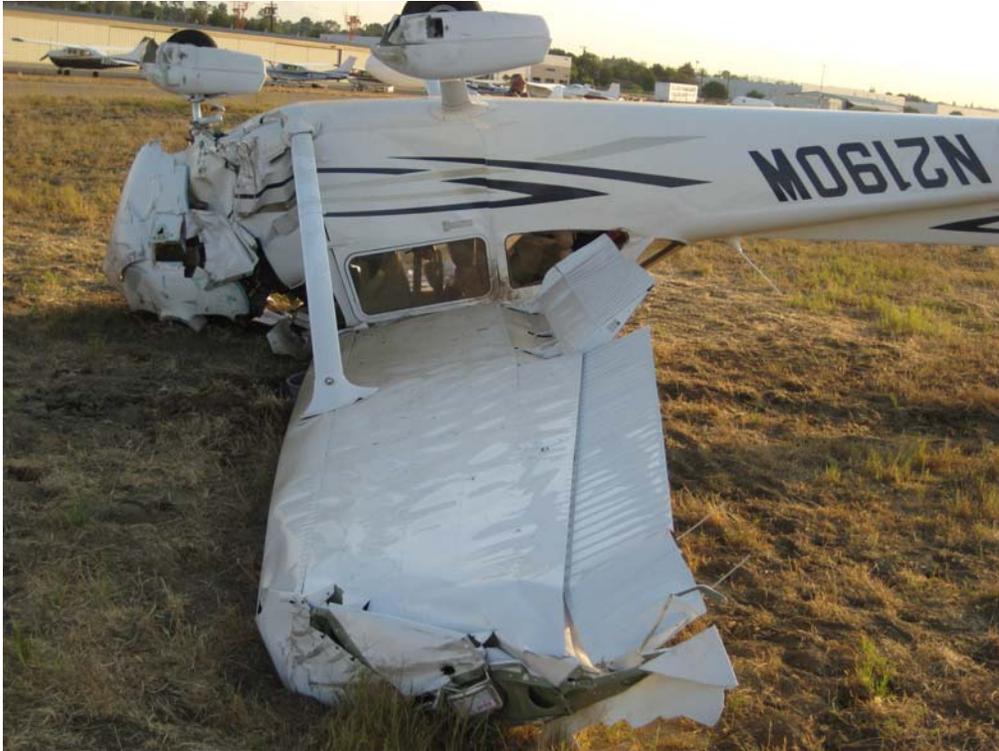
The primary impact to the airplane was on the right wingtip and on the nose of the aircraft. The engine was displaced aft toward the left and up. The primary impact direction was from the front right. The nose gear was still attached and displaced slightly aft. The rear spar carry-through was separated, except at the passenger door frame. The aircraft came to rest upside down. After the crash, the pilot released his restraint and exited through the left door. Photographs showing the final rest position of the aircraft are shown in Figure 1, Figure 2 and Figure 3. Damage to the aircraft can further be seen once the wings were removed and the aircraft was placed in an upright position, Figure 4.

Figure 3: A photograph showing the aircraft in its final rest position showing the damage to the nose and the right wing tip. (The photo is looking toward the front, right seat.)

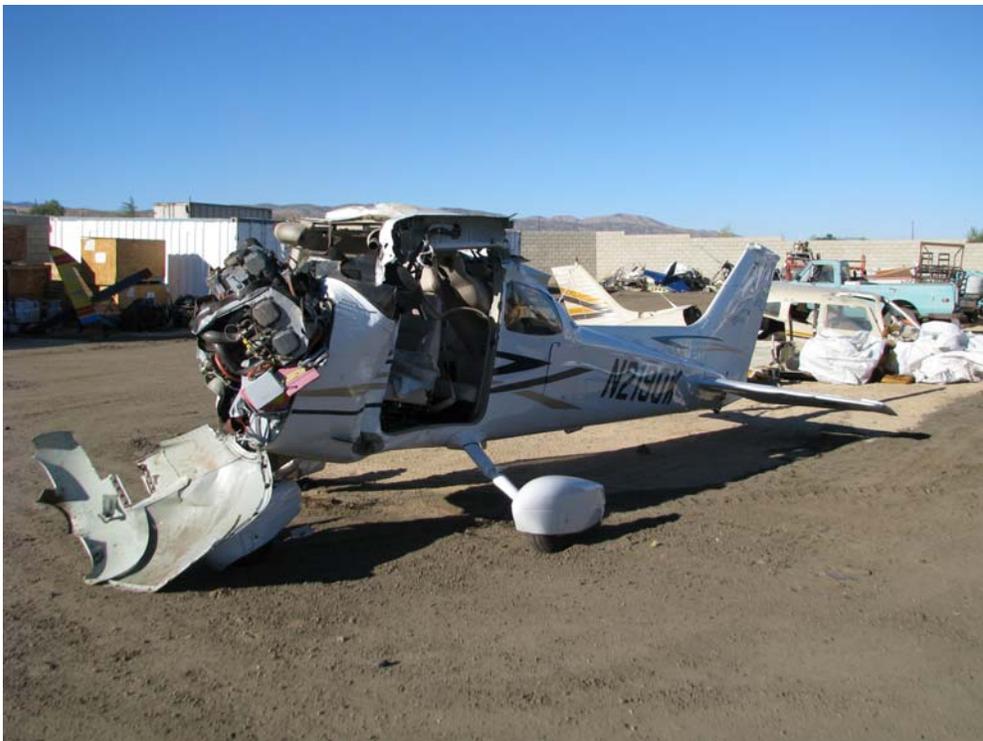
Figure 4: A photograph showing the damage to the aircraft. (The wings were removed.)

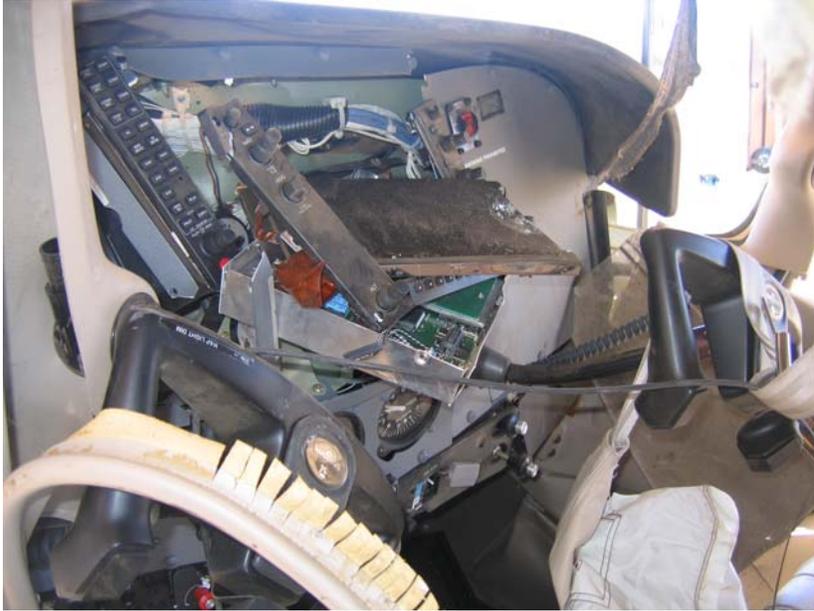
Figure 6: A photograph showing damage to the instrument panel and the displacement of both yokes.

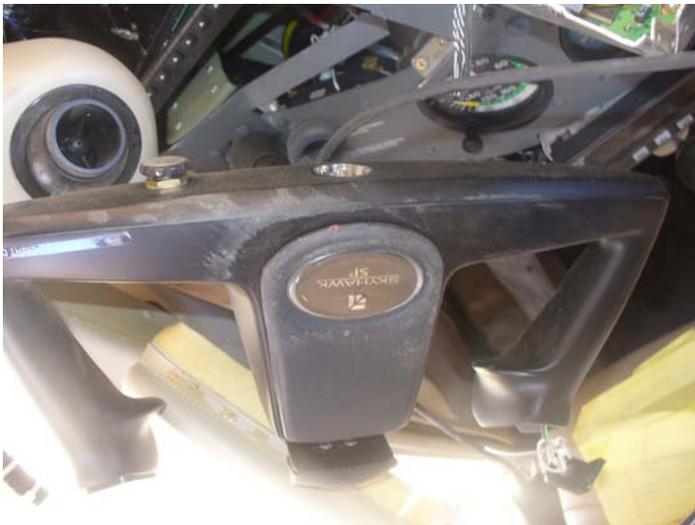
Figure 7: Scrape marks on the underside of the pilot's yoke.

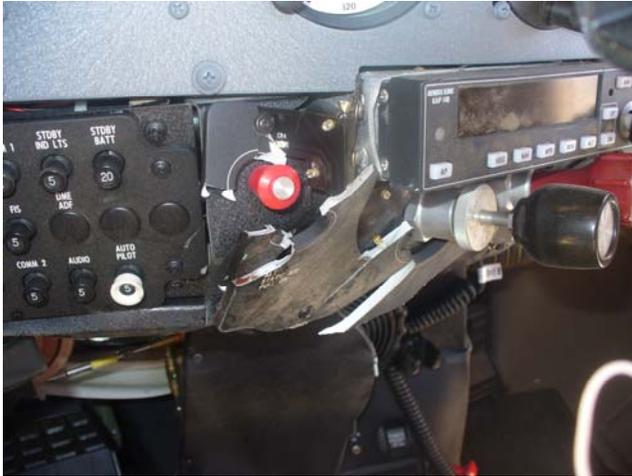
Figure 8: Damage in the region of the alt static air pull-on knob.

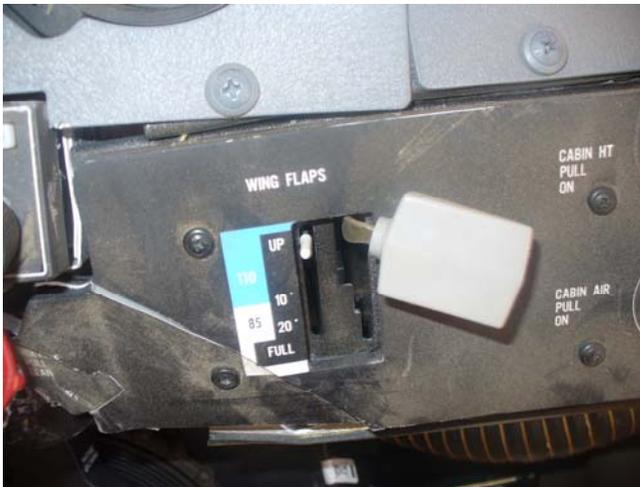
Figure 9: The wing flap knob was deformed to the right.

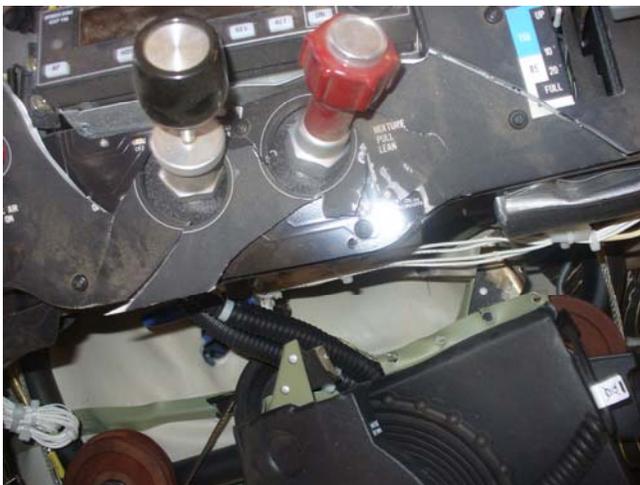
Figure 10: The throttle and mixture knobs were displaced to the right.

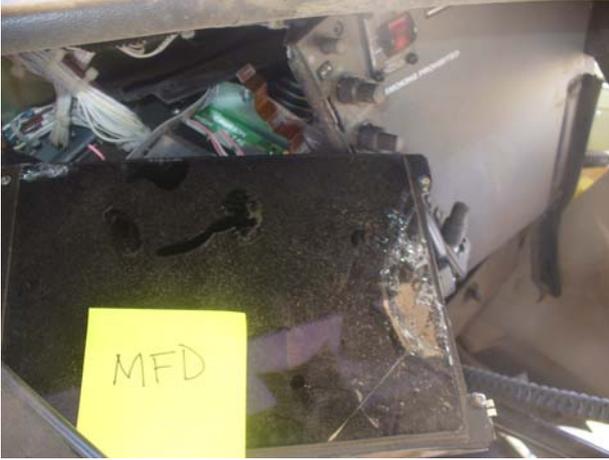
Figure 11: A small semi-circular crack was noted on the right side center of the multi function display unit.

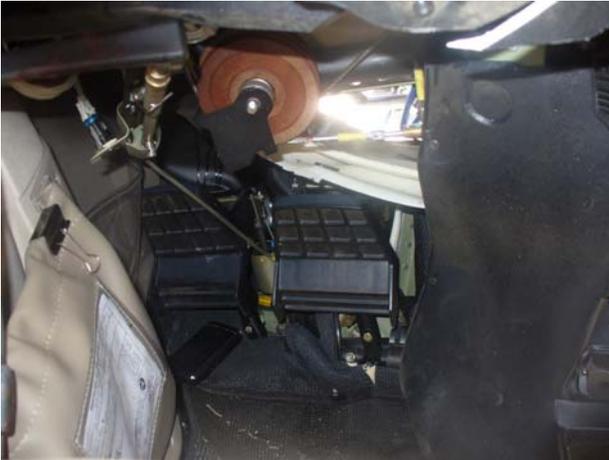
Figure 12: Deformation to the pilot's foot well was noted due to the displacement of the lower center pedestal.

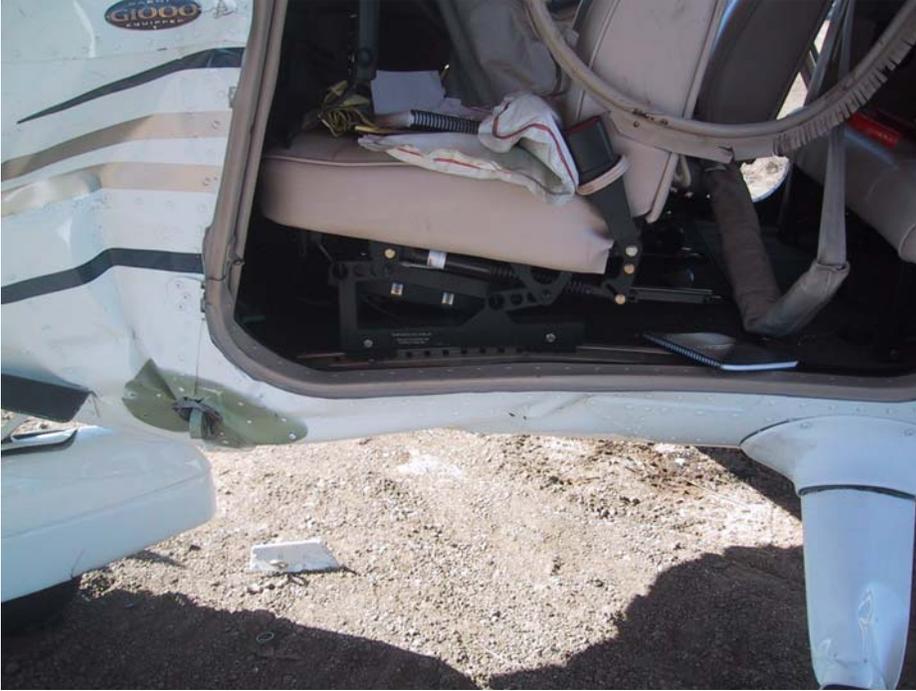
The pilot's seat was found in the 3rd pin back from full forward. Minor deformation was noted to the pilot's seat track (Figure 13) matching the damage to the bottom of the aircraft (Figure 14). The passenger seat was in the 11th pin back from full forward. There were 13 total seat track positions for each seat. The pilot's seat did not appear to be vertically compressed although the front right corner of the seat pan appeared slightly lower. The seat did move forward but did not move aft due to the deformation of the seat track. All seat position adjustments were functional once the seat was removed from the airplane. The dimensions of the pilot's seat are shown on a generic general aviation seat in Figure 15. The seats are assembled by Cessna and are not specifically marked with any tracking numbers. These seats were not equipped with an energy absorbing seat pan structure as seen in some other investigations.² Instead, there was a foam cushion in between the surface of the seat pan and the underlying structure of the seat itself. (Figure 16) No noticeable deformation of the seat pan structure was found. In addition, there was no indication of vertical loading to the seat structure. There was a slight displacement of the seat frame to the right.

Figure 13: The pilot's seat track showed a slight deformation, or curvature upward, matching the damage to the aircraft under this seat position.

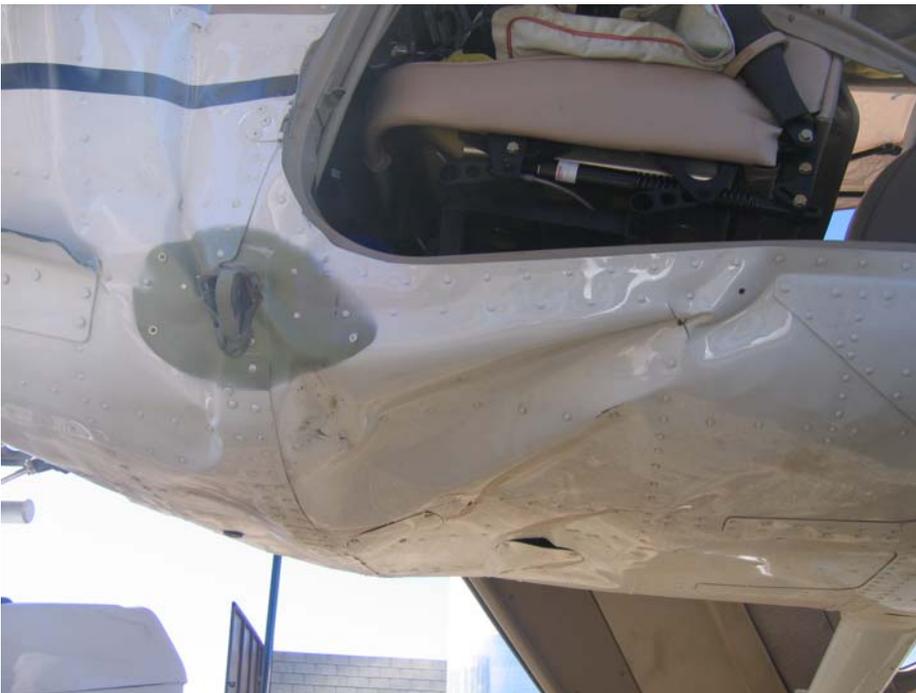
Figure 14: Damage to the underside of the aircraft under the pilot's seat position.

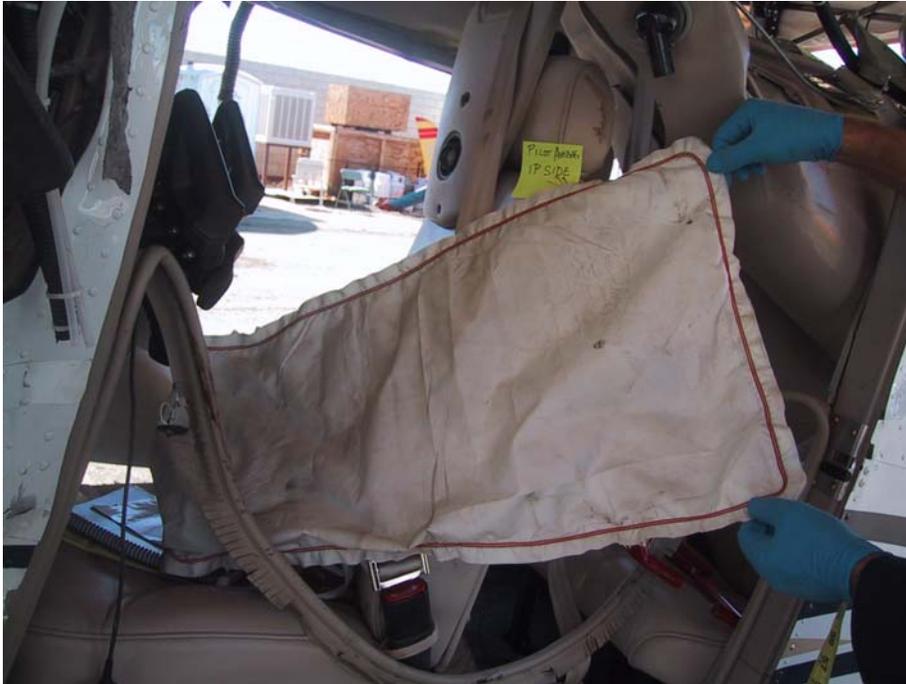
The general dimensions of the pilot side airbag were 30" long, 17" wide at the top of the airbag, and 14" wide at the bottom of the airbag. (Figure 20) On the instrument panel side of the airbag (i.e., surface that strikes the instrument panel), transverse or side-

Figure 20: A photograph showing the pilot's airbag on the side facing the instrument panel. The top of the airbag is toward the right of the photograph.

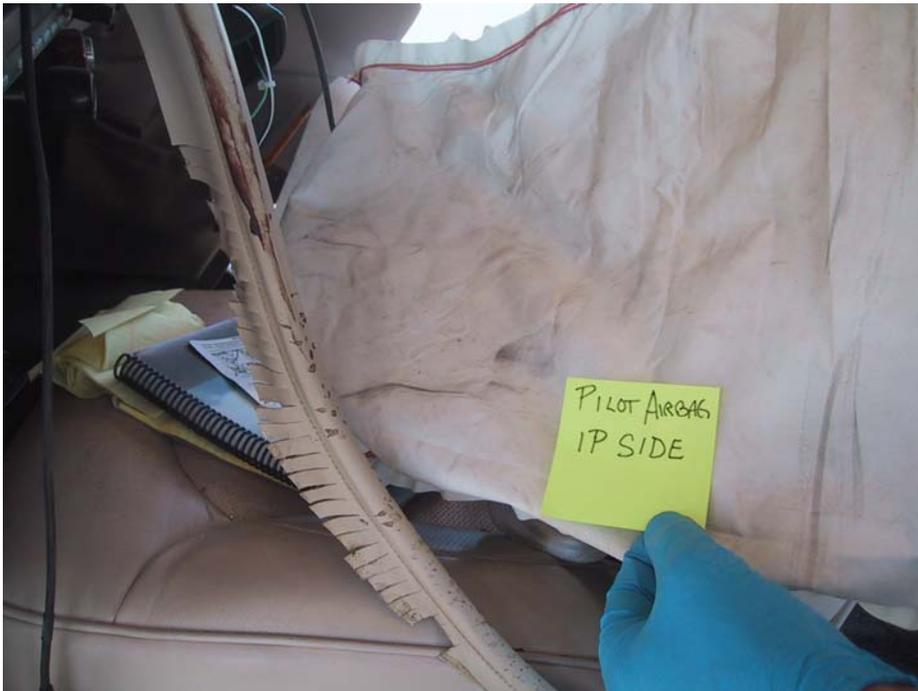
to-side scuff marks were found 14" up from the bottom of the airbag. A black vertical scuff mark was noted 3" from the left seam, extending from 4" from the bottom of the airbag to 7". Round scuff marks were noted 5" from the left seam and 7" from the bottom of the airbag with a 1.5" diameter. (Figure 21) (The emblem on the control yoke has a similar diameter on the short axis.) The black vertical scuff mark appeared to correspond in position to scuff-marks found on the right lower portion of the left yoke. (Figure 22) A final set of scuff marks were noted in the center of the airbag on the bottom, extending vertically upward to 4".

Figure 21: Scuff marks on the instrument panel side of the pilot's airbag.

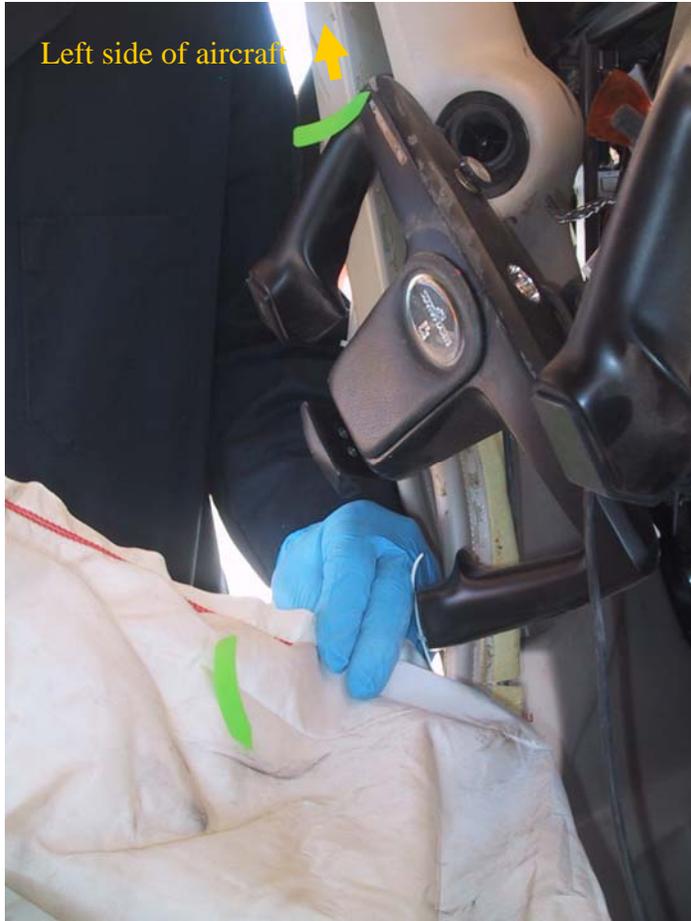
Figure 22: Scuff marks corresponding to marks on the pilot's yoke.

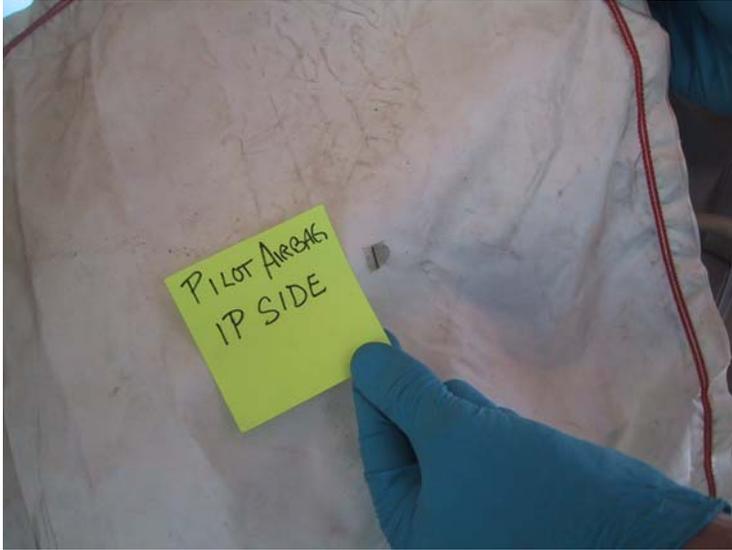
The airbag is equipped with a single vent hole that exhibited squaring to six strands. (Figure 23) Generally, the airbag was in good condition, showing no tears or cuts, and a small normal separation at the belt. On the pilot's side of the airbag (i.e., the surface that strikes the pilot, Figure 24), two blood spots were found in the upper right corner, 2" from the right seam and 3" down from the top. There were small scattered blood spots on the upper left quadrant of the bag. The belt was also in good condition and the airbag cover appeared to split normally.

Figure 23: The single vent hole on the pilot's airbag.

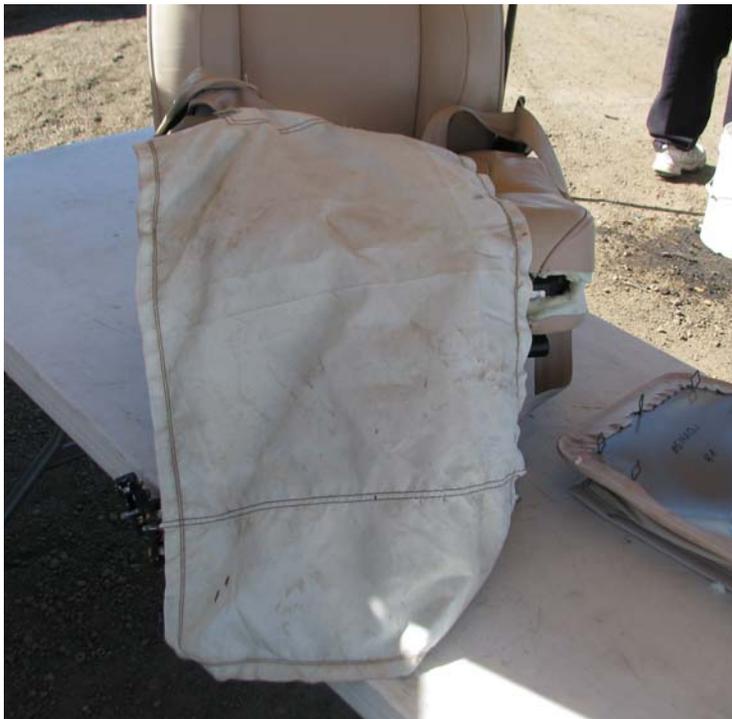
Figure 24: A photograph showing the pilot's airbag on the occupant's side. The top of the airbag is at the bottom of this photograph.

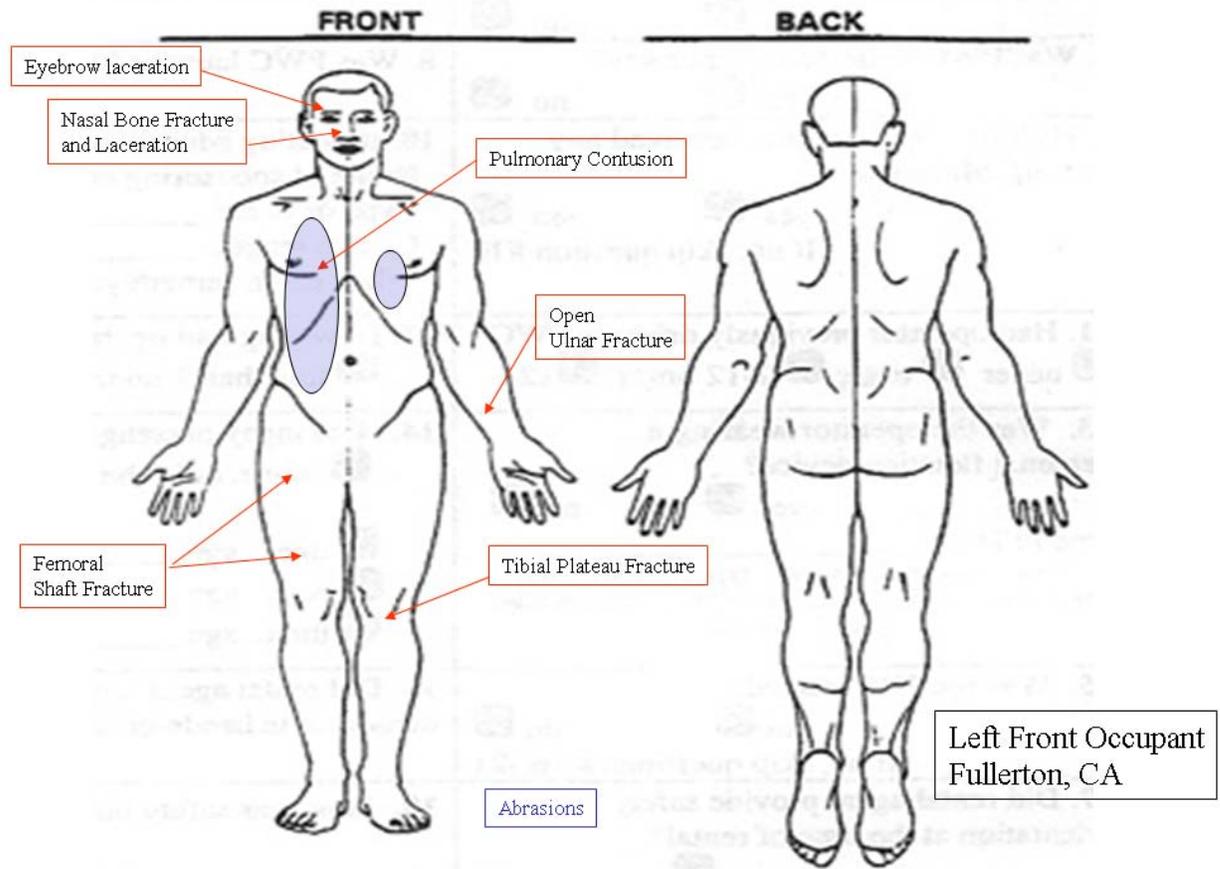
Occupant Location	Gender	Age	Height	Weight	Description Of Injuries	Injury Classification
1 st Row, Left	M	1/14/49	5' 11.5"	245 lbs	Right proximal femoral shaft fracture; left tibial plateau fracture; right distal nondisplaced femoral shaft fracture; right open ulnar fracture; right anterior pulmonary contusion; nasal bone fracture; stellate laceration across bridge of nose (6 cm); right eyebrow laceration (3 cm); abrasion, hematoma on left chest; abrasions across right upper and lower quadrant	Serious

Figure 25: A diagram showing the injury locations.
