Survival Factors and Biomechanics
Airbag Safety Study Field Notes
May 18, 2009

Location: Deltona, FL
Aircraft Type: Cirrus SR20
Accident Date: February 17, 2009
Accident Time: 1513
Accident Number: ERA09FA169
Airbag Equipped: yes

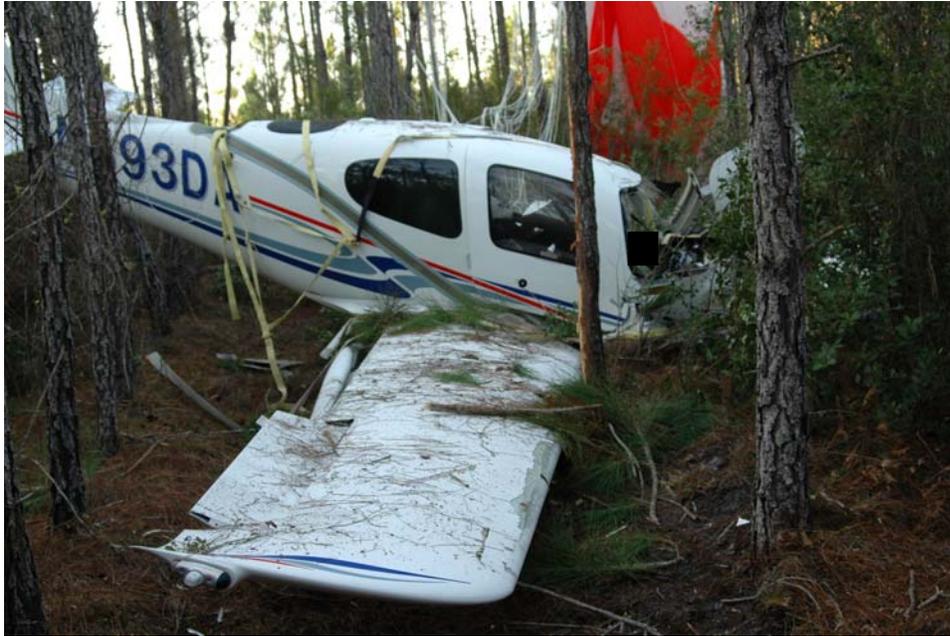
Significant damage was noted to the nose of the aircraft (see Figure 1 and Figure 2) with intrusion into the cockpit region at the level of the instrument panel and the foot wells. The windshield was broken. The left and right cabin doors remained attached to the fuselage and neither door window was broken. The right cabin door was found in the opened position. A longitudinal crack was noted on the roof of the aircraft. (See Figure 3.) The cabin roof was fractured at the aft bonded roll cage but the remaining cabin roof was intact. The instrument panel intruded into the passenger compartment by between 10 and 15".¹ Extensive floor crush was also noted in this accident airplane. In addition, the outboard rudder pedal on the left seat side was fractured on the top, outboard corner. (See Figure 4.) The Cirrus Airframe Parachute System (CAPS) had been activated. The enclosure cover was found 40' forward of the right wing tip. The CAPS rocket motor, pick-up collar, rocket lanyards and other associated equipment were found 52' forward of the wreckage.²

Figure 1: An on-scene photograph of the accident airplane looking at the right side of the aircraft.

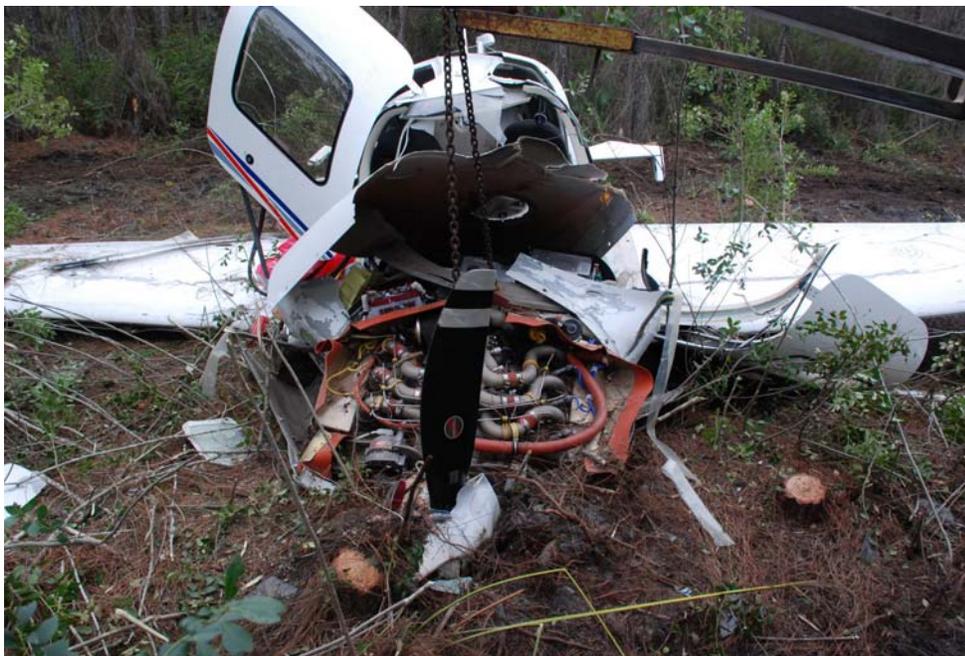
Figure 2: An on-scene photograph of the accident airplane at the nose of the aircraft after the trees were removed from the region.³

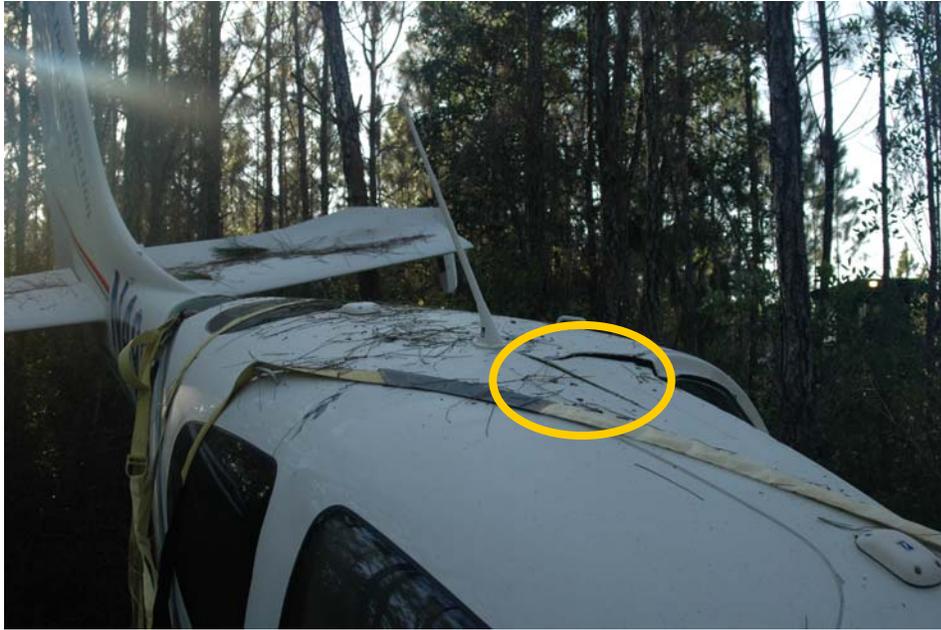
Figure 3: An on-scene photograph showing the longitudinal crack in the roof of the aircraft. (yellow circle)

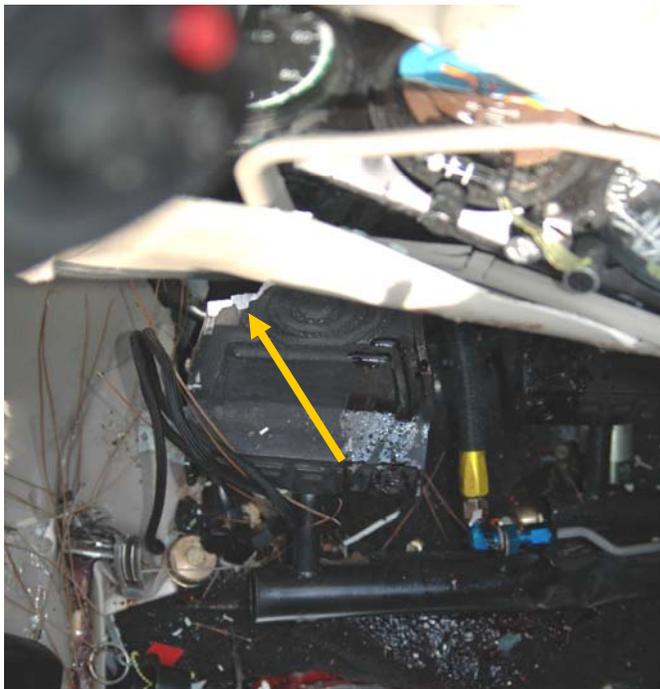
Figure 4: A photograph showing the fractured outboard rudder pedal on the left seat side.

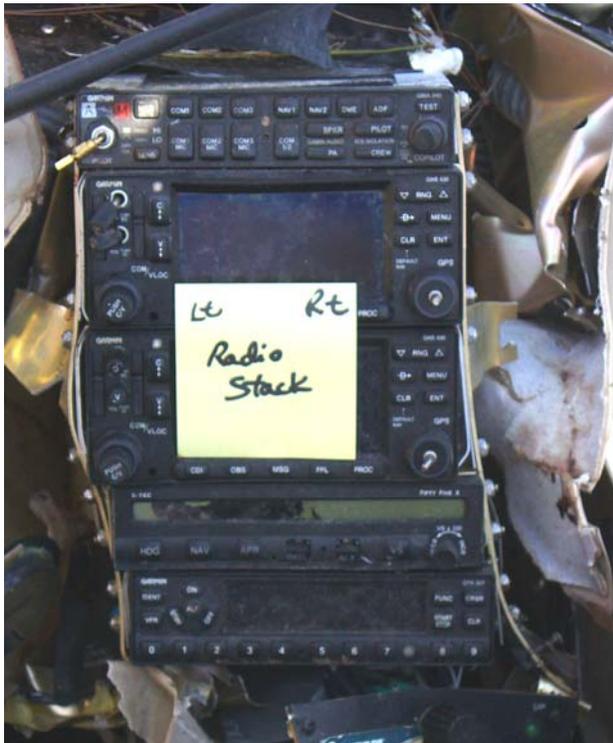
On-scene photographs detailed many impact marks in the cockpit. The overhead visors were broken on both sides of the aircraft. On the left seat side, impact marks were noted on the left side of the radio stack including the Garmin Pilot adjustment which was bent down and to the left and the knob was missing. The Garmin Push SQ and the Push ID adjustments were also bent down and to the left. The Garmin GPS knob was missing and the adjustment was bent

down and to the left. (See Figure 5.) Damage was also noted to the throttle which was bent toward the left side. (Figure 6) A photograph of the interior of an exemplar aircraft is shown in Figure 7. Blood was noted on the top, left side of the radio stack and on the left side radio stack controls. Blood was also present on the instrument panel adjacent to the left side of the radio stack. The left seat occupant's head came to rest on the left upper corner of the radio stack, with the airbag trapped between the head and radio. The restraint shoulder straps were on the shoulders. The left side stick controller was visible directly adjacent to this occupant's left elbow.

Figure 5: Damage to the radio stack.

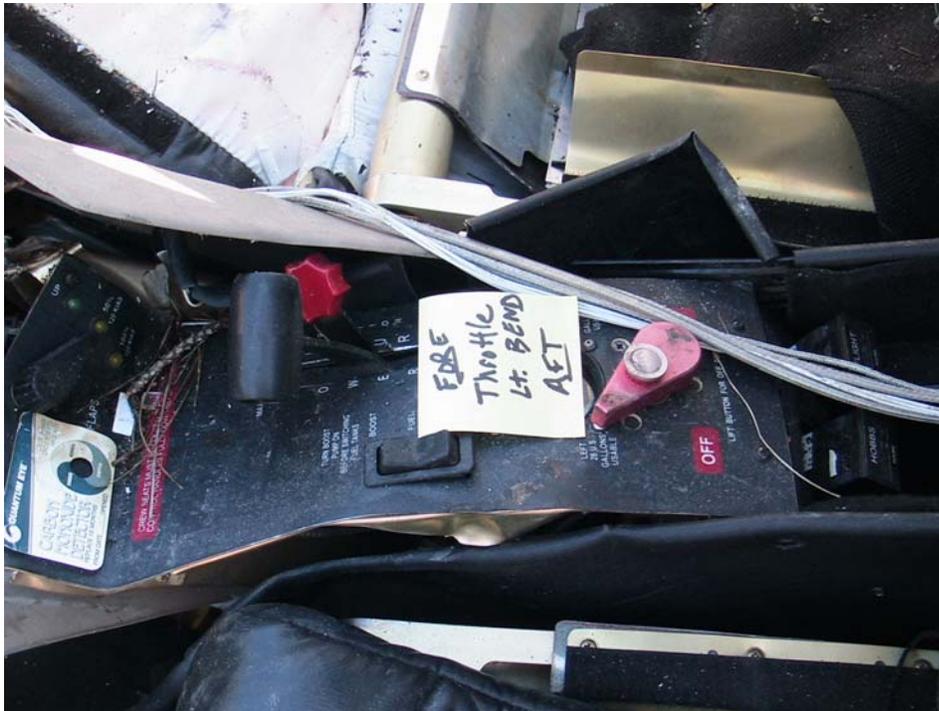
Figure 6: Damage to the throttle.

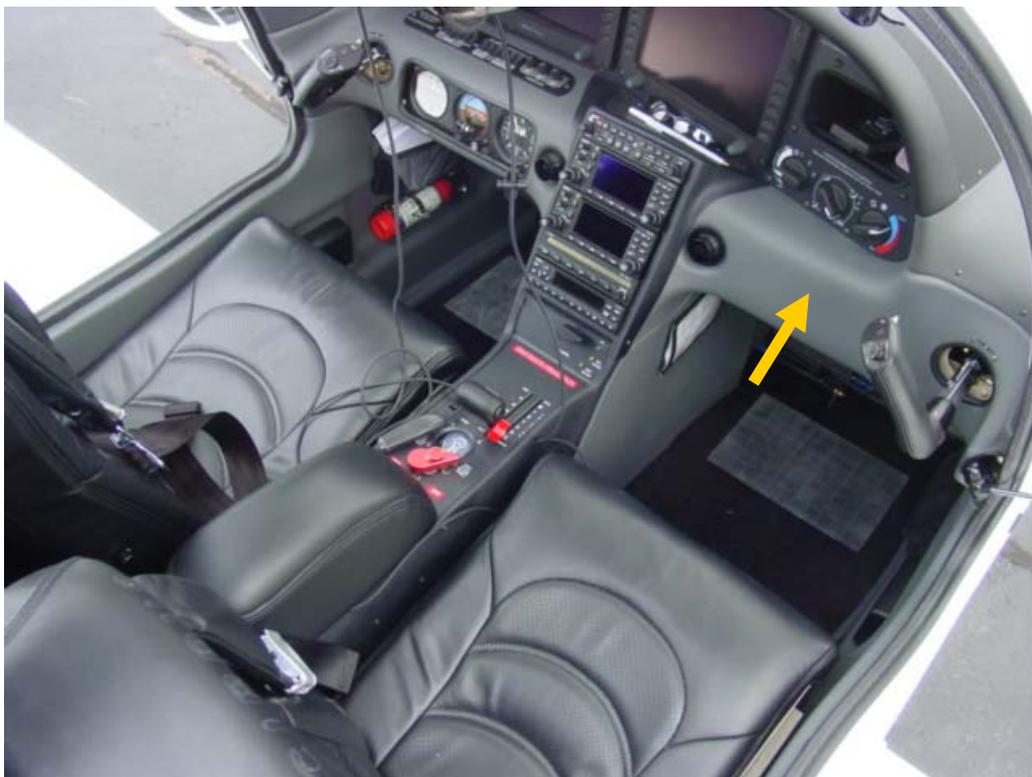
On the right seat side, the temperature gauges were damaged with the knobs missing from the two outboard temperature controls. The instrument panel was found to have a concave depression and buckling in the region indicated by the yellow arrow in Figure 7. Blood was found across the surface of the instrument panel, with the heaviest concentrations found next to the control stick. The right seat occupant's head came to rest at the location of the temperature controls. The restraint shoulder straps were on the shoulders, and the airbag was to the right of the occupant. The right side cabin door also showed damage to the region of the arm rest and under the door handle. (See Figure 8.)

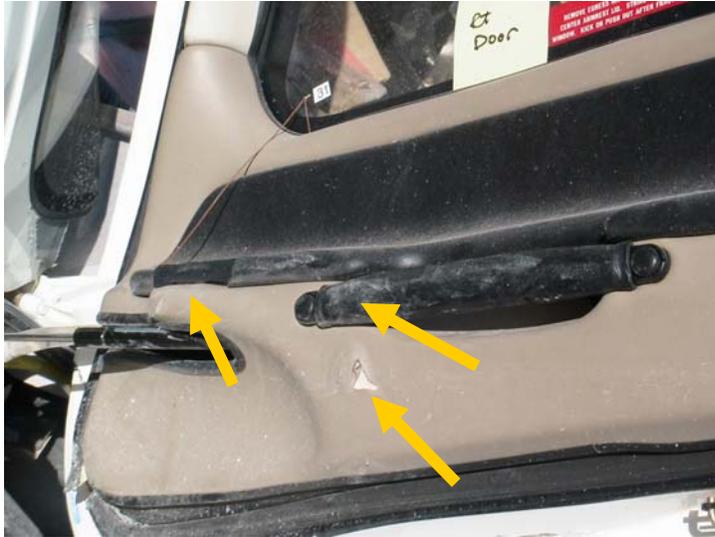
Figure 8: Damage to the forward portion of the right cabin door.

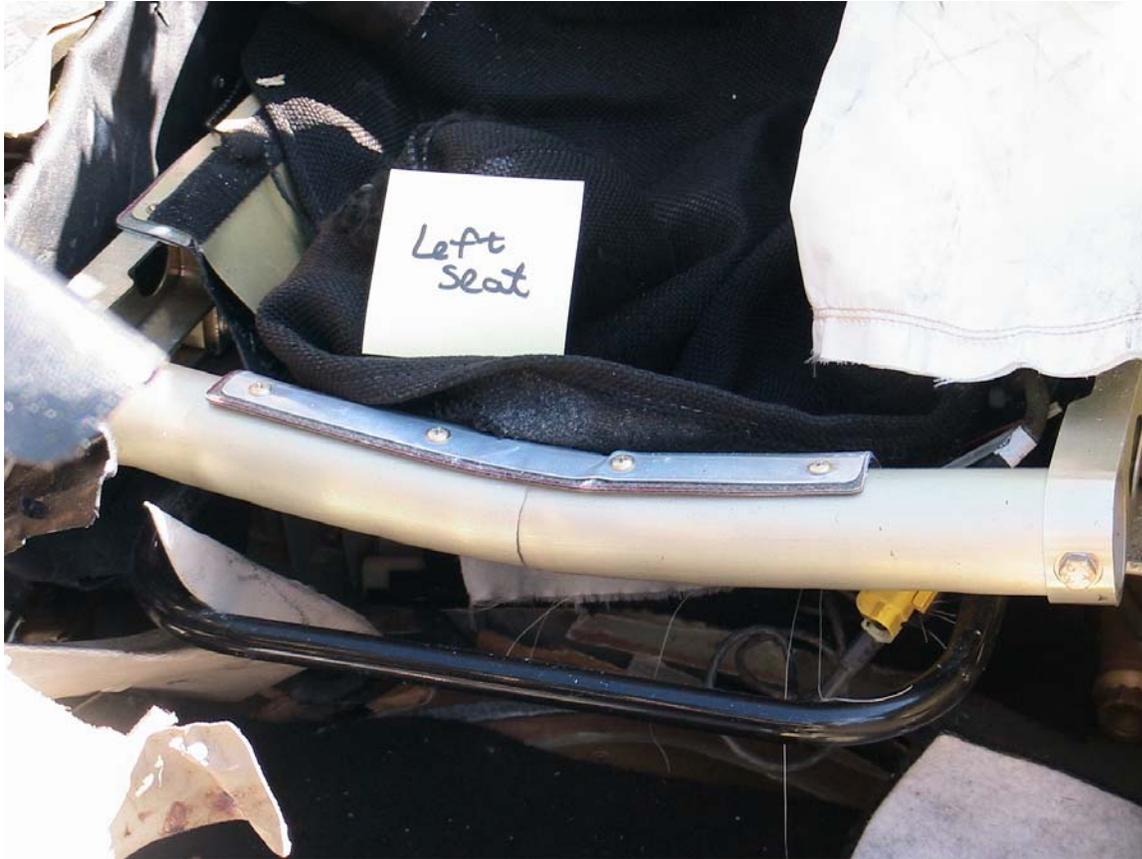
The seats were examined at Quality Aircraft Salvage⁴ yard. The general seat dimensions are shown in Figure 9. The left seat was found in a position that was five pins back from full forward. On the left seat, the carbon fiber seat pan was fractured on both the outboard and inboard front corners. The rear corners were not fractured. The front spreader tube was cracked and deformed downward. (See Figure 10.) The outboard spreader beam was deformed at the support beam 5.5" back from the front spreader tube. The energy absorption module in the seat pan was also deformed. The remaining thickness of the module was documented and is shown in Figure 11.

Figure 10: Cracked front spreader tube on the left seat.

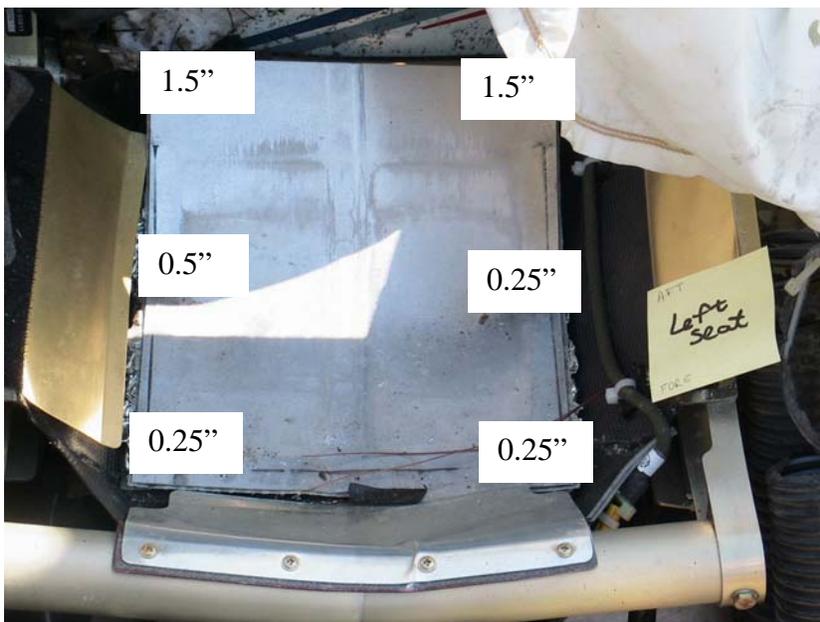
Figure 11: Energy absorption module on the left seat.

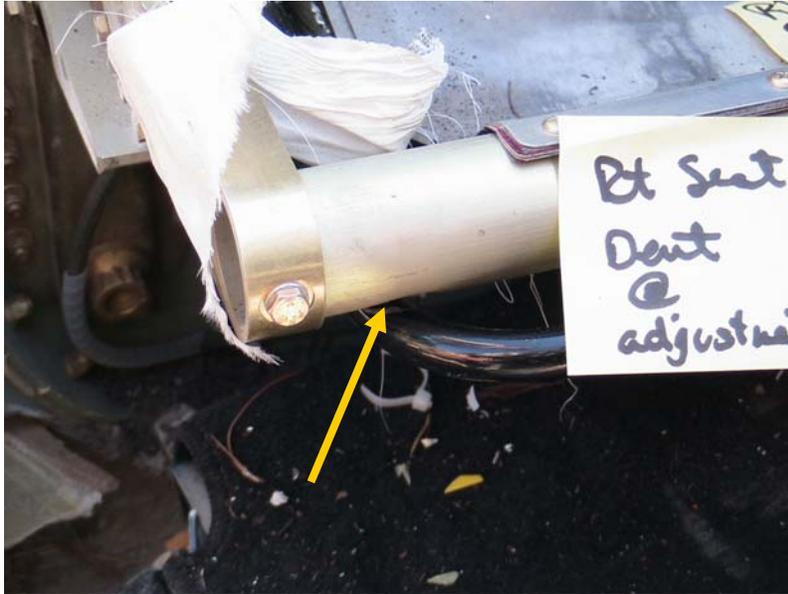
the outboard front edge with the crack propagating horizontally back 4” toward the seat back. There was no spreader beam damage on this seat but the spreader tube was dented on both the inboard and outboard edges where it impacted the seat adjustment bar. (See Figure 12.) The energy absorption module in the seat pan was also deformed. The remaining thickness of the module was documented and is shown in Figure 13.

Figure 12: Dents on the spreader tube resulting from contact with the seat adjustment bar.

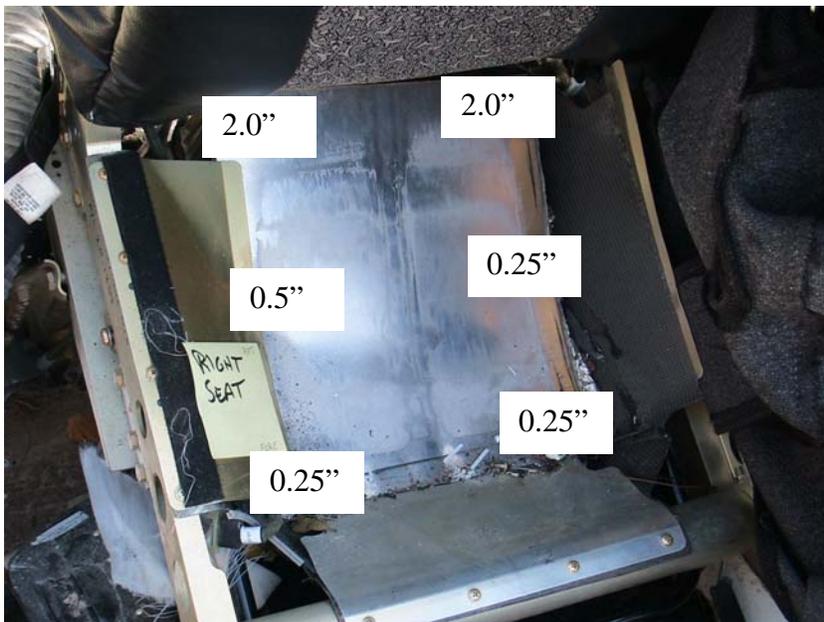
Figure 13: Energy absorption module on the right seat.

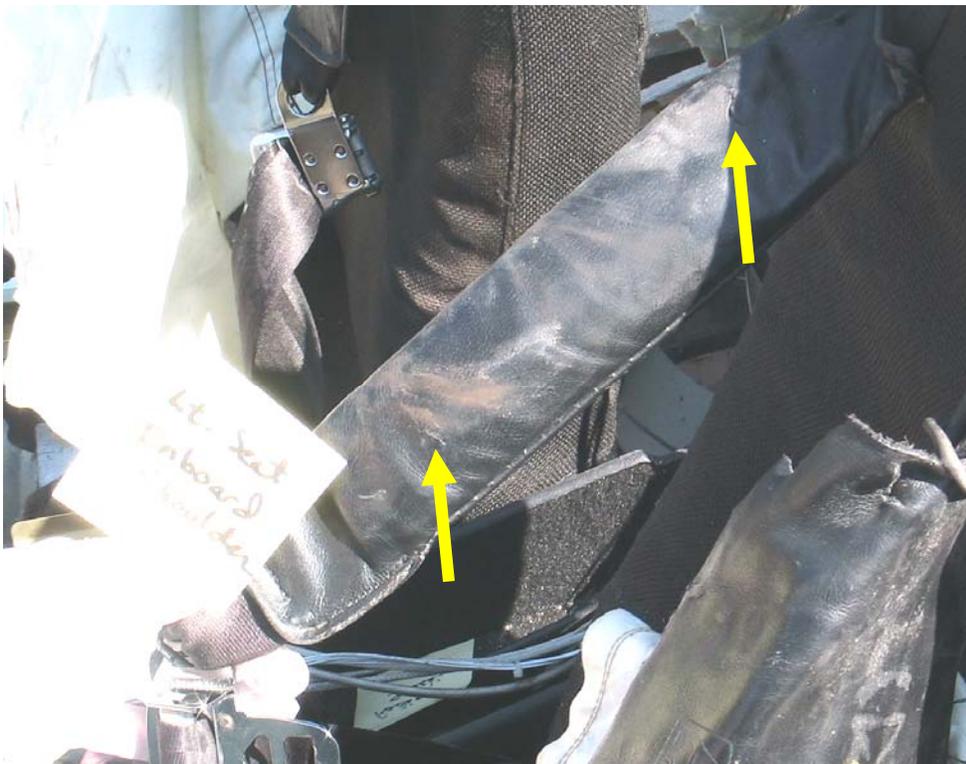
The accident aircraft was equipped with four-point restraint systems at all four seating positions. For the left, front seat, the position of the load bar was documented in its position as found. The load bar on the buckle side was located 18” from the anchor bolt. On the connector side, the load bar was also located 18” from the anchor bolt. Both inertia reels and the buckle were functional. Scuff marks (Figure 14) were noted to the inboard shoulder harness on the leather cover. In addition, there were two cuts on the leather cover. The first cut was located 5” from the center of the connector and the second cut was 13” up from the center of the connector. On the connector side of the belt, there was a small divot (Figure 15) on the upper pawl⁵ corner. Witness marks (Figure 16) were found under both the inboard and the outboard side of the shoulder harness under the found position of the connector and buckle load bars, respectively. The witness marks were noted to be the result of heavy loading on the restraint systems.

Figure 14: Scuff marks and cuts on the inboard shoulder harness on the left, front seat.

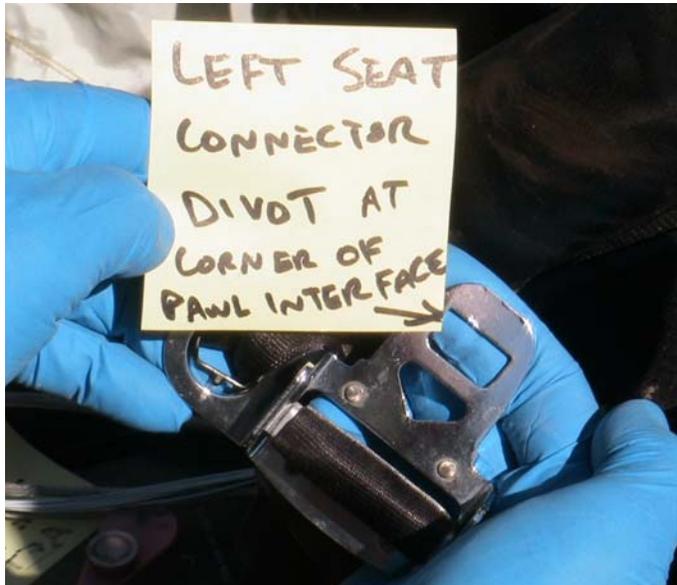
Figure 15: A divot noted on the connector side of the left, front seat's restraint system.

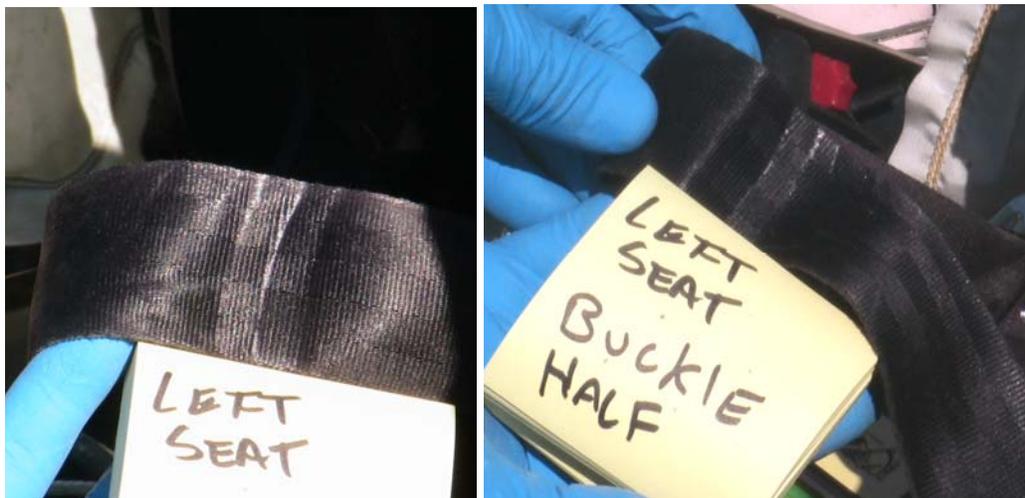
Figure 16: Witness marks on the connector side (left photograph) and the buckle side (right photograph) found under the load bar position for the left, front seat restraint system.

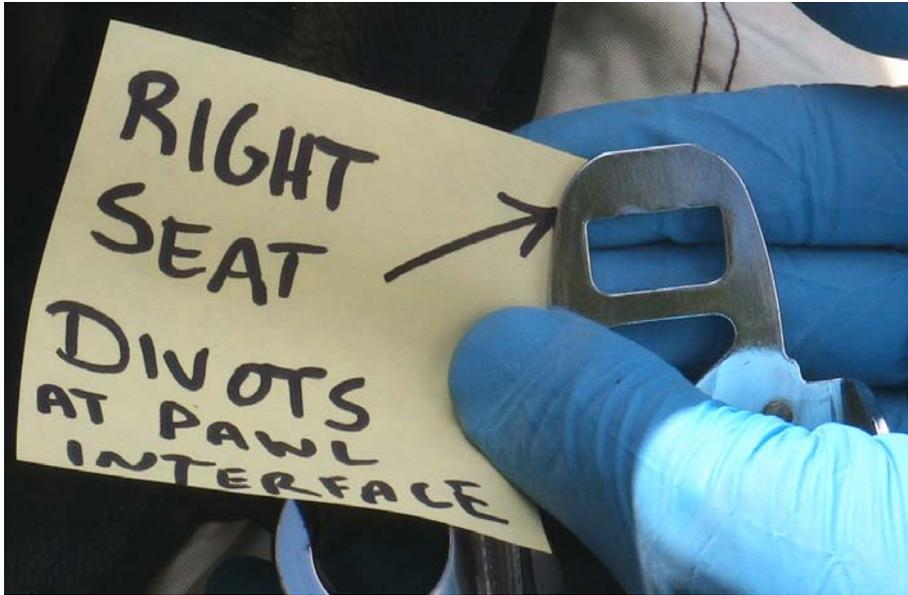
For the right, front seat, the position of the load bar was documented in its position as found. The load bar on the buckle side was located 16.5" from the anchor bolt. On the connector side, the load bar was located 20.5" from the anchor bolt. Both inertia reels and the buckle were functional. On the connector side of the belt, there were two divot marks (Figure 17) on each end of the pawl corner. A small divot (Figure 18) was also noted on the pawl side of the buckle and corresponded to the connector divot on the upper edge. A tear (Figure 19) was documented in the webbing on the connector side of the shoulder restraint, which was located 17.75" from the anchor bolt. Witness marks on this restraint were not as heavy as on the left seat's restraint system. On the connector side, the witness marks began near the tear and extended from 17.75" to 19.75" from the anchor bolt. On the buckle side, the heavy witness marks (Figure 20) were noted under the location of the load bar. Blood was also noted on the inboard shoulder harness on the side facing the occupant. Upon examination, the inboard

Figure 17: Divot marks on the connector side of the right, front seat's restraint system.

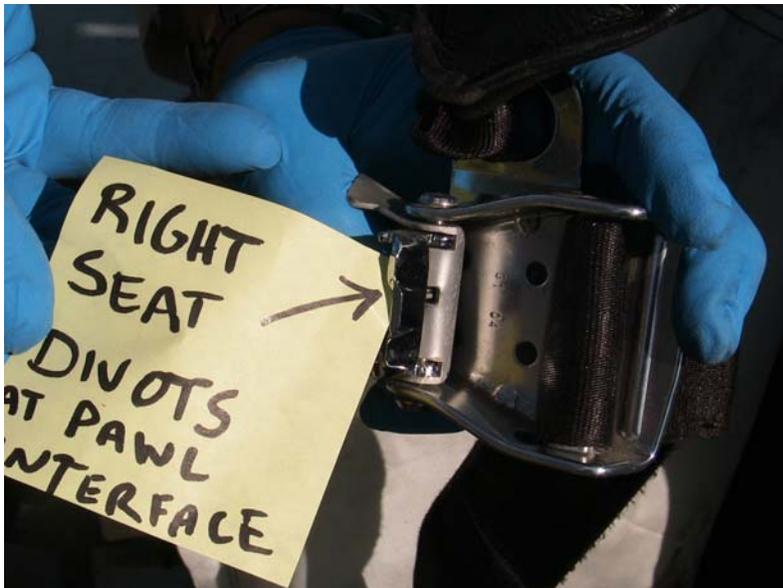
Figure 18: A small divot mark on the pawl side on the buckle, corresponding to the upper edge divot on the connector side.

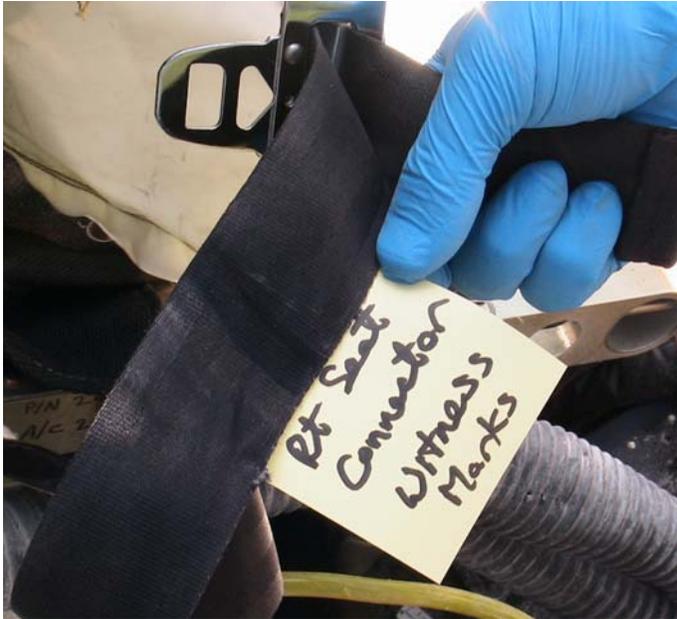
Figure 19: Witness marks and a tear in the webbing on the connector side of the right, front seats restraint system.

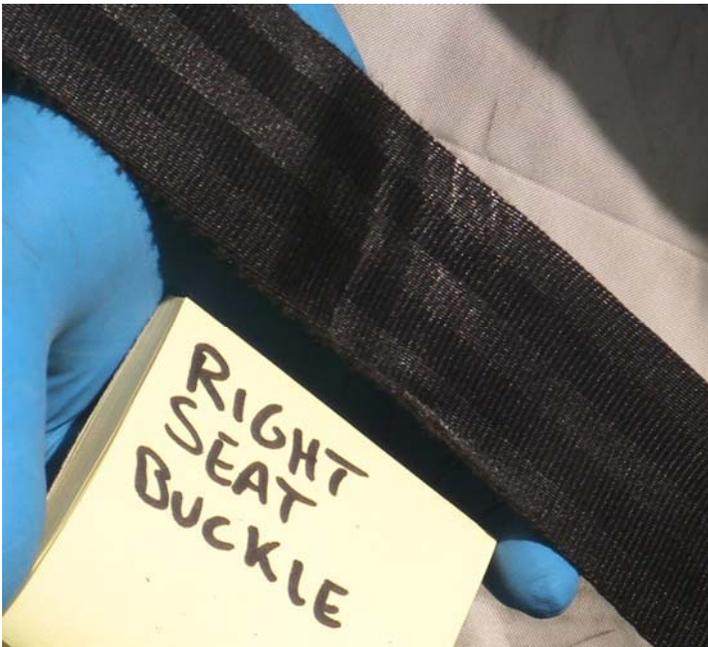
Figure 20: Witness marks on the buckle side found under the load bar position for the right, front seat restraint system.

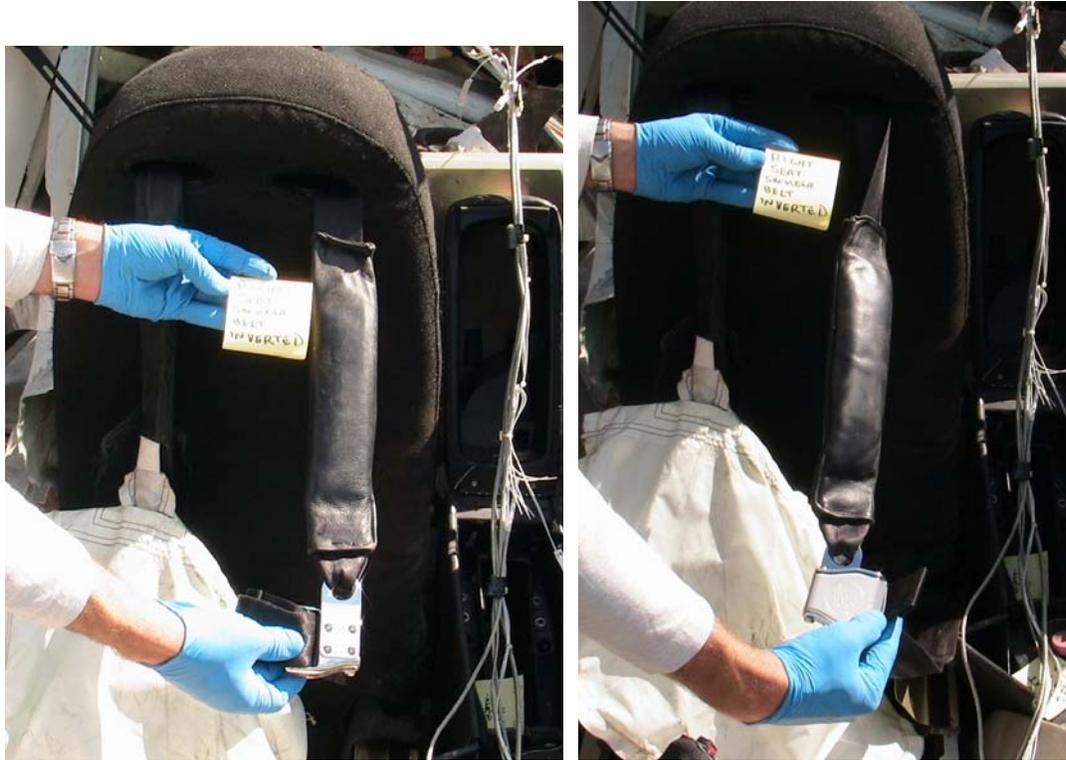
shoulder harness was found to be twisted (Figure 21) such that the buckle was facing inboard rather than outboard. After removal of the seat cover, it was discovered that the twist was in the webbing between the inertia reel and the top of the seat back (Figure 22) where the webbing passes through to the front of the seat.

Figure 21: Photographs showing the inverted inboard shoulder harness on the right, front seat.

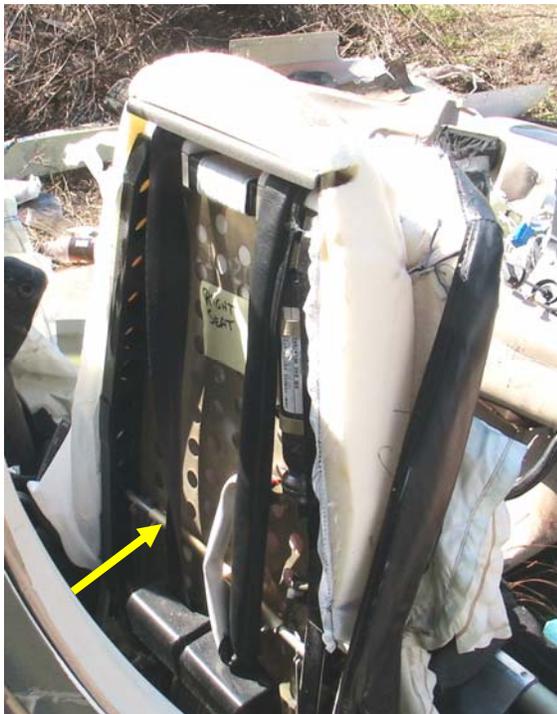
Figure 22: The twist in the webbing, marked with a yellow arrow, of the inboard shoulder harness on the right, front seat originated between the inertial reel and the top of the seat back.

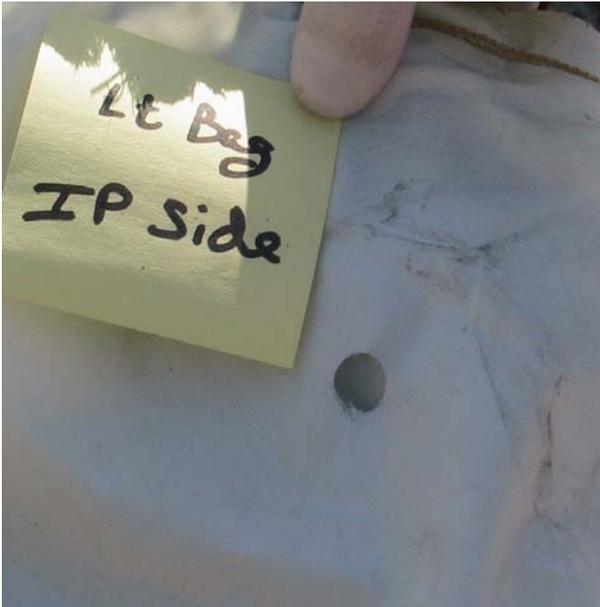
For the left, front seat airbag, the top vent hole (Figure 27) was squared extending to 15 threads. The squaring was also noted to be asymmetric. The bottom vent hole (Figure 28) was squared extending 11 threads with a more classic V-shaped pattern. The doubler panel⁶ vent hole was also squared extending approximately 10-11 threads.

Figure 27: The top vent hole on the instrument panel side of the left, front airbag.

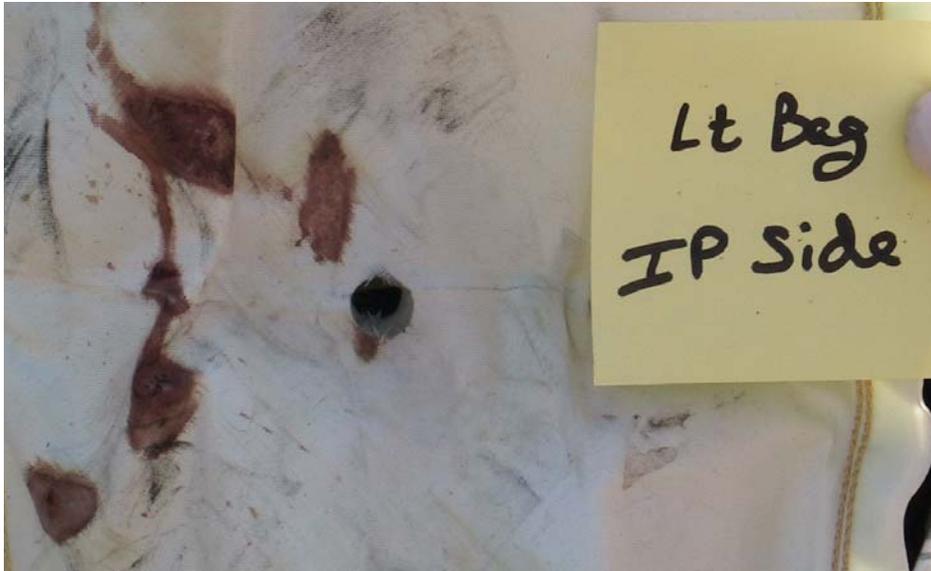
Figure 28: The bottom vent hole on the instrument panel side of the left, front airbag.

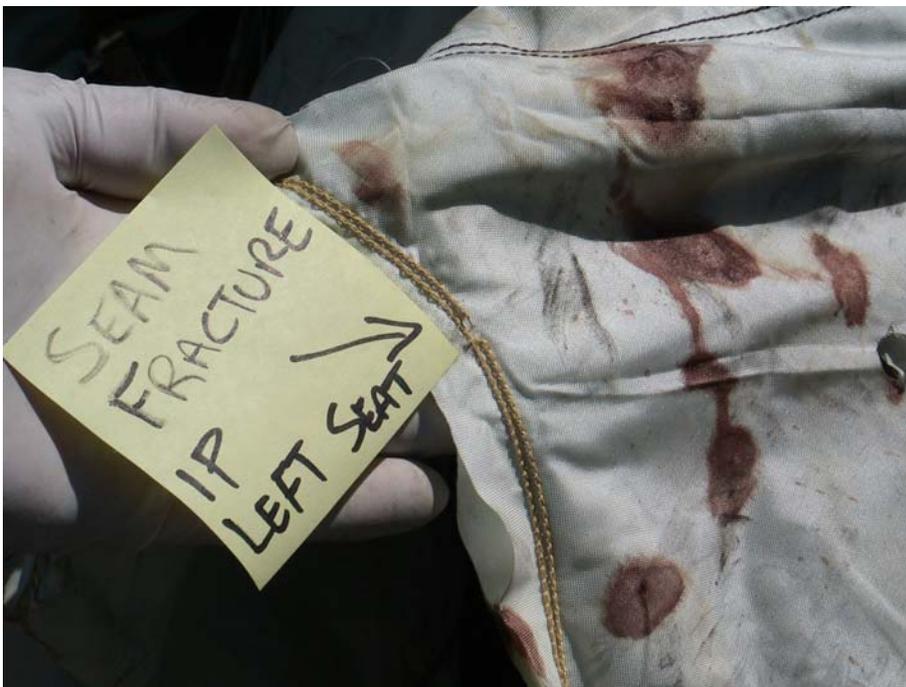
The perimeter seams did not show seam combing (or stretching of the airbag seams). The perimeter seam was fractured (Figure 29) on the lower inboard side, below the curve at two stitch points. The doubler seams were intact. The mounting seams, those seams that attach the airbag to the belt, were intact and the hose attachment⁷ seams were intact. Upon examination of the seat back, after the seat cover was removed, it was noted that the inflator brackets, mounted on the seatback, were loose. The inflator hose was intact. A half-moon shaped tear was present on the instrument panel side of the airbag. The threads on the torn edges were heavily frayed. The tear (Figure 30) was located 9" from the top of the bag on the inboard edge of the bag and terminated 9" from the top of the bag in the center of the airbag. The total length of the tear was approximately 9". Scraping marks were noted along the tear pattern on the lower side of the tear. In addition, black scuff marks were found extending from the bottom of the tear toward the bottom of the airbag. A thread scrape extending 3.5" from the inboard edge of the tear down toward the middle of the tear was documented and was noted to be in line with the black scuff marks and also inline with a partial puncture/divot (0.5" below the tear, 0.5" in diameter) in the airbag (Figure 31).

Figure 29: The perimeter seam was fractured on the lower inboard side, below the curve at two stitch points on the left, front airbag.

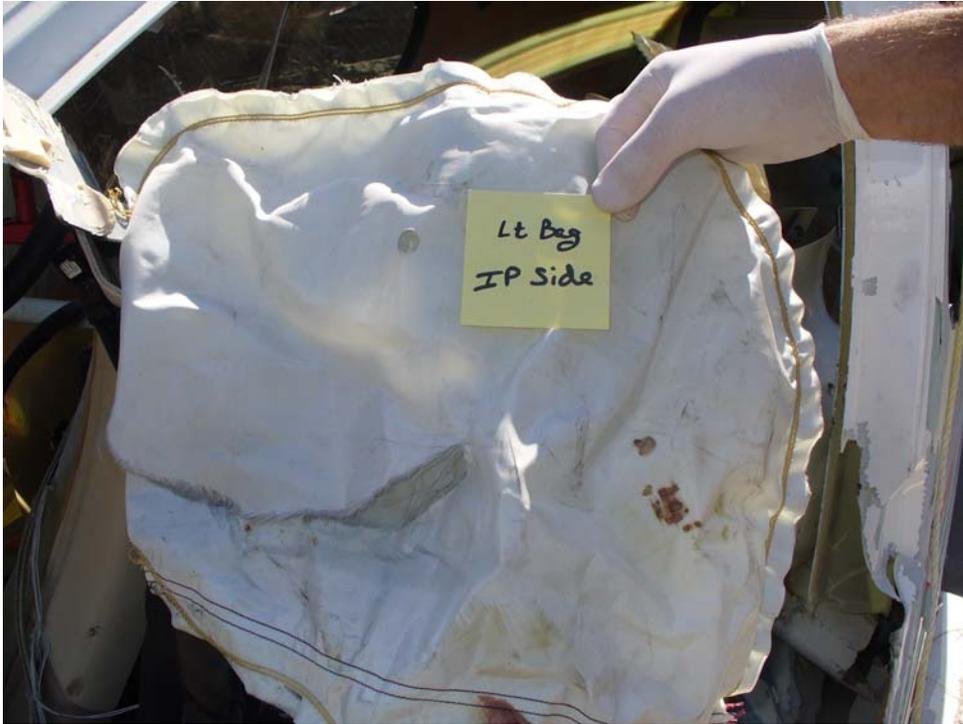
Figure 30: A tear was documented on the instrument panel side of the left, front airbag.

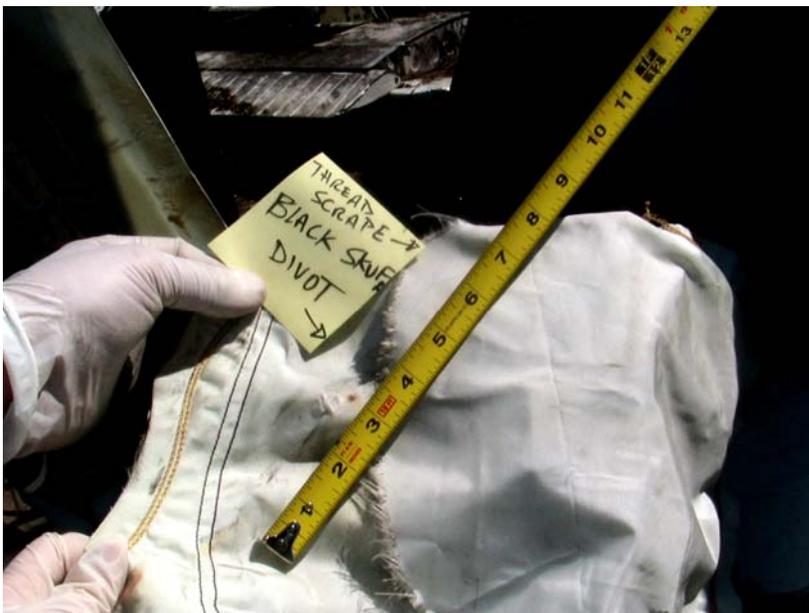
Figure 31: A thread scrape extending 3.5 “ from the inboard edge of the tear down toward the middle of the tear was documented and was noted to be in line with the black scuff marks as well as a partial puncture/divot (0.5” below the tear, 0.5” in diameter) in the left, front airbag.

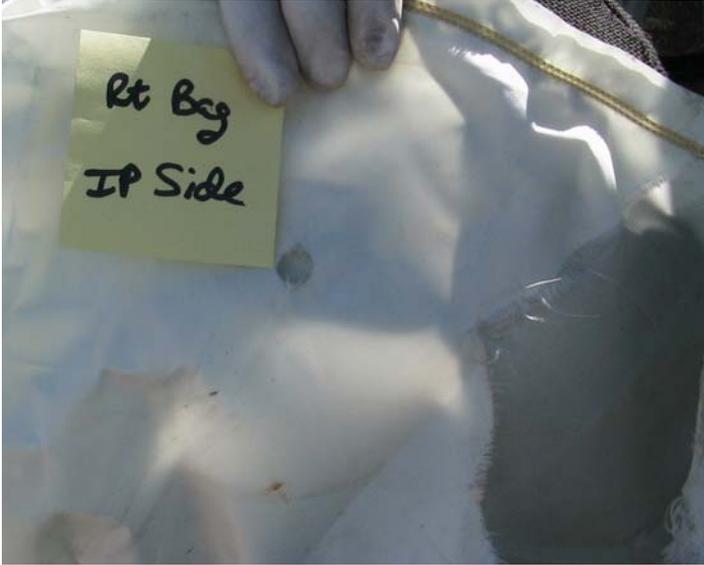
For the right, front seat airbag, the top vent hole (Figure 32) was squared extending 15 threads. The bottom vent hole (Figure 33) was squared also extending 15 threads. The doubler panel vent hole was also squared extending approximately 8-9 threads. The perimeter seam was fractured (Figure 34) on the curve on the lower inboard side two to three stitch points. The doubler seams were intact. The mounting seams were intact and the hose attachment seams were intact.

Figure 32: The top vent hole on the instrument panel side of the right, front airbag.

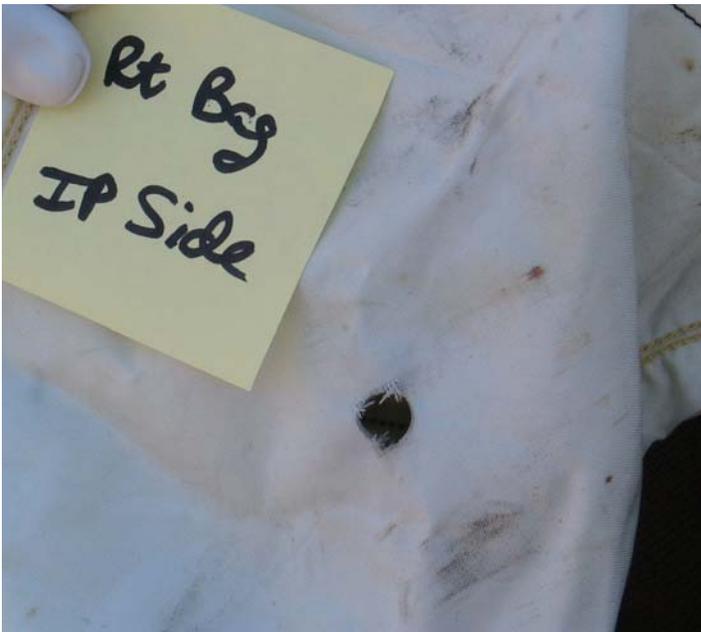
Figure 33: The bottom vent hole on the instrument panel side of the right, front airbag.

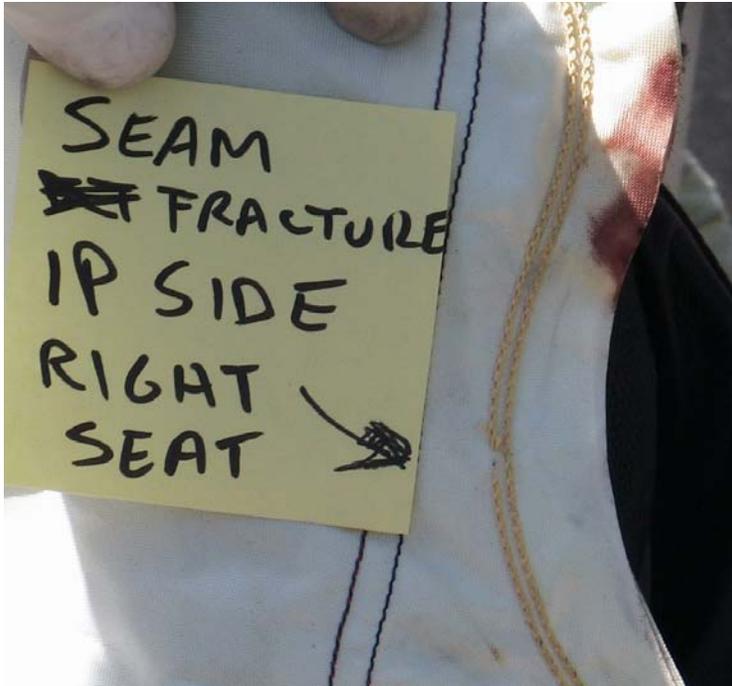
Figure 34: The perimeter seam was fractured on the lower inboard side, along the curve at two to three stitch points on the right, front airbag.

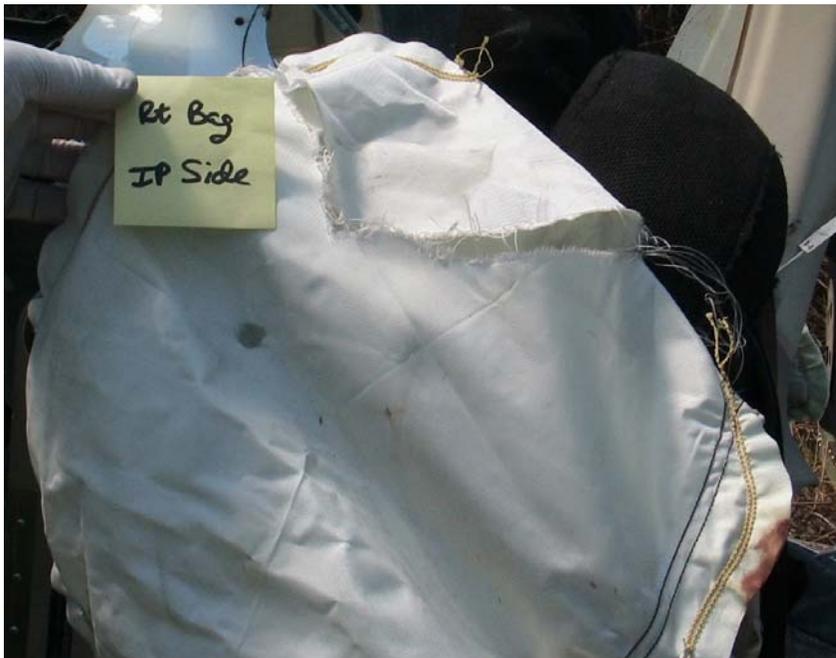
An L-shaped tear was present on the upper corner on the instrument panel side of the airbag. The tear (Figure 35) started at the top seam and 15" from the outboard edge. The tear progressed 5" straight toward the center of the airbag and then tore out 6.5" toward the inboard edge of the airbag. The tear terminated on the inboard edge of the airbag, 9" down from the top and 19" from the outboard edge. In the center of the airbag on the instrument panel side, there were half-moon shaped scrape marks that extended from the inboard top edge across the entire upper lobe and were approximately 16" in length. A black mark was noted near the tear (Figure 36) corresponding to the notch in the tear where the tear appeared to slightly change direction. In addition, black scrape marks were noted on the bottom lobe of the airbag.

Figure 35: An L-shaped tear was found on the instrument panel side of the right, front airbag.

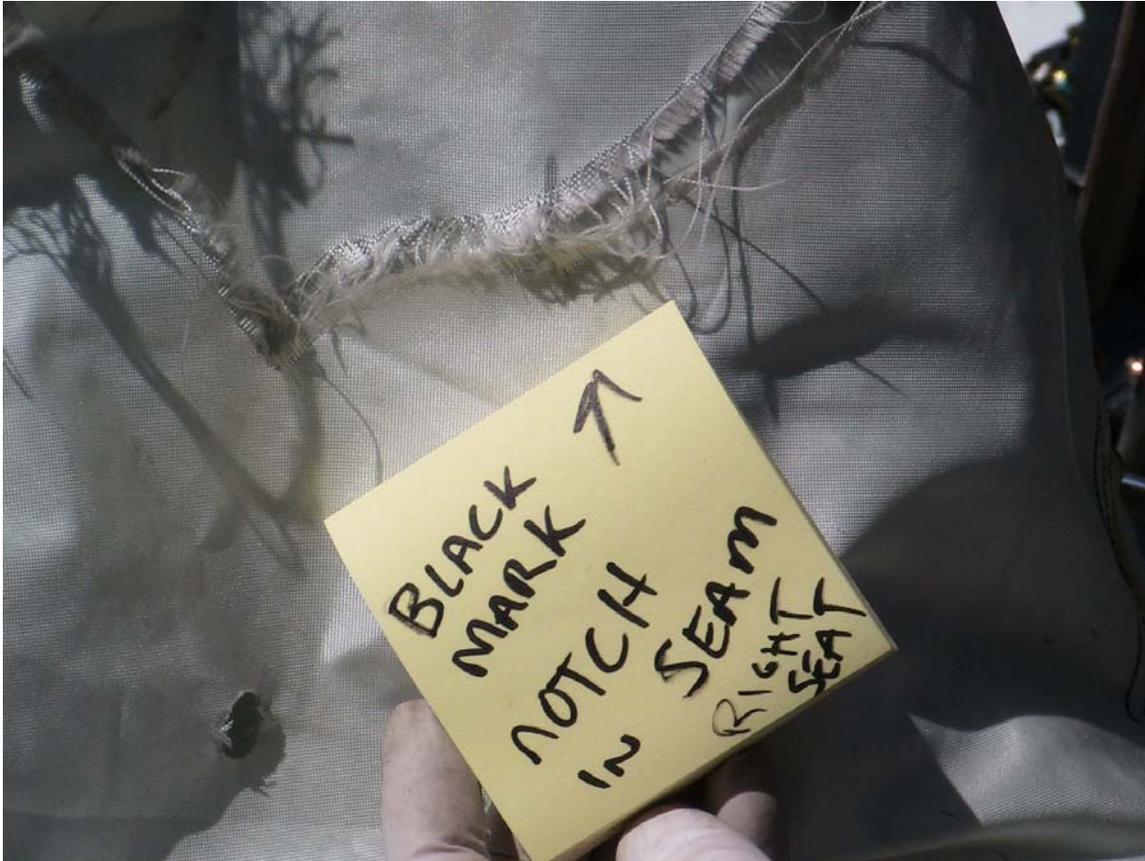
Figure 36: A black mark was noted near the tear on the instrument panel side of the right, front airbag. The mark was near the notch in the tear.

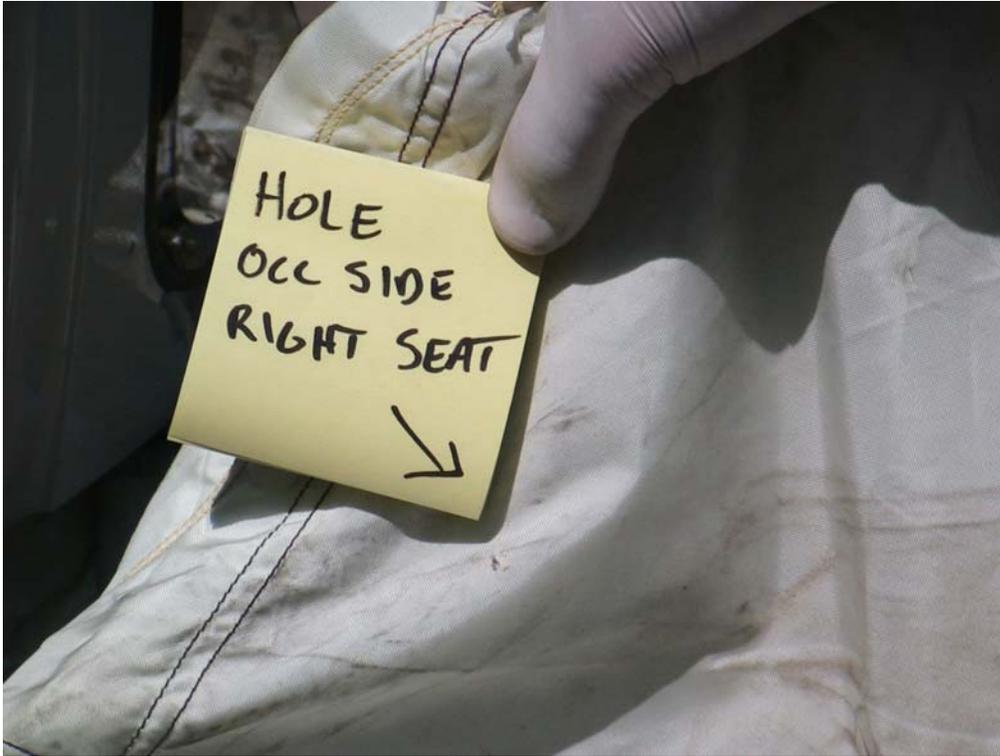
Two blood marks were noted on the instrument panel side of the airbag (Table 3) predominately on the lower edges of the airbag. Blood marks were not found on the occupant side of the airbag. Black scuff marks were noted of the occupant side of the airbag at the top of the airbag on the upper lobe. Black scuff marks were also present on the bottom, outboard edge of the airbag. A small hole on the occupant side of the airbag was found 12" down from the top and 11" from the outboard edge of the airbag. The hole was approximately 0.25" in diameter or approximately 4-5 threads in diameter (Figure 37).

Figure 37: A small hole was found on the occupant side of the right, front seat airbag.
