## Survival Factors

### Airbag Safety Study Factual

July 14, 2009

**Location:** Groton, Connecticut  
**Aircraft Type:** Cessna 172  
**Accident Date:** November 19, 2008  
**Accident Time:** 1833 EST  
**Accident Number:** ERA09LA064  
**Airbag Equipped:**

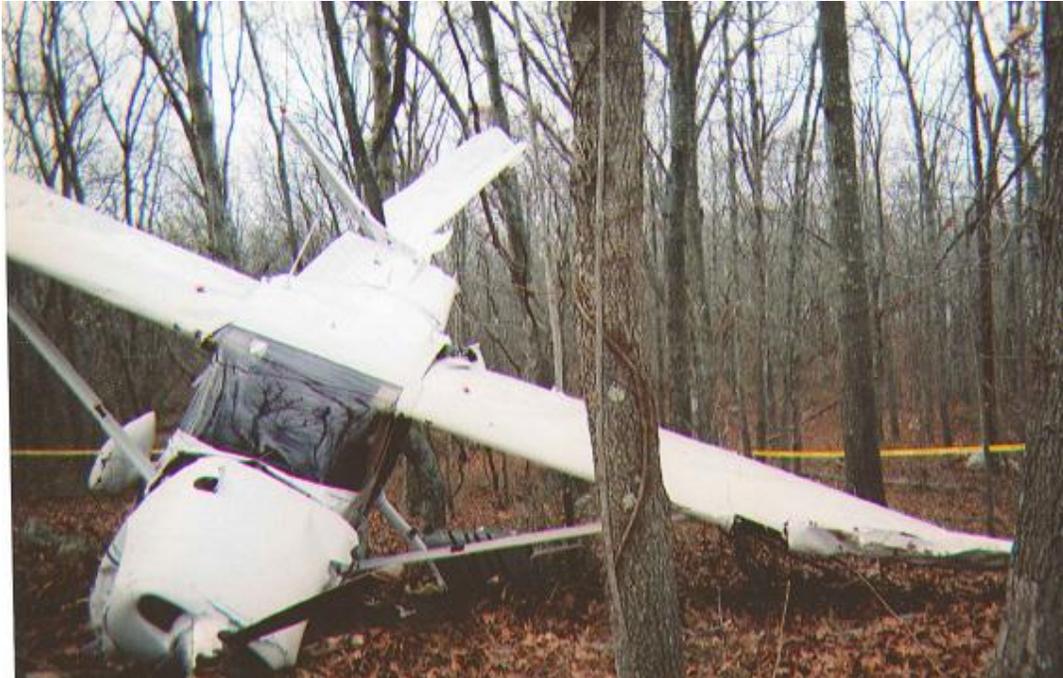
The airplane impacted the ground at the forward left side of the engine and came to rest nose down with its left wing tip crushed from impact with the ground (figure 1). The nose gear collapsed and the engine partially separated from its mounts. The glare shield was scratched across the upper window pane. The tail of the empennage was bent to the right at the middle of the registration number. The right cabin door was compressed inboard about 1 inch and the door was jammed in the closed position. The left cabin door separated from the airplane and its hinges were sheared where the door mounted to the upper and lower hinges.<sup>1</sup>

**Figure 1: The final rest position of the accident aircraft**

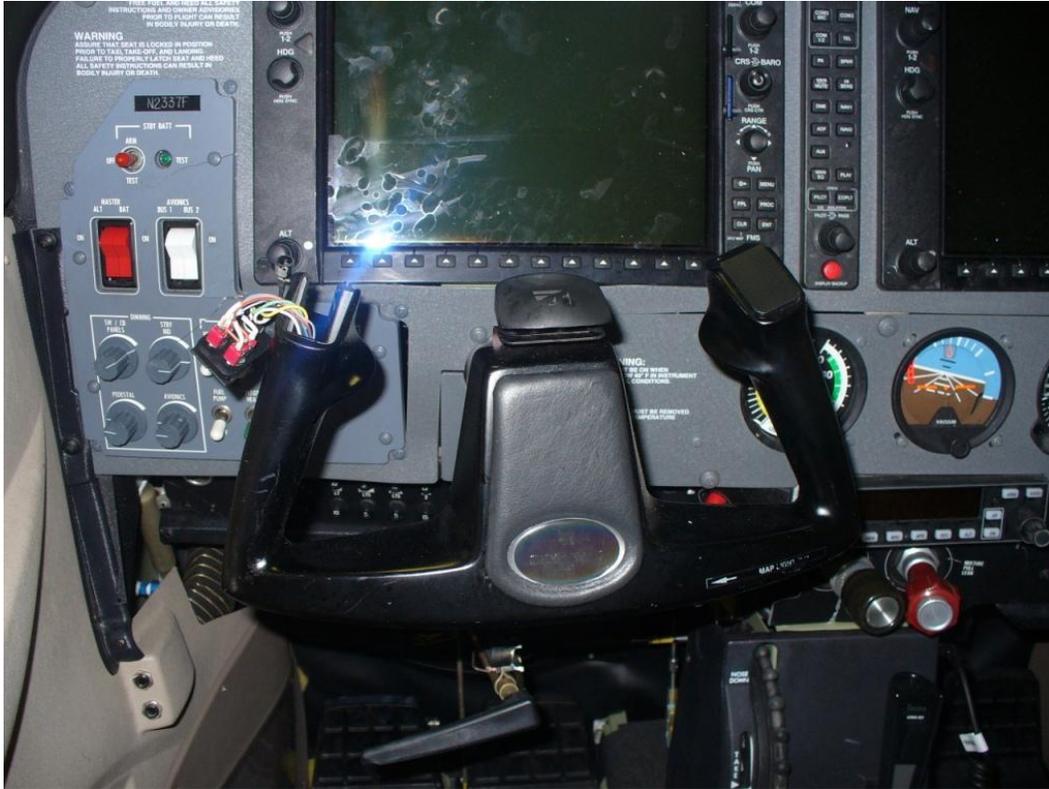
The upper trim control on the left side control column was fractured exposing the trim electrical wires (figure 2). The throttle lever was bent inboard towards the mixture control and the adjacent mixture lever was bent inboard towards the throttle lever resulting in a .10 inch gap between the throttle and mixture levers (figure 3). Additionally, the "wing flaps" lever on the right side of the cockpit was bent downward (figure 4) and the parking brake bracket was fractured and bent rearward. The fuel shutoff was in the "off" position. The fuse panel on the right lower side of the instrument panel was compressed forward and fractured at the outboard and center console. The outboard side of the instrument panel was compressed 4 inches forward toward the firewall and the inboard side next to the center console was compressed 3 inches forward. The panel containing: Master/Avionics, and Battery/Dimming/Lights switches on the left side of the instrument panel was displaced outboard about .10 inch and cracked in the middle of the panel. The Hobbs meter registered 899.2 hours.

Figure 2: The upper trim control on the left side control column.

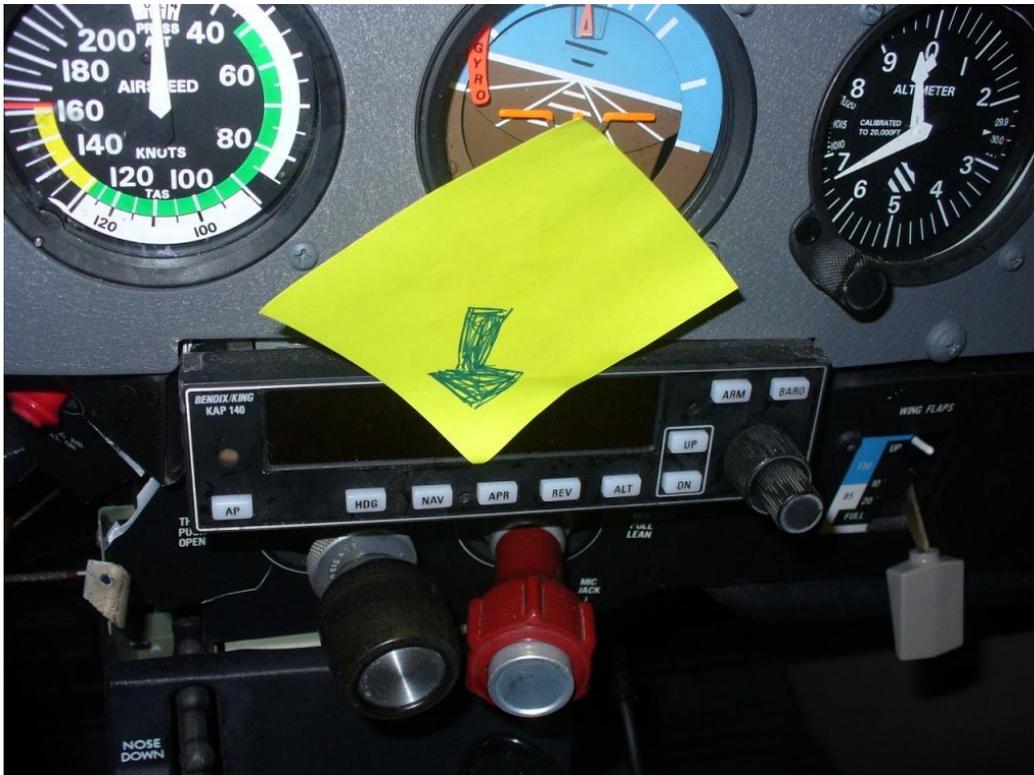
Figure 3: The throttle and mixture levers.

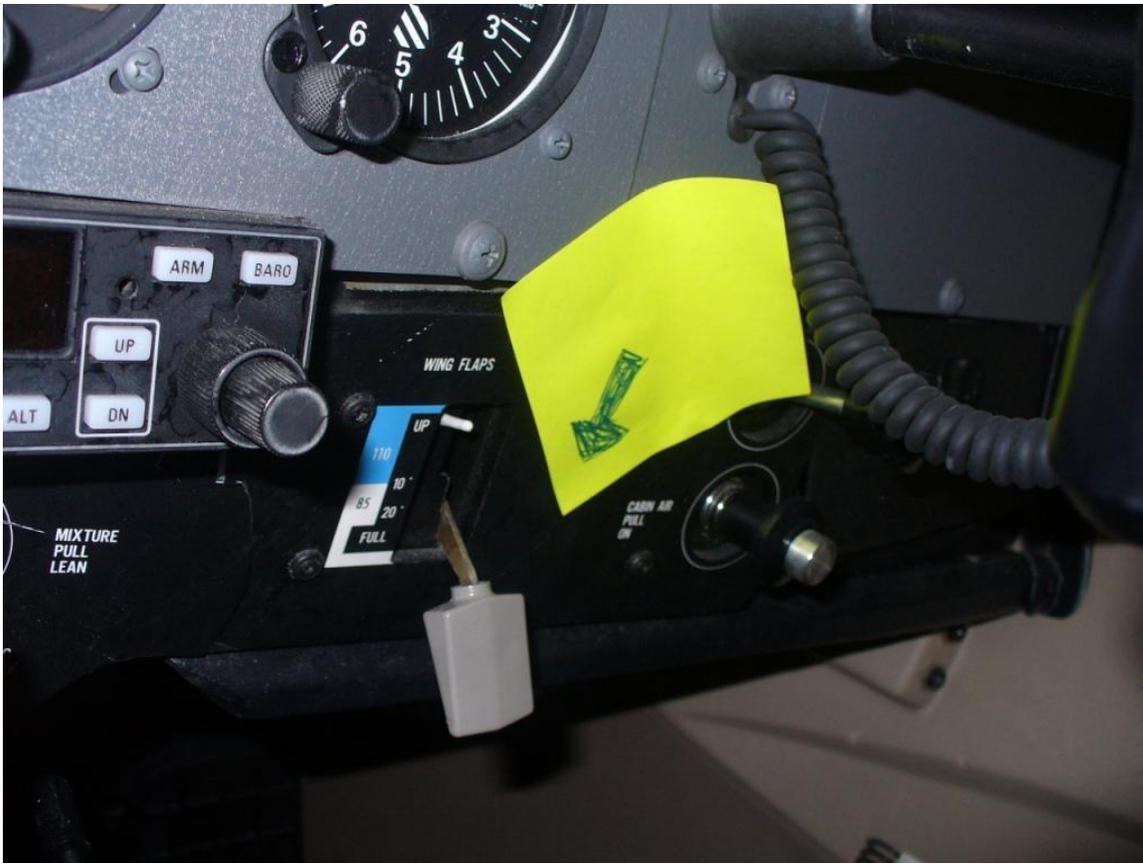
**Figure 4: The wing flaps lever on the right side of the instrument panel.**
