**TANK-TRUCK COMBINATION OVERTURN  
ONTO VOLKSWAGEN MICROBUS**

**U.S. ROUTE 611,  
MOSCOW, PENNSYLVANIA  
SEPTEMBER 5, 1971**

**REPORT NUMBER: NTSB-HAR-72-6**

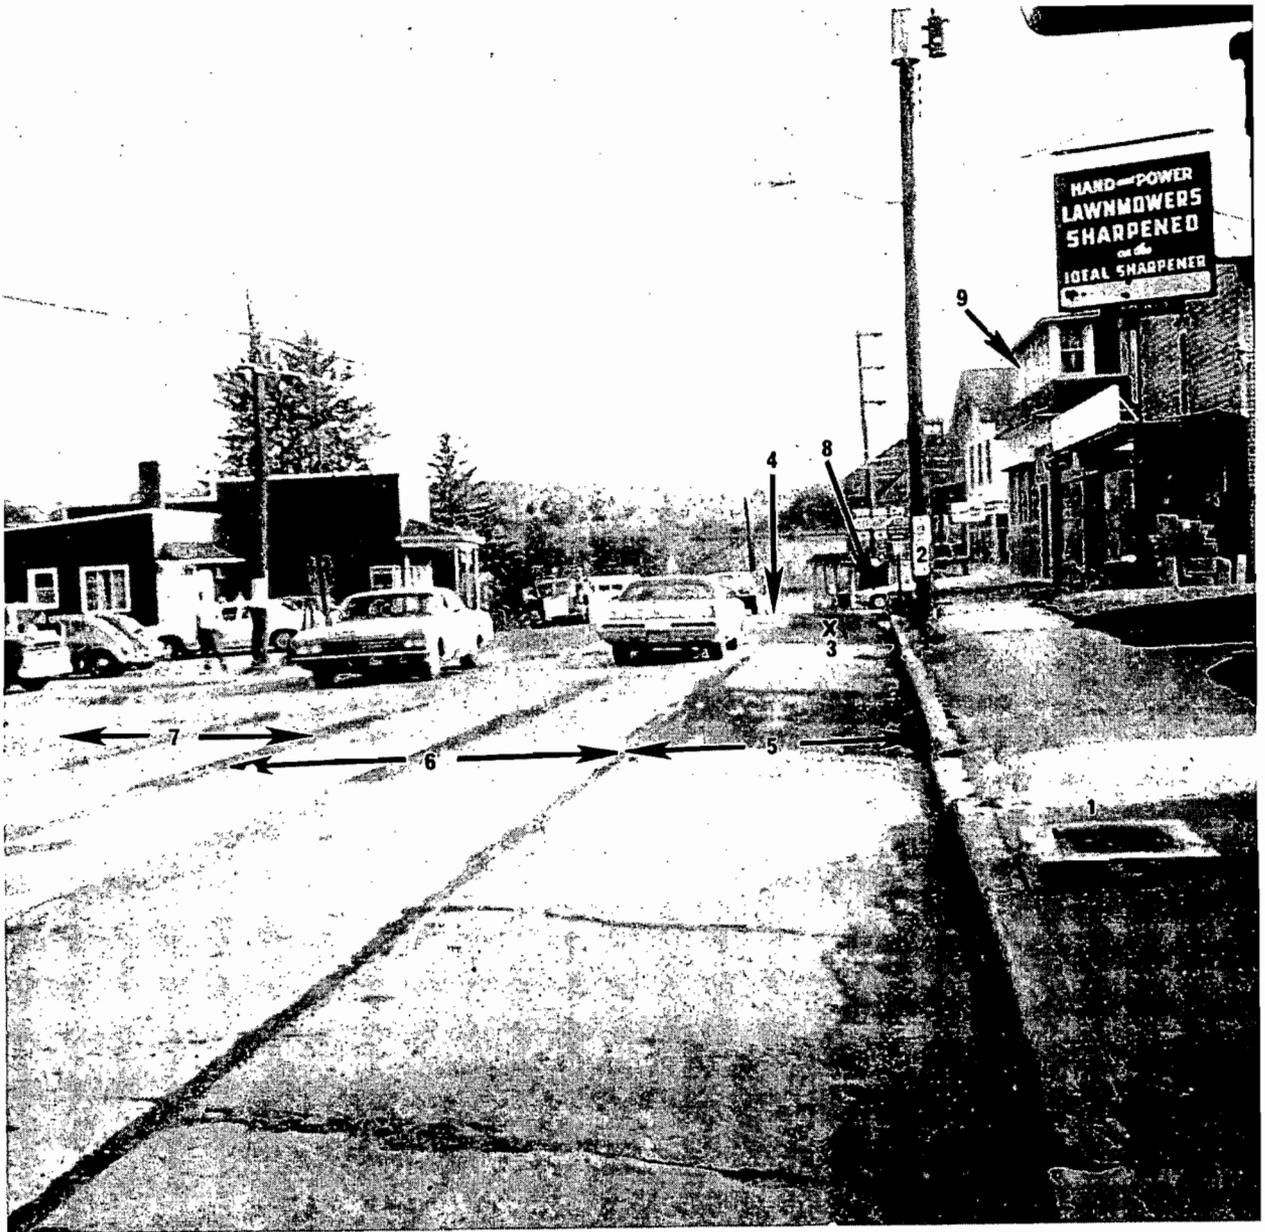
Photograph 1. The accident site (picture taken from the vehicles' final position facing south).

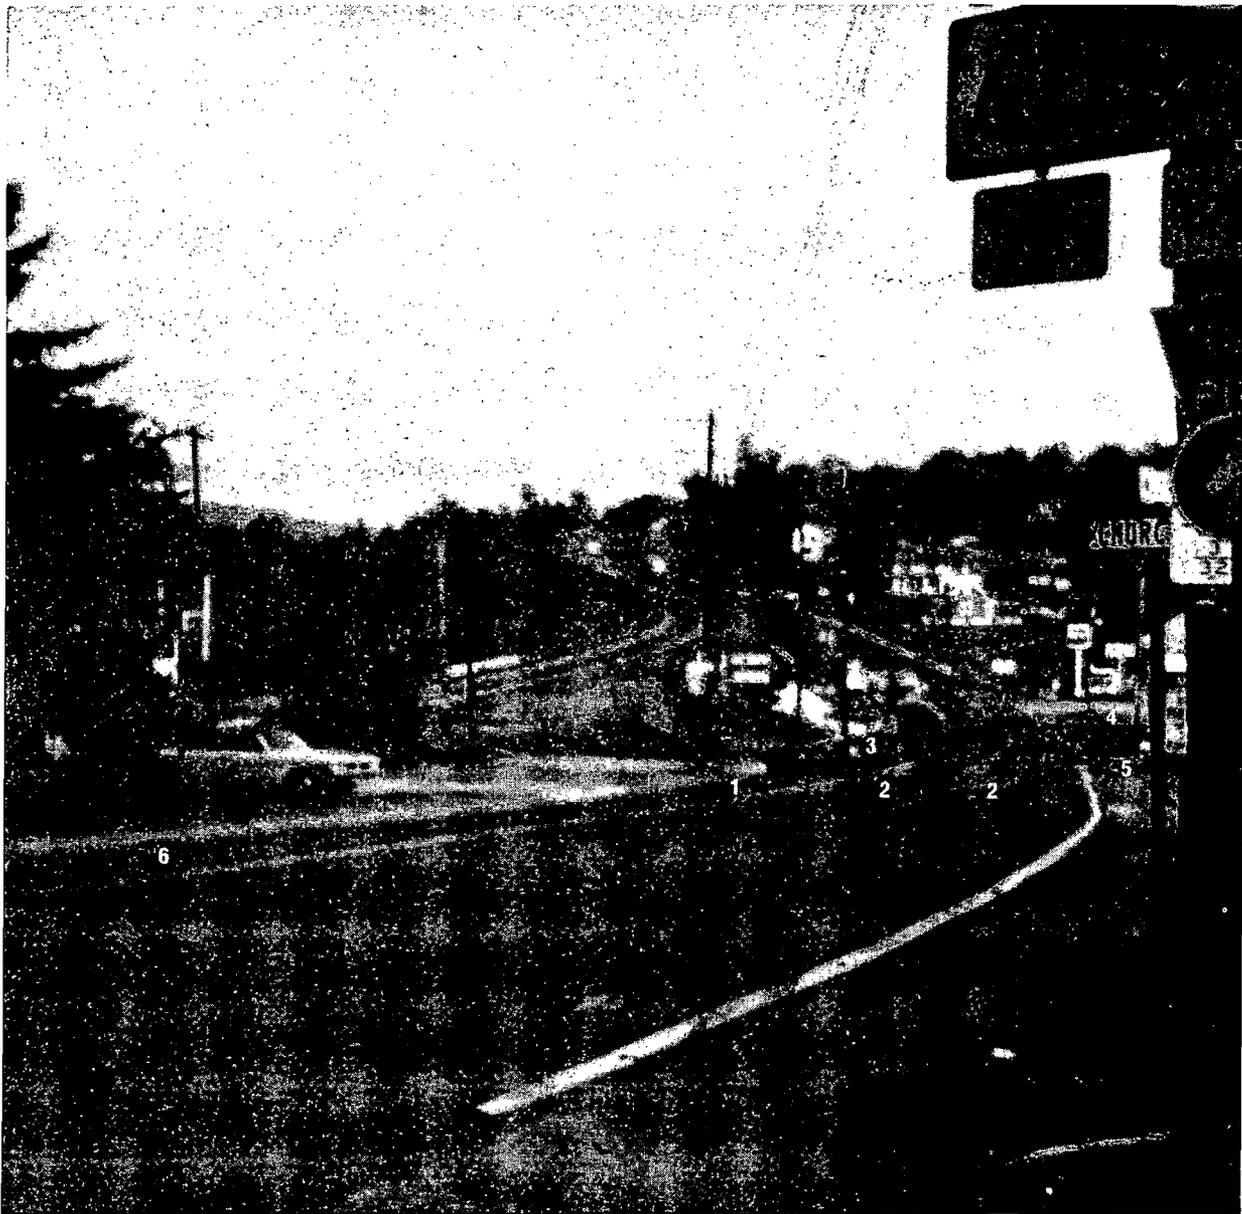
**Photograph 2. U.S. Route 611 (picture taken from the Church Street intersection facing south).**

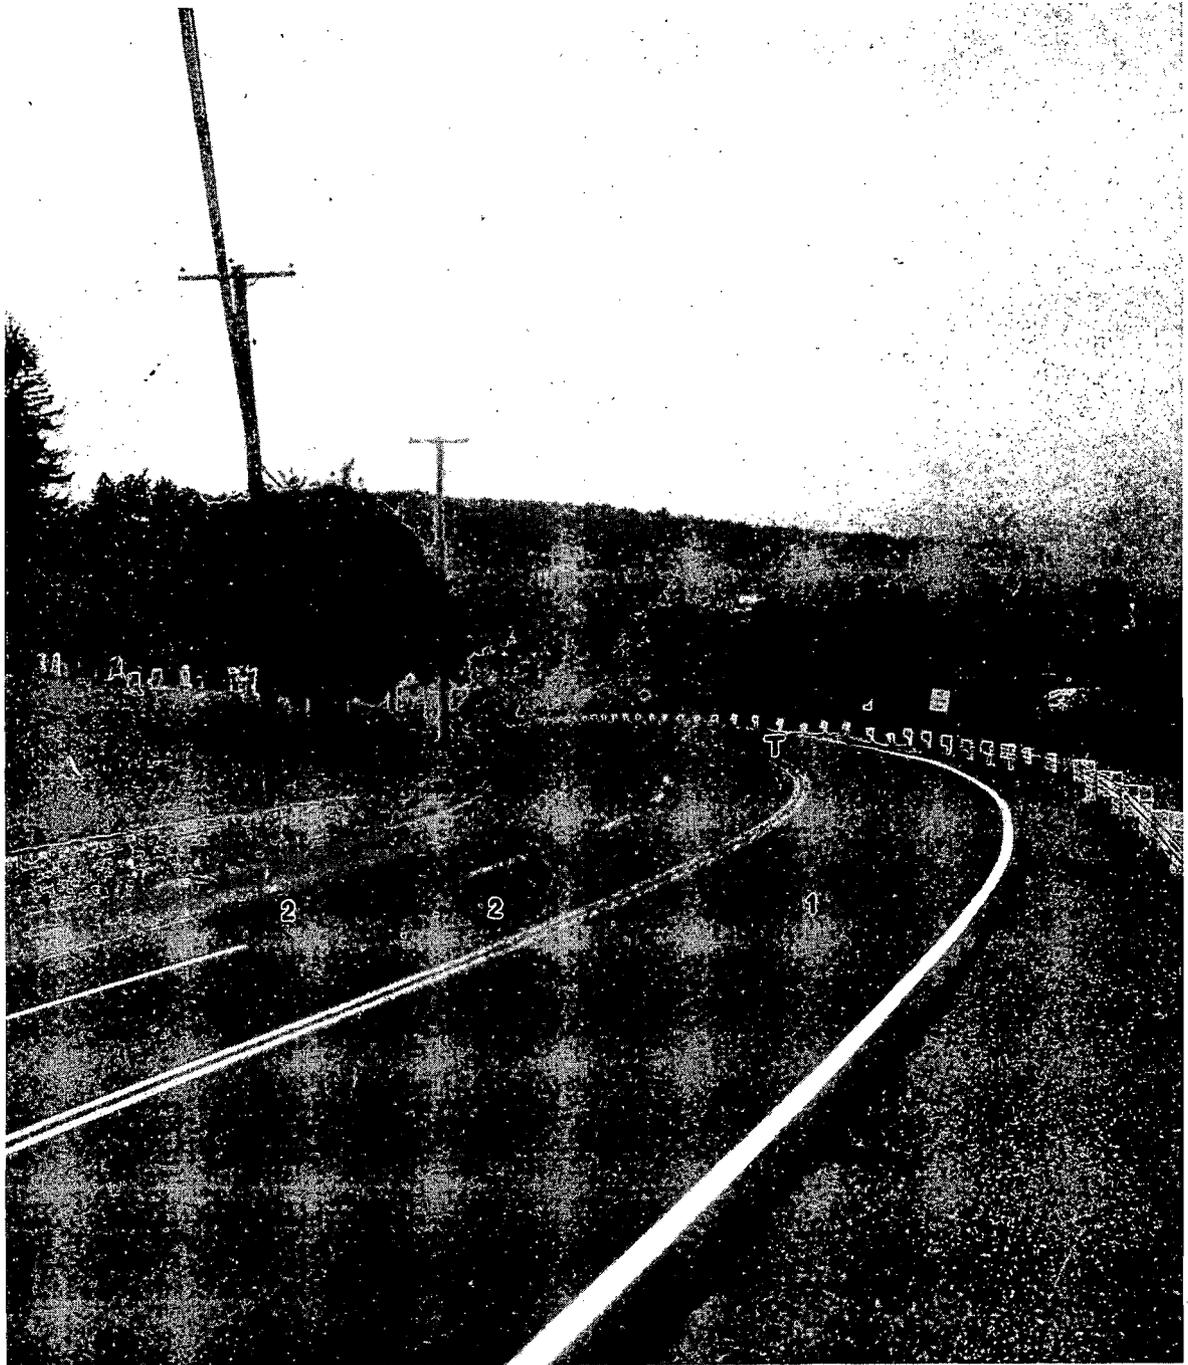
**Photograph 3. U.S. Route 611 (picture taken 2,000 feet south of the impact point facing north).**

- (1) Northbound lane
- (2) Southbound lanes
- (T) Location of tractor-semitrailer when the pickup truck entered U.S. 611 from Market Street

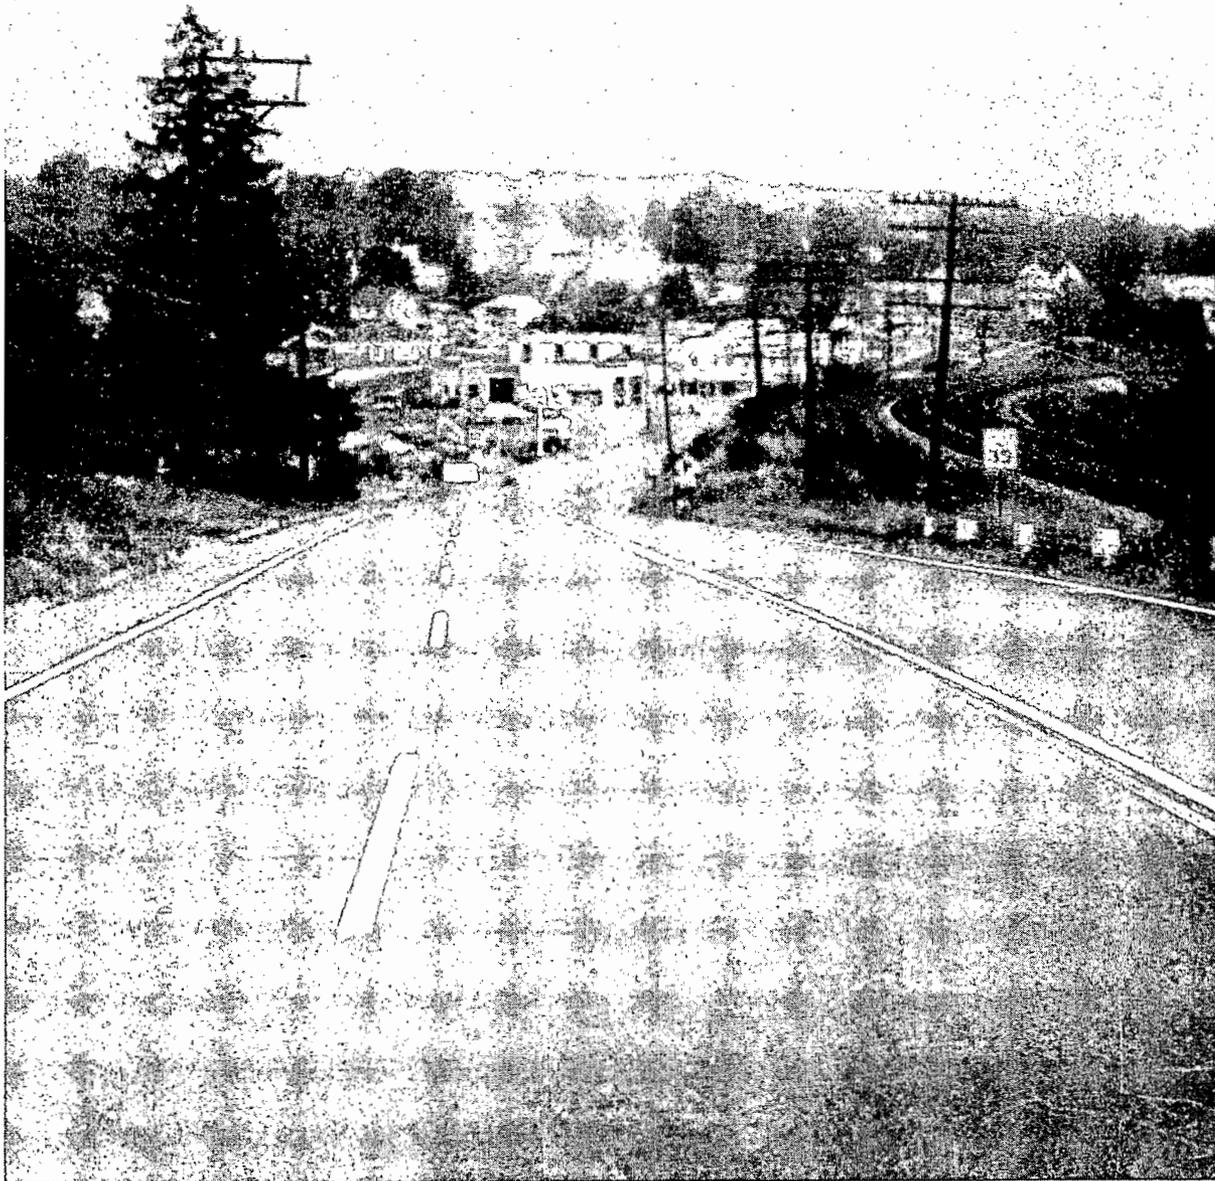
**Photograph 4. U.S. Route 611 (picture taken 1,400 feet south of the impact point facing north).**

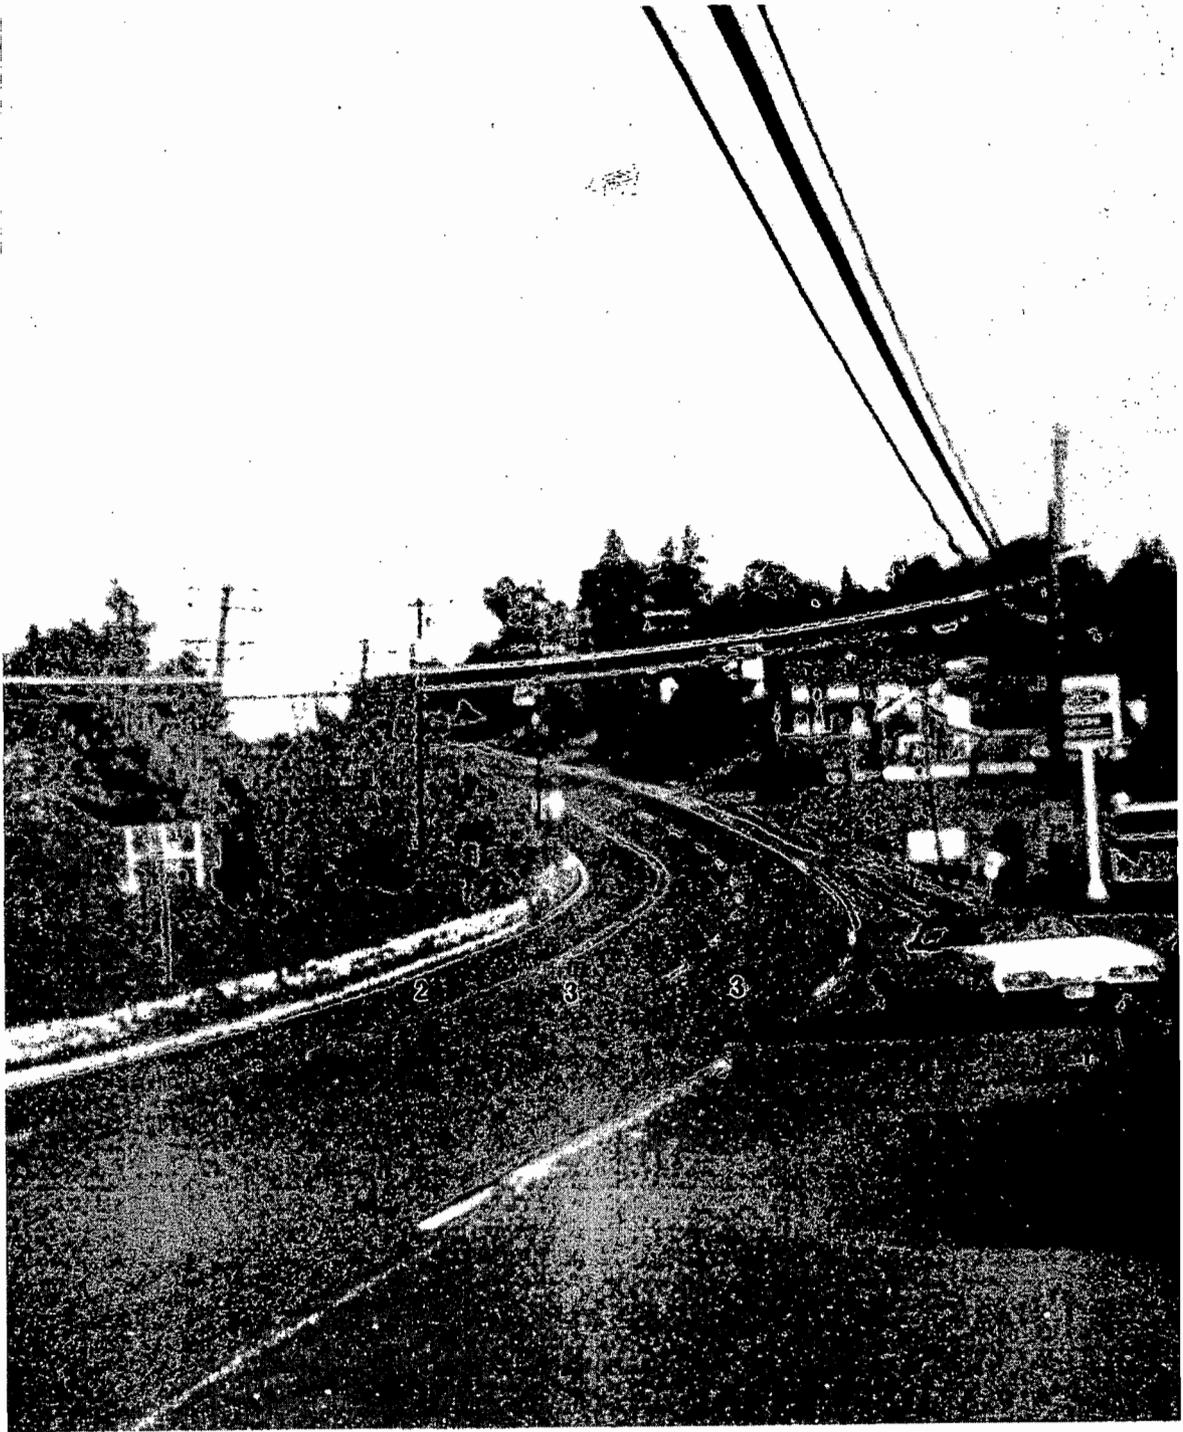
**Photograph 5. U.S. Route 611 (picture taken 700 feet south of the impact point facing south).**

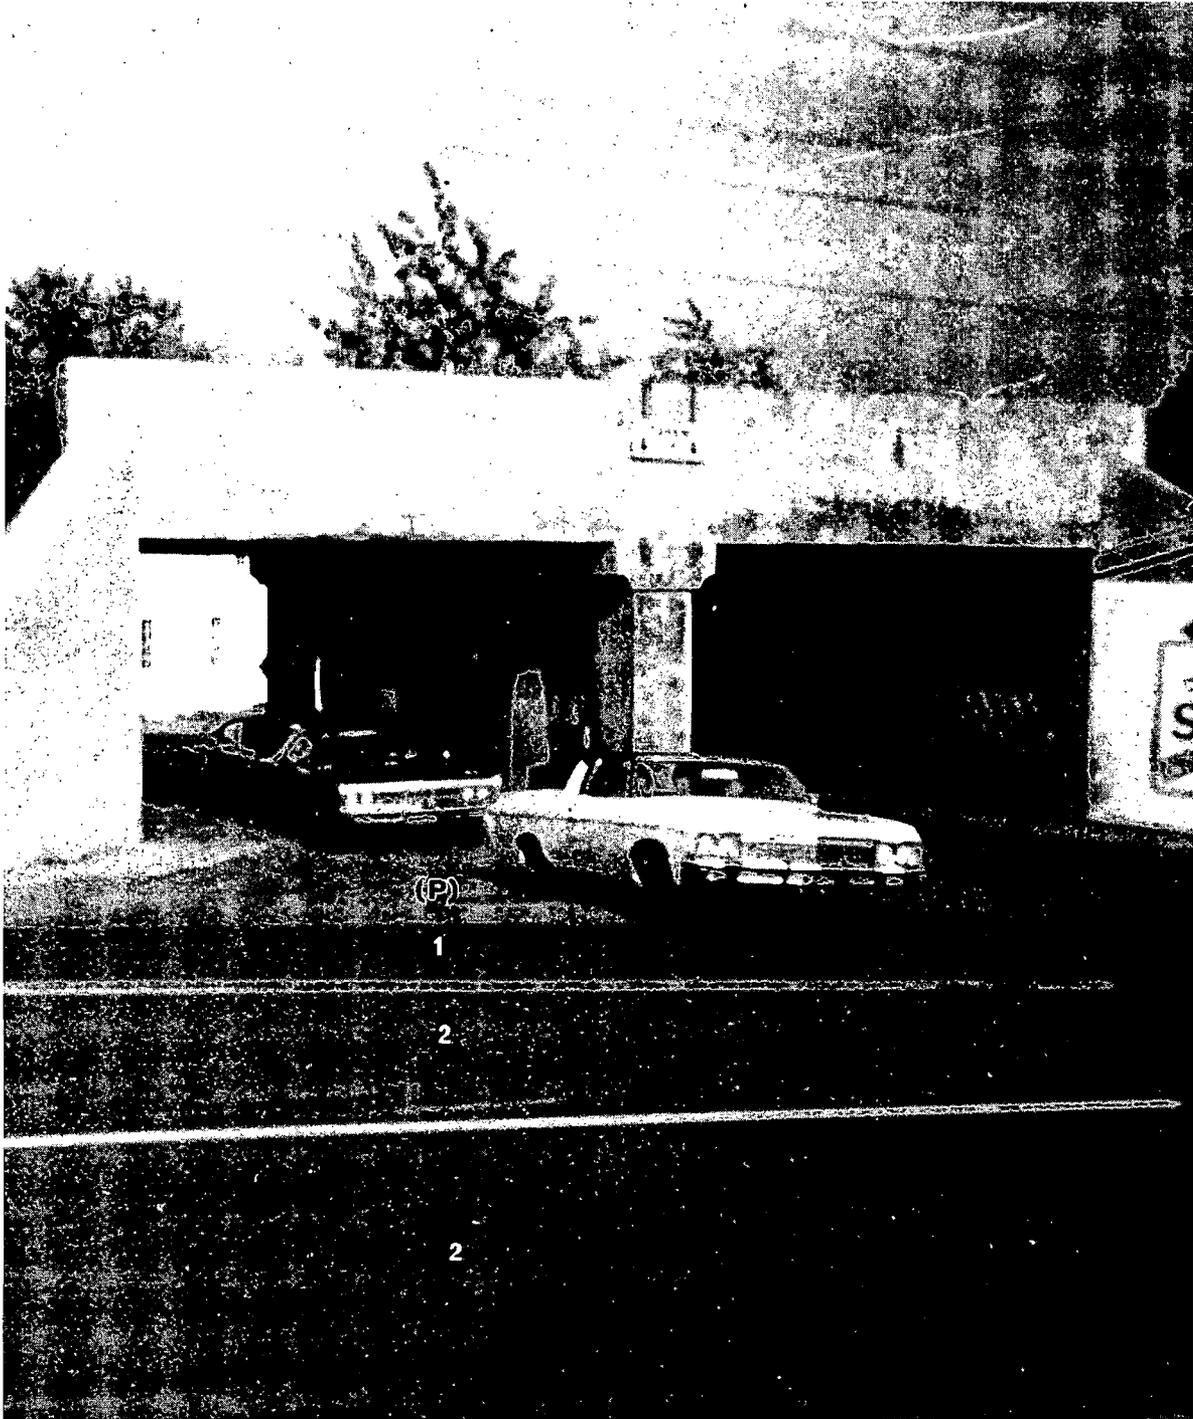
**Photograph 6. The intersection of Market Street with U.S. Route 611.**

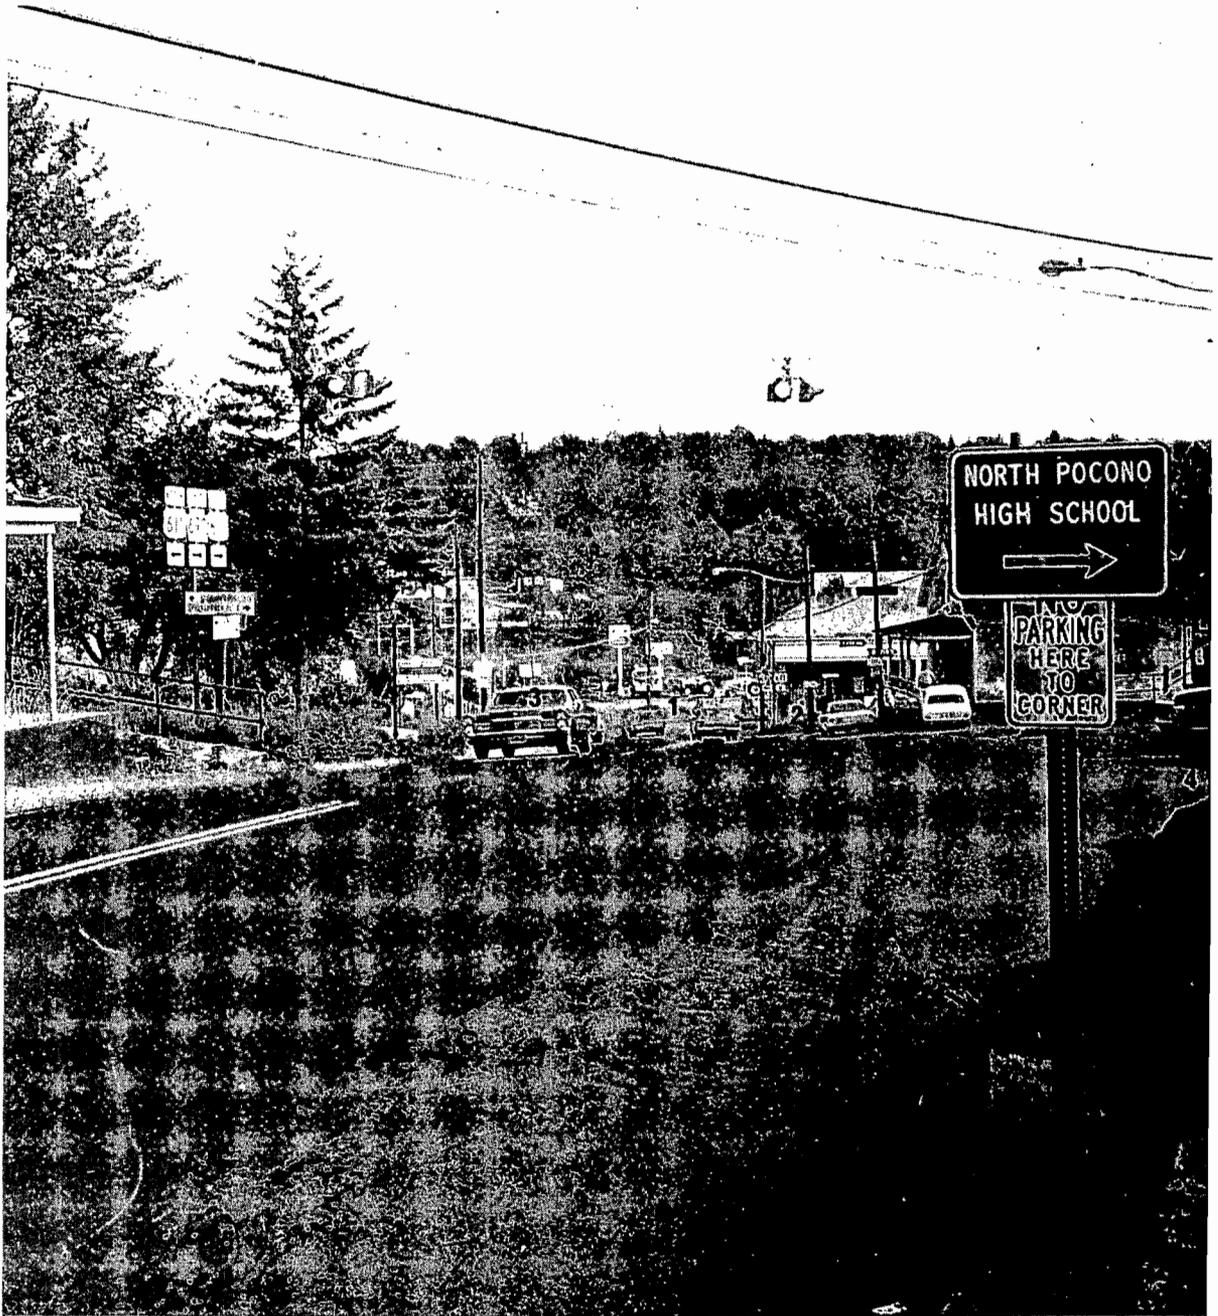
Photograph 7. U.S. Route 611 (picture taken from the point of impact facing south).
