NATIONAL TRANSPORTATION SAFETY BOARD

SPECIAL INVESTIGATION REPORT

**SURVIVAL IN
HAZARDOUS MATERIALS
TRANSPORTATION ACCIDENTS**

NTSB-HZM-79-4

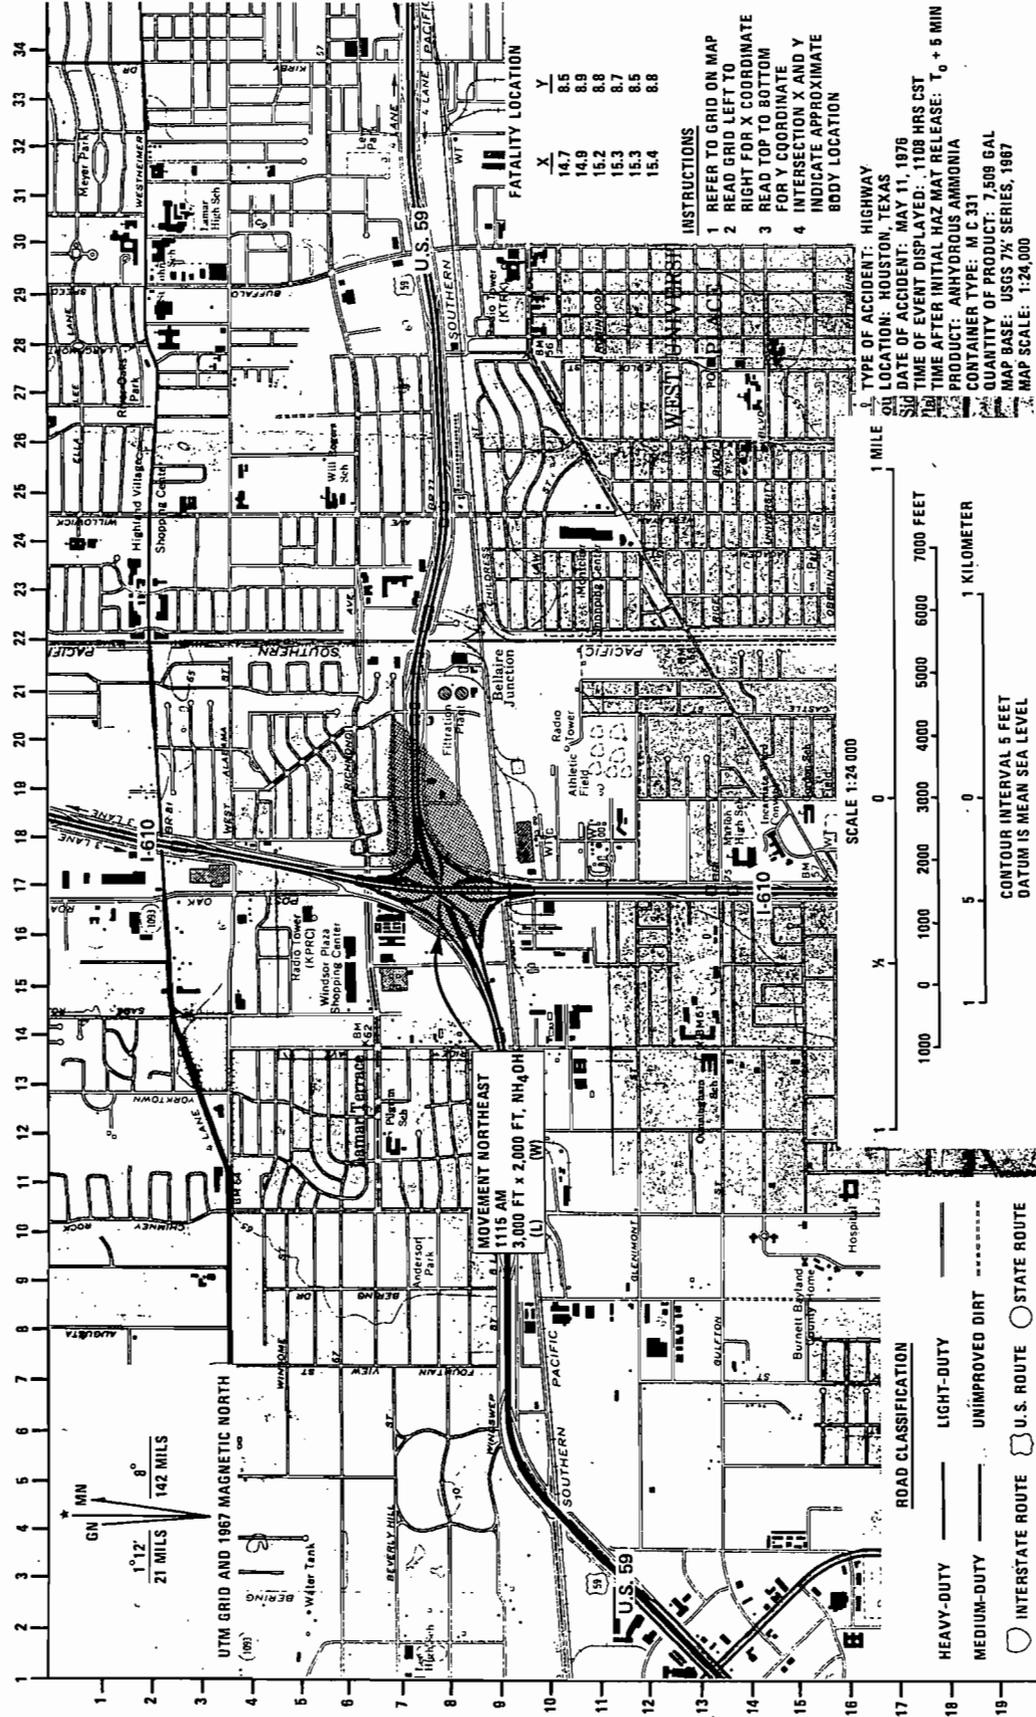
Figure 1. View of the accident site. Shaded area at interchange denotes ground contacted by ammonia cloud.

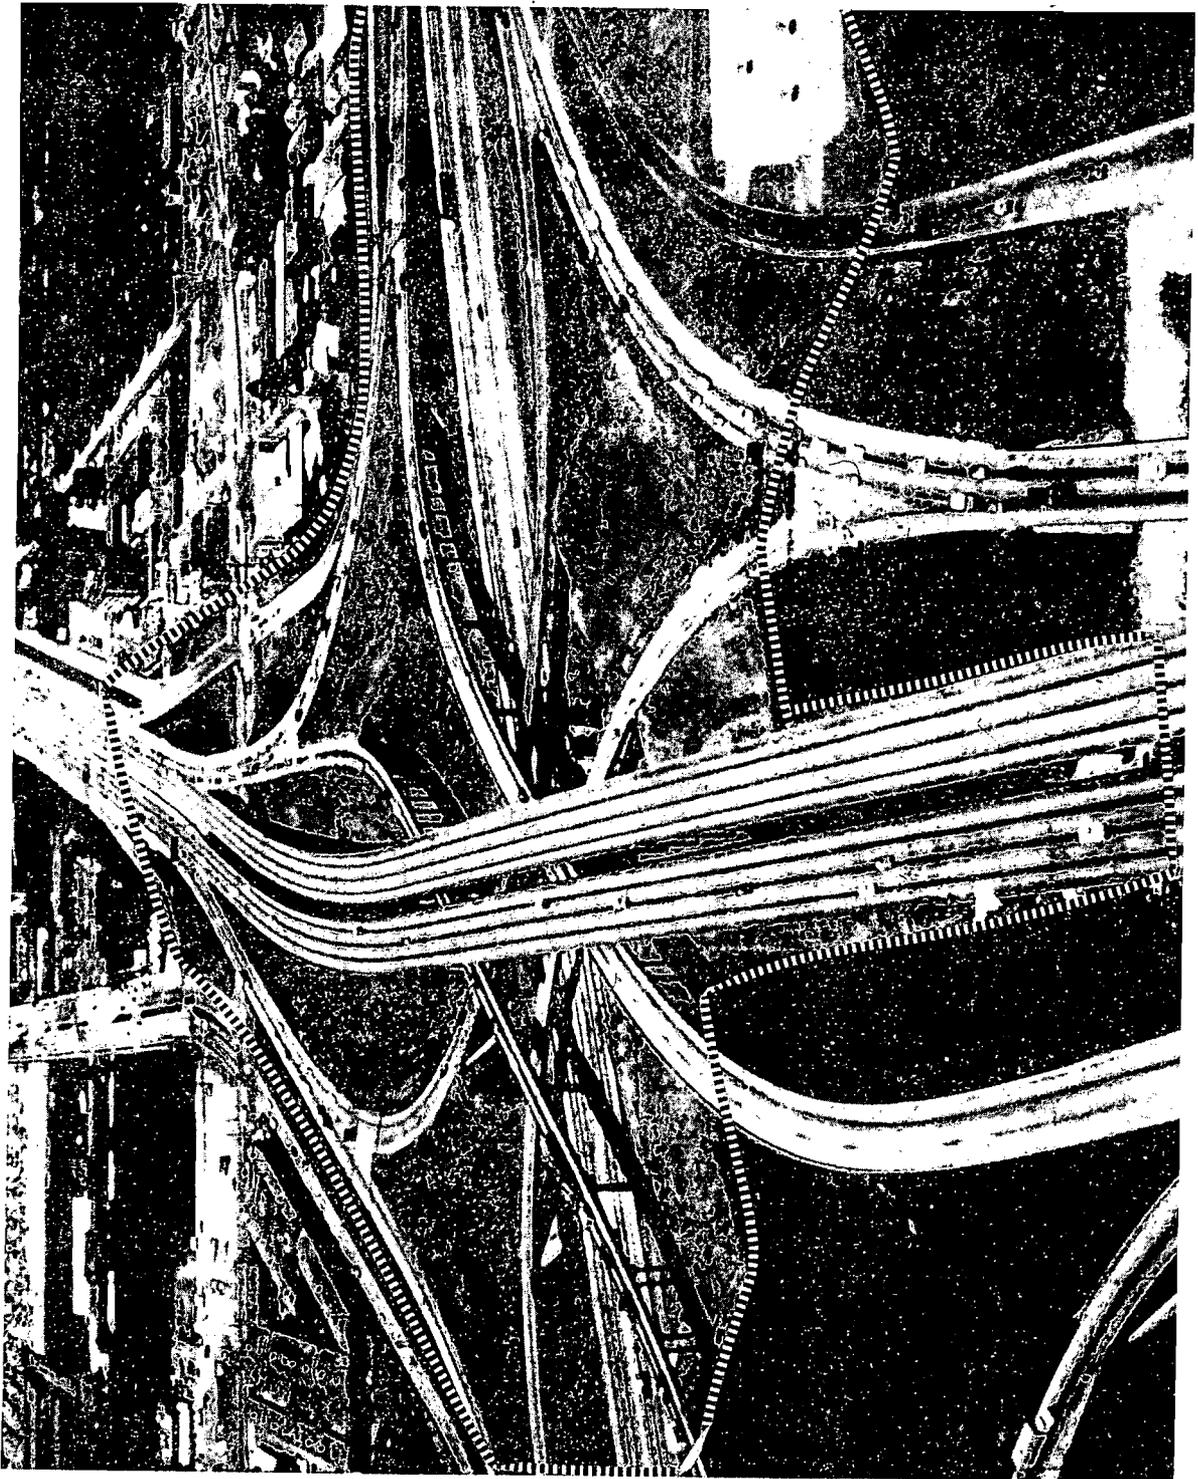
Some of the ammonia vaporized and formed a large gas cloud. (See figure 2.) As the cloud absorbed heat from the surrounding warm air, it became buoyant and began to rise from the surface into the atmosphere. As the buoyant gaseous ammonia was carried upward, the cloud was limited and directed downrange by a moist, 7-mph wind. (See figure 3.) The meteorological conditions at the crash site and the large amount of suspended ammonia maintained noxious concentrations of ammonia droplets 3,000 feet downwind for 3 to 5 minutes. (See figures 4 and 5.) Cold liquid ammonia flowed along the contours of the ground and formed in pools along the ditches bounding U.S. 59. The advancing cloud caused exposed vegetation to temporarily brown. (See figure 6.)

Figure 6. Infrared-enhanced photograph of U.S. 59 and I-610 interchange showing temporary vegetation browning.

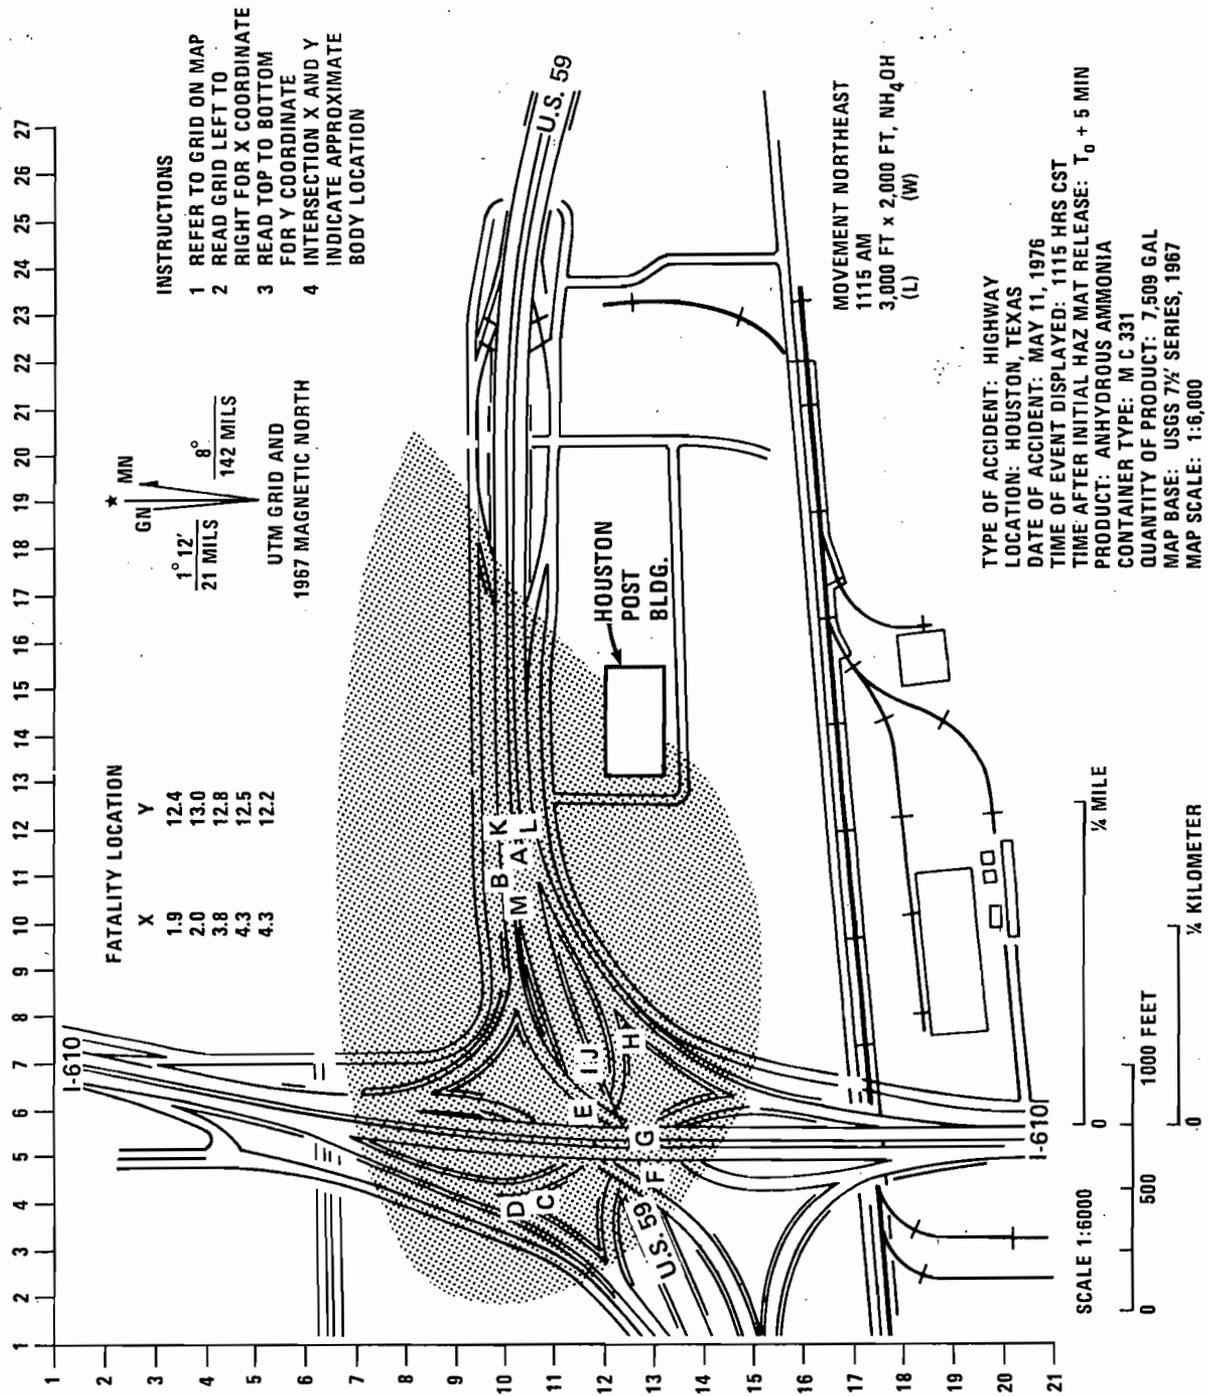
The following cases explain in more detail how some motorists on U.S. 59 reacted to the emergency (see figure 7):

Figure 7. Location when rescued of victims discussed in case histories.

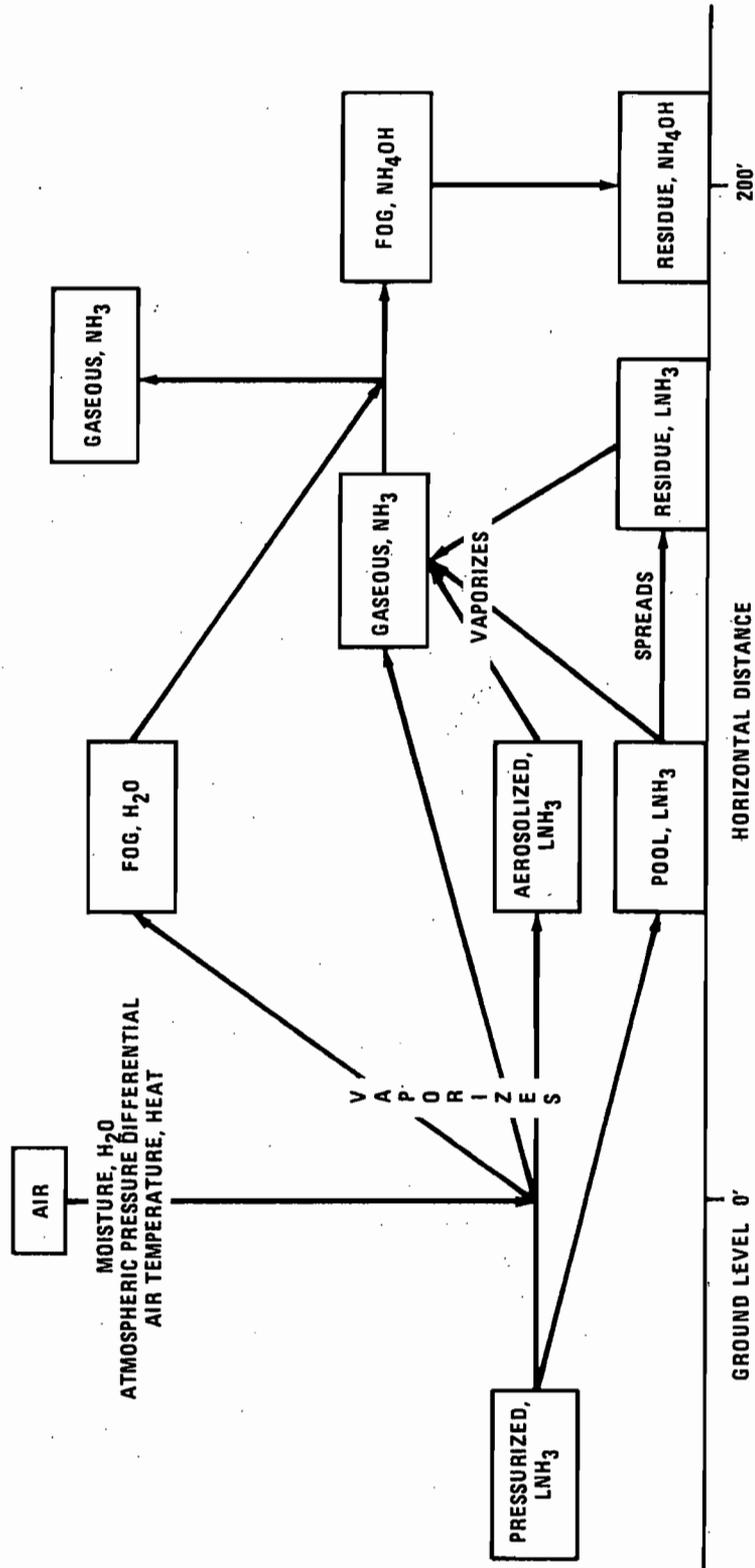
Figure 8. Formation of 1st puff between T_0 (time when ammonia first released) and $T_0 + 1$ minute.

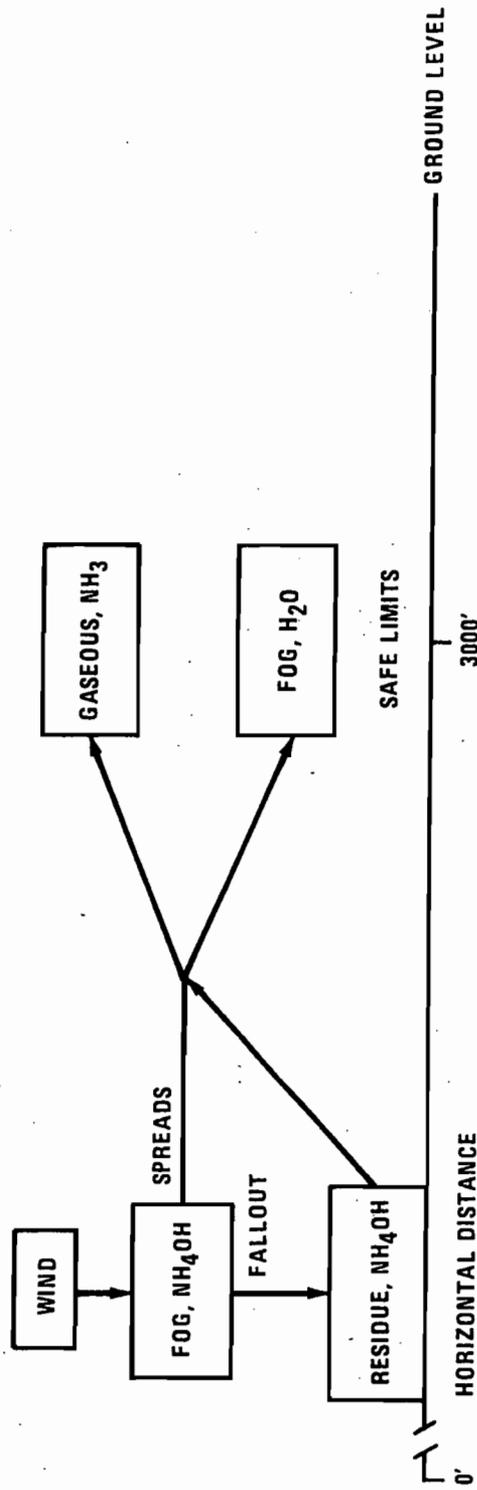
surrounding moist air, reduced the dewpoint of the air, and resulted in water vapor condensation or fog. Because of the affinity of anhydrous ammonia for water, some ammonia was attracted to condensed moisture in the fog, interacting to form small liquid droplets of ammonium hydroxide, which was probably the "blinding snowstorm" described by victims. This formation of ammonium hydroxide also produced heat, which warmed the surrounding air and gas mixture, contributing to the buoyancy of the gaseous ammonia and to the evaporation of the water droplets. Beyond the visible fog was an invisible olfactory region of gas vapors emitted by the fuming ammonia. This region was relatively thin, reportedly less than 50 feet beyond the visible fog, and contained strong incapacitating gas concentrations. (See figure 8.) Within 5 minutes, the puff migrated farther downwind. The boiling liquid ammonia pools continued to give out gas that formed a plume. This plume continued until the pools were diluted by the firefighters, after which only residue remained in the ditches. (See figure 9.)

Figure 9. Migration of puff and residue outgassing between $T_0 + 1$ minute and $T_0 + 5$ minutes.

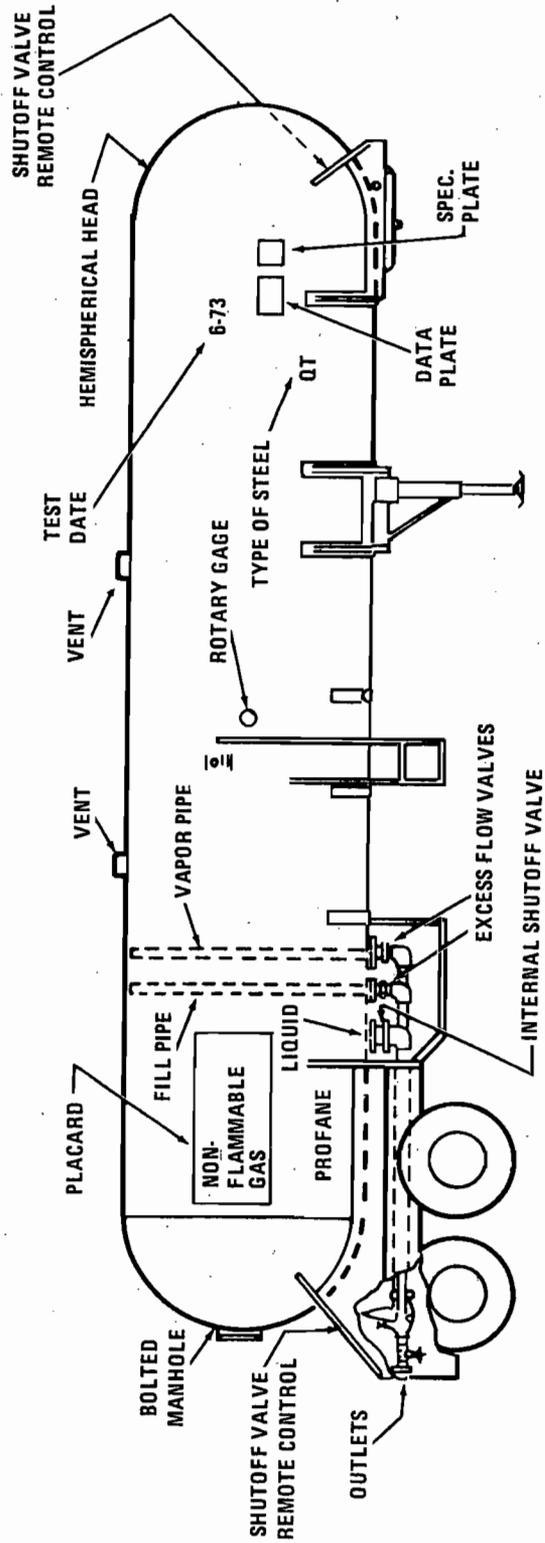
Cargo Tanks. — Title 49 CFR 178 prescribes the minimum packaging for hazardous materials in transportation. The DOT says these requirements are to contain the materials "to withstand conditions normally incident to transportation and minimize the chance of an incident". ^{4/} Title 49 CFR 178.337-11 prescribes emergency discharge controls for MC 331 cargo tanks, such as the one involved in the Houston accident. Emergency discharge controls, which are provided to minimize the possibility of overloading the tank from internal pressure, consisting of two pressure-relief vents, excess-flow valves, and emergency controls, are not effective in case of catastrophic damage to the tank. (See figure 11.)

Figure 11. Inspection guide for MC 331 cargo tank safeguards.

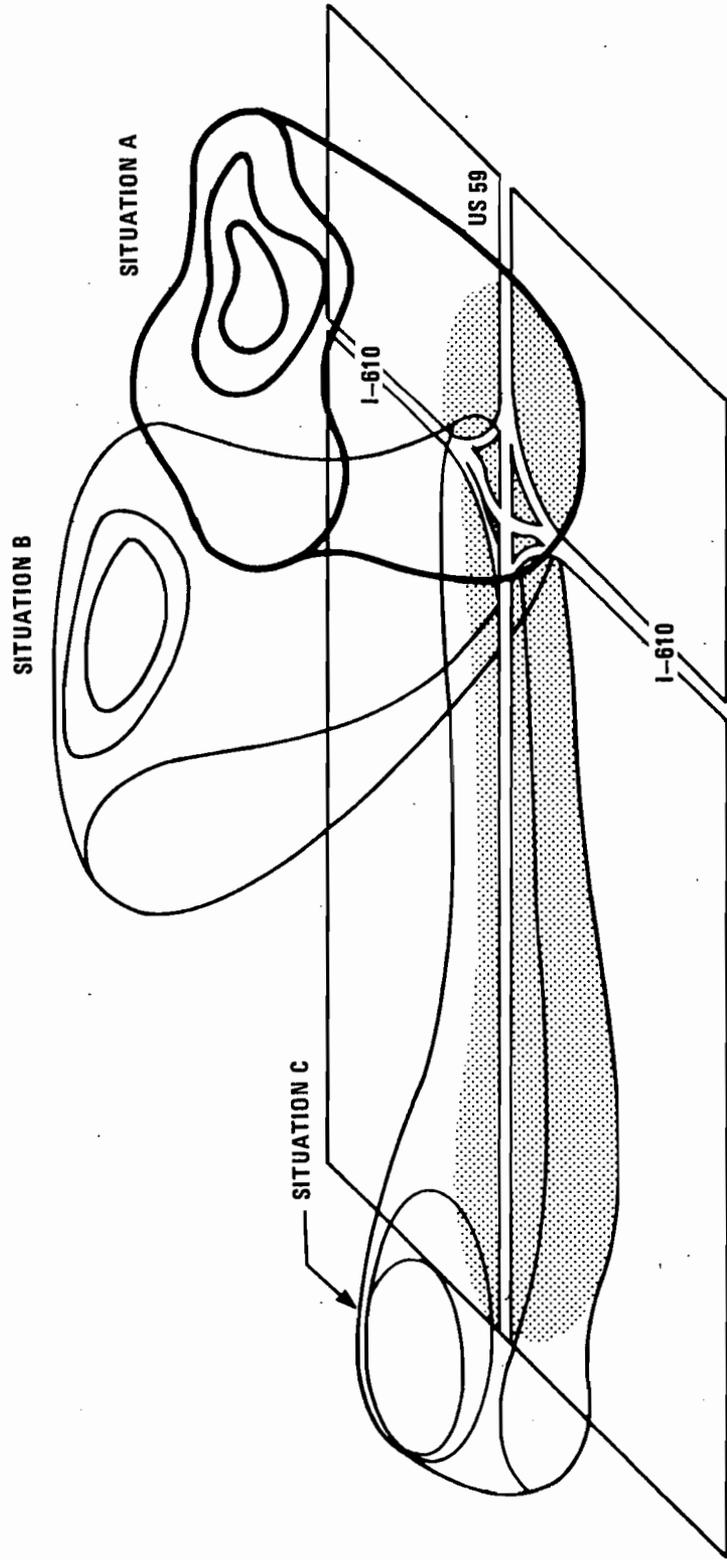
In Houston, the dispersion rate of the released cargo was limited and directed by the meteorological conditions following the puff release. Figure 12 depicts the predicted dispersion of the anhydrous ammonia release in Houston under three different potential meteorological situations. Meteorological conditions at Houston at 11:15 a.m. on May 11, 1976, produced a condition

Figure 12. Artist's concept of the spread of ammonia under three different meteorological situations.

comparable to Situation A, the least harmful dispersion. The Safety Board found examples of "Situation C" in its investigation of the Pensacola accident where a puff traveled more than 9 miles along the surface under a light steady wind, and in its investigation of the Crete accident where a strong temperature inversion at 4° F produced a heavy ground vapor concentration forcing a house-to-house search and evacuation of 200 to 300 persons.
