# NATIONAL TRANSPORTATION SAFETY BOARD

## AIRCRAFT ACCIDENT REPORT

IN-FLIGHT ICING ENCOUNTER AND LOSS OF CONTROL  
SIMMONS AIRLINES, d.b.a. AMERICAN EAGLE FLIGHT 4184  
AVIONS de TRANSPORT REGIONAL (ATR)  
MODEL 72-212, N401AM  
ROSELAWN, INDIANA  
OCTOBER 31, 1994

VOLUME 1: SAFETY BOARD REPORT

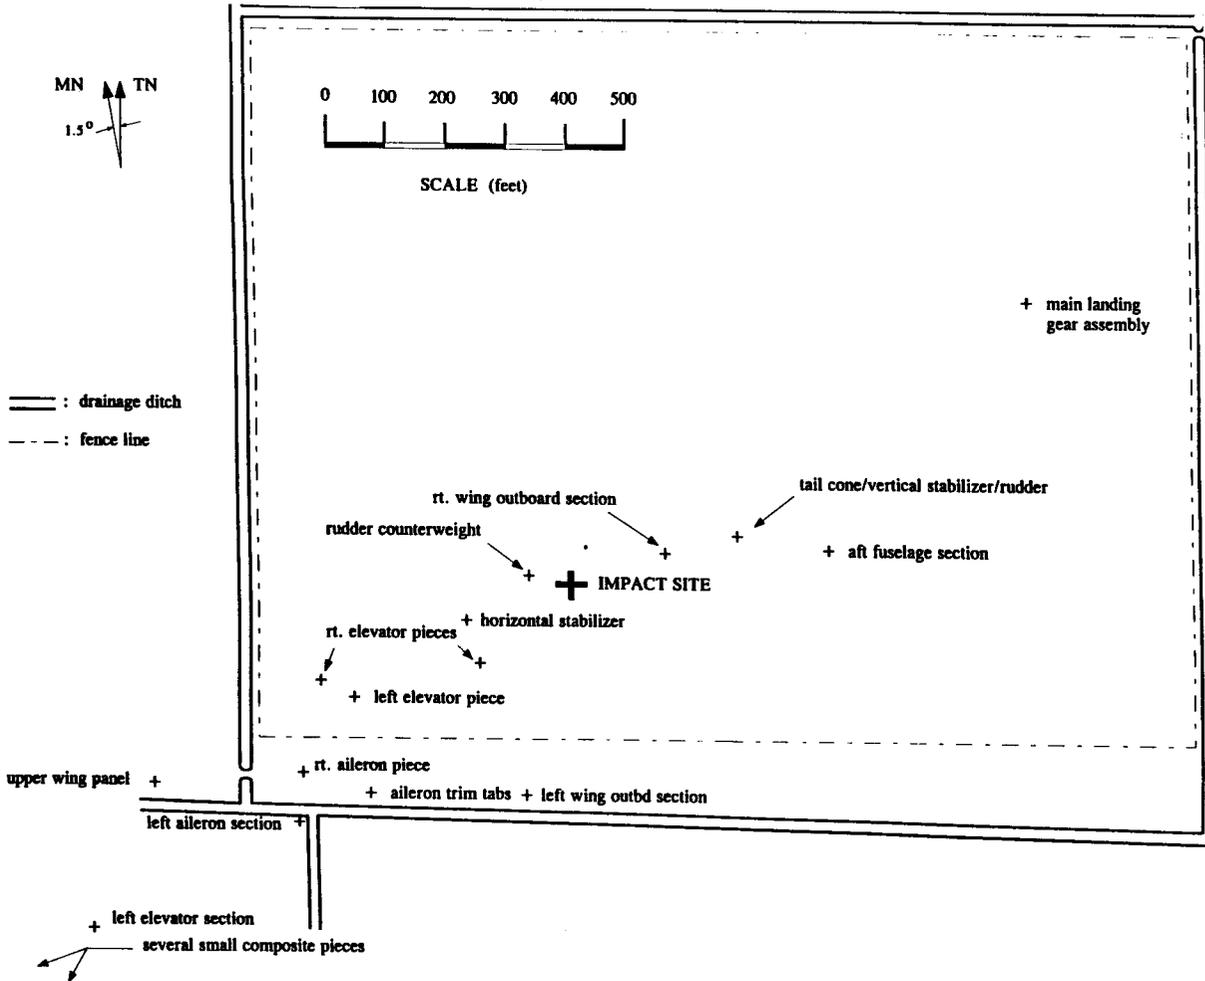
Figure 10a.--Wreckage distribution diagram.

Two smaller impact craters, consistent with the size of the left and right engines, were found on both sides of the larger, main impact crater (the size and orientation of the three craters, identified as crater 1, crater 2A, and crater 2B, are shown in Figure 10b). Most of the human remains, as well as portions of the

airplane structure and components, were located to the east-northeast of the impact craters. Portions of the wings and empennage were found to the south and southwest of the craters. The first major airplane structure found in the debris field, located farthest southwest from the impact craters, was a portion of the left elevator. Numerous small lightweight pieces of composite material were found about 1,000 feet southwest of the elevator. The last pieces in the debris field, farthest northeast from the impact craters, consisted of a main landing gear assembly (main landing gear wheel and tire) a portion of the flightcrew/passenger oxygen bottle, and two hydraulic pumps located in the lower section of the airplane.

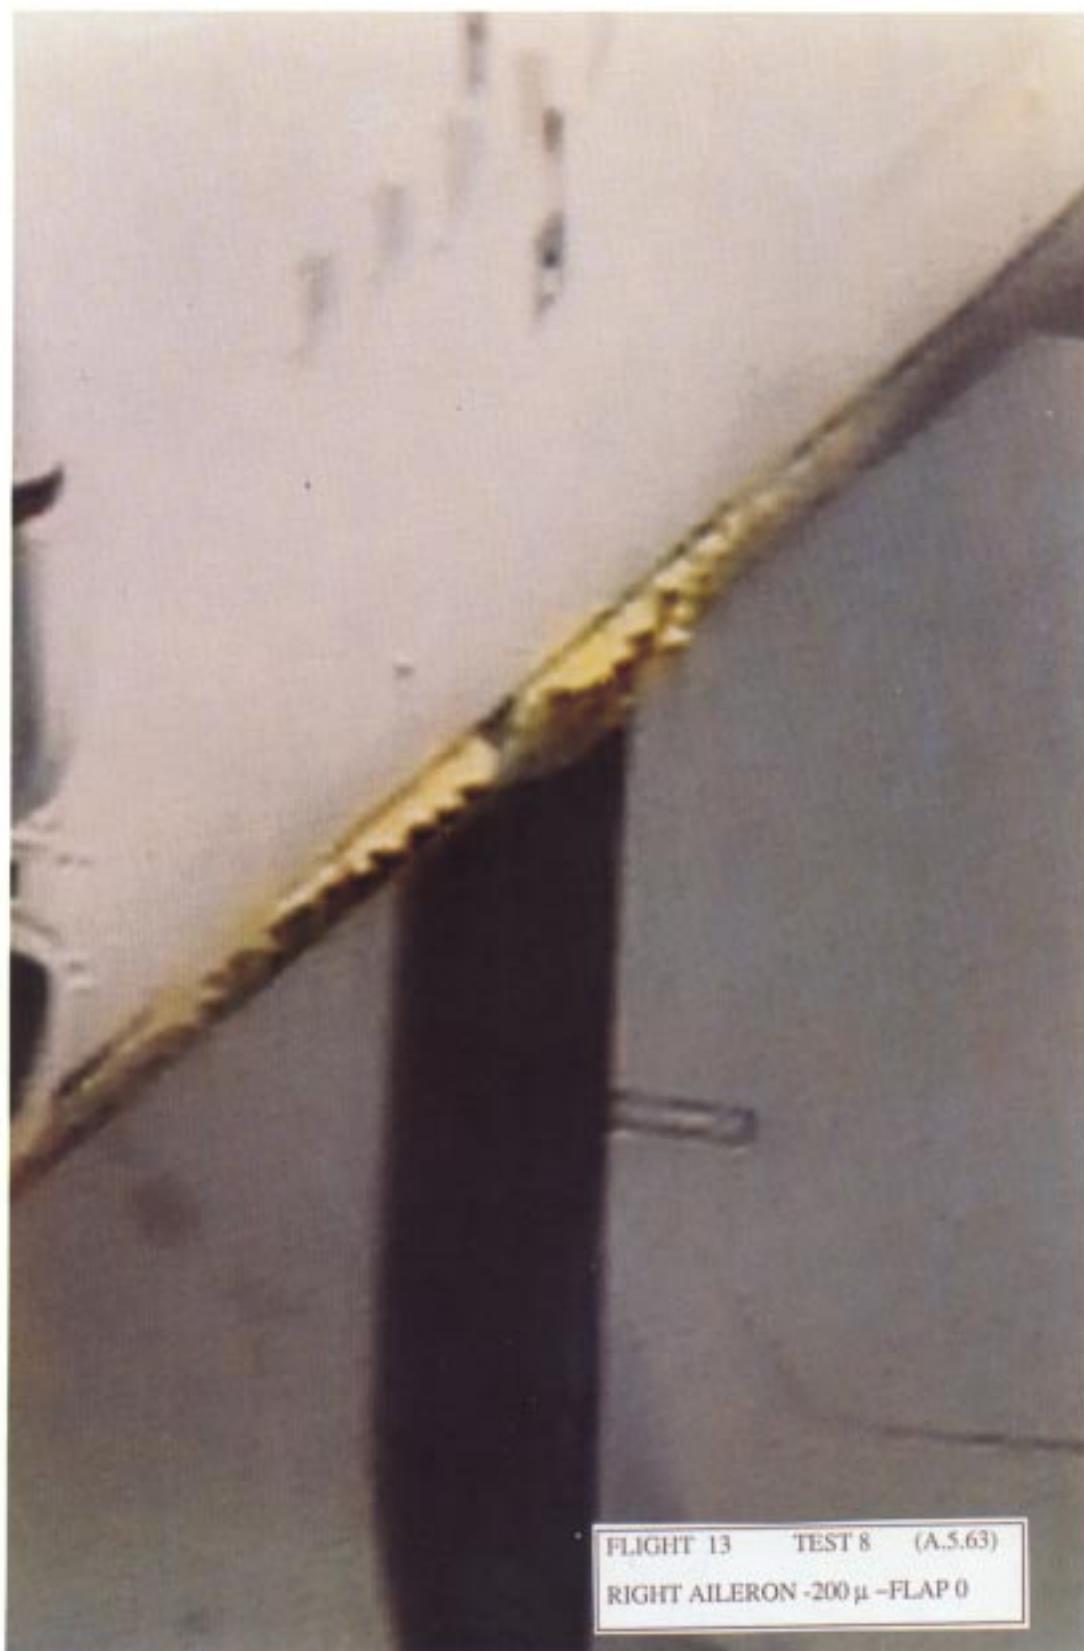
FLIGHT 13 TEST 8 (A.5.63)  
RIGHT AILERON -200 μ -FLAP 0

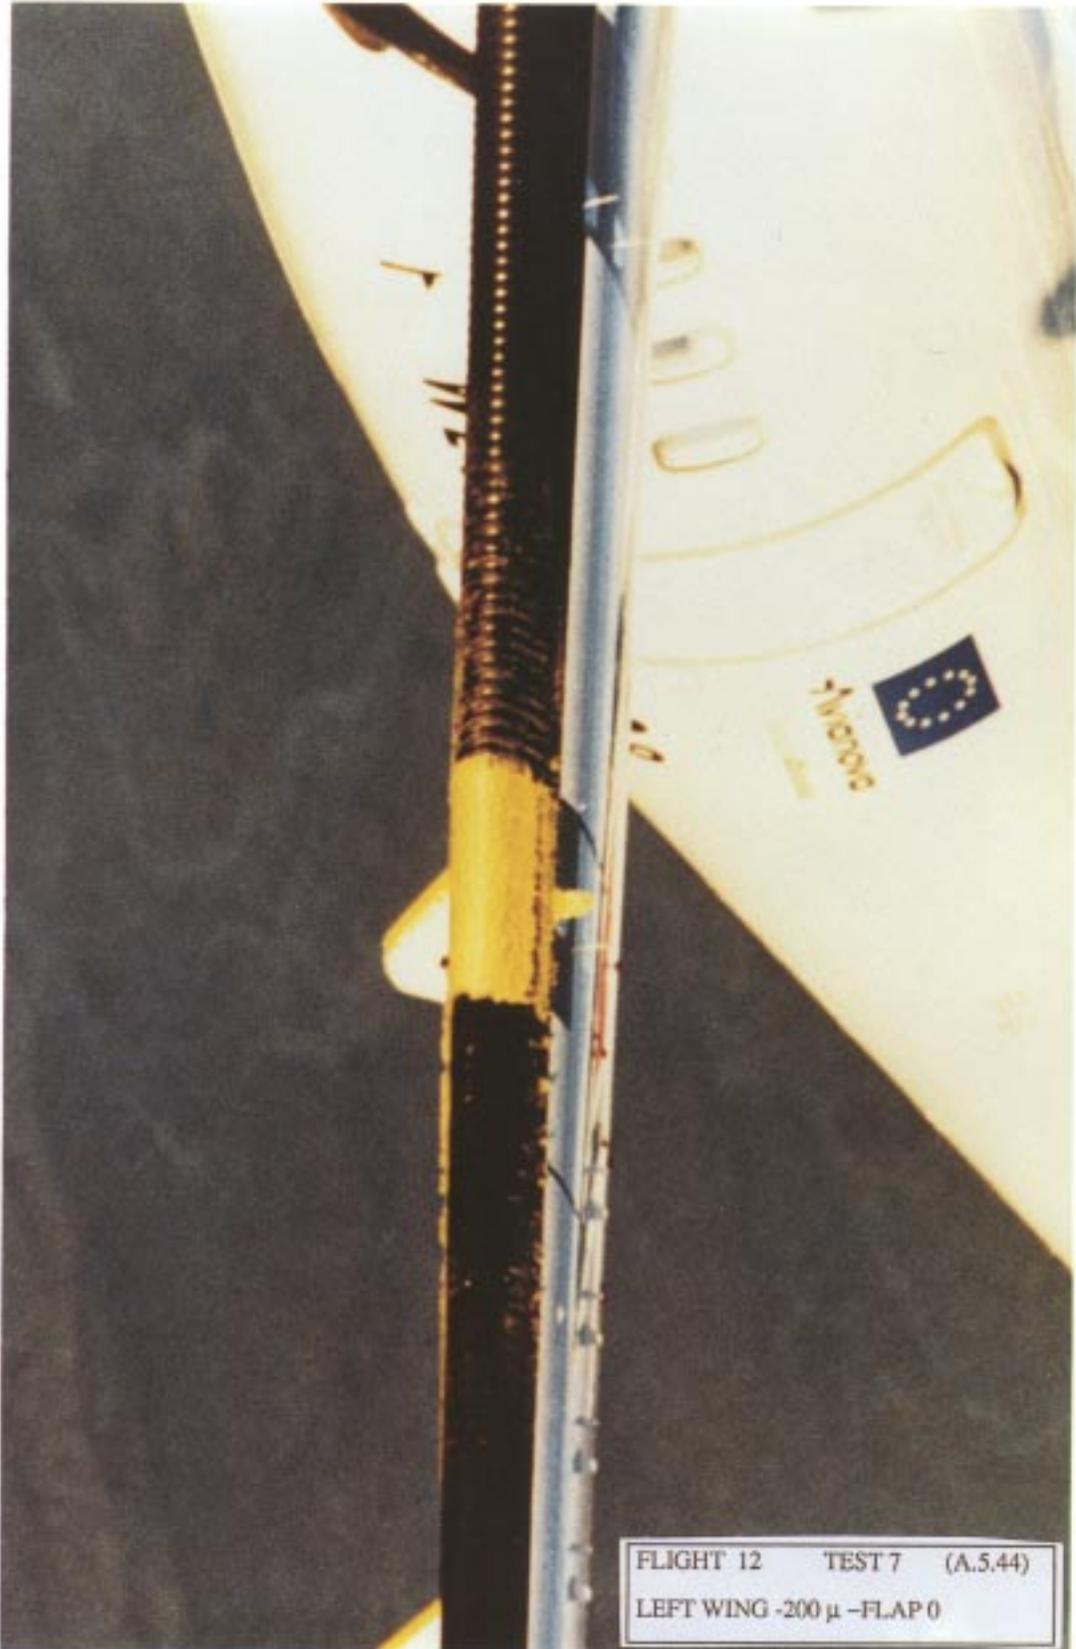
FLIGHT 12 TEST 7 (A.5.44)  
LEFT WING -200  $\mu$  -FLAP 0

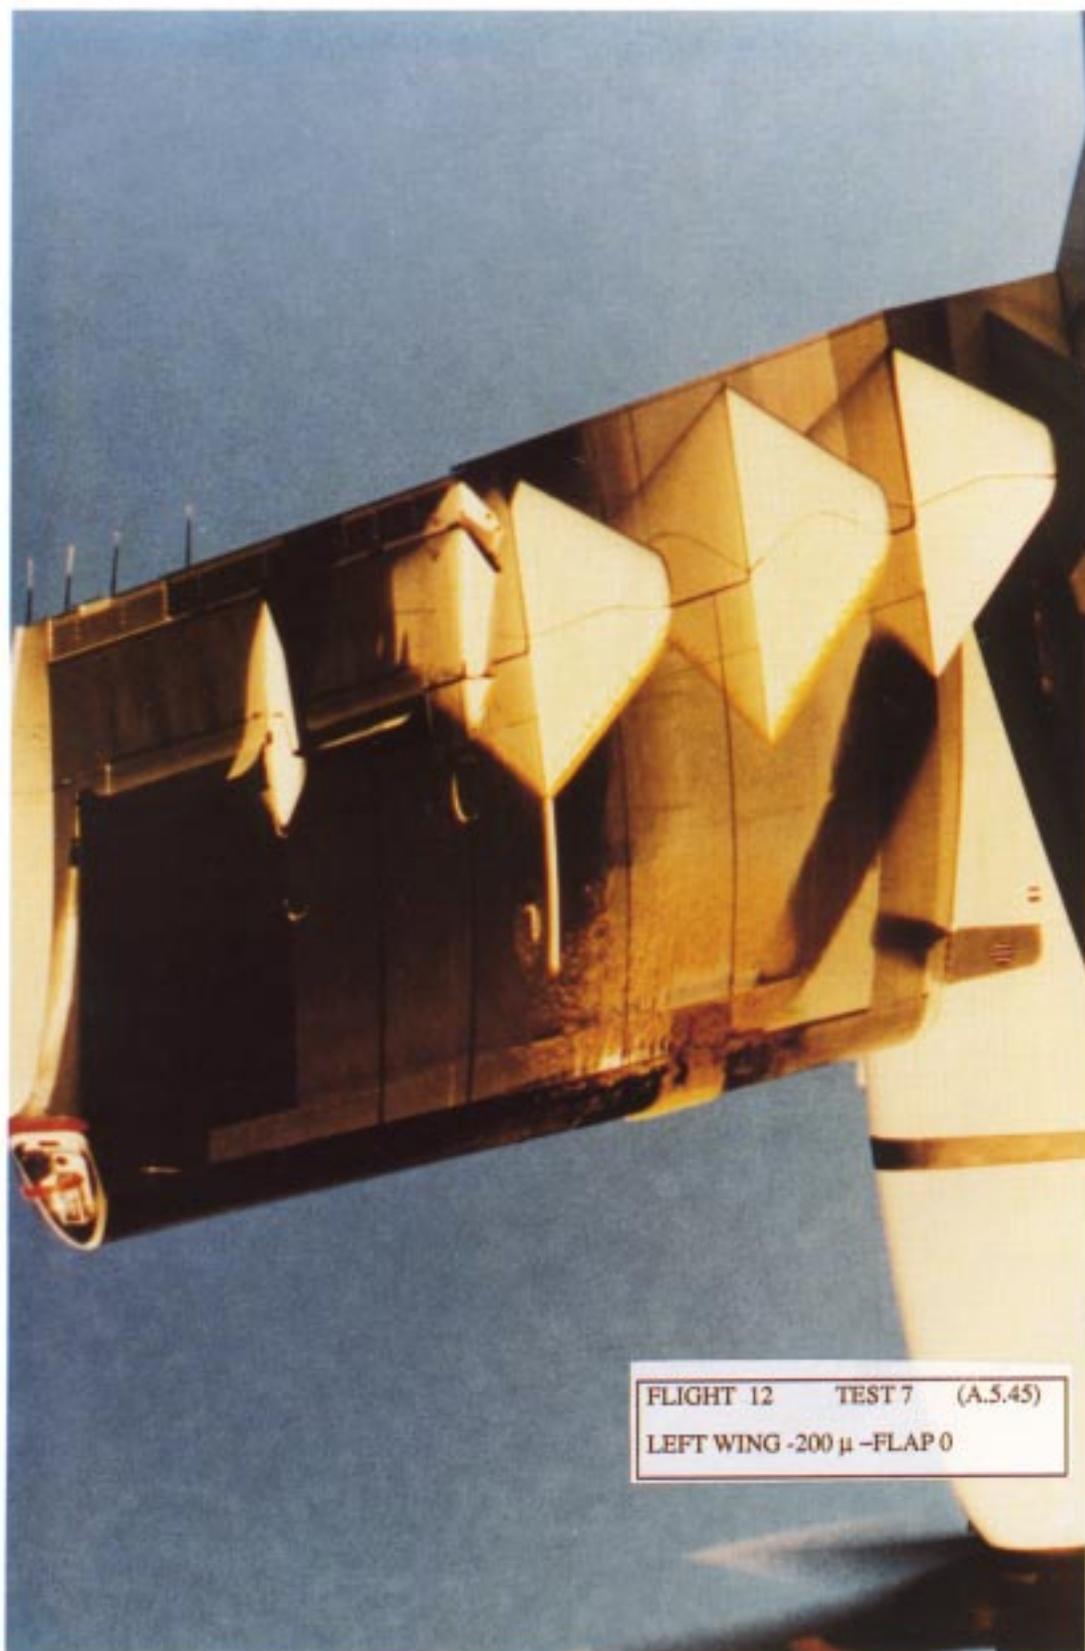
FLIGHT 12 TEST 7 (A.5.45)  
LEFT WING -200  $\mu$  -FLAP 0
