Aircraft Accident Report
Crash During Takeoff of Carson Helicopters, Inc. Firefighting Helicopter Under Contract to the U.S. Forest Service
Sikorsky S-61N, N612AZ
Near Weaverville, California
August 5, 2008

NTSB/AAR-10/06
PB2010-910406

NTSB/AAR-10/06
PB2010-910406
Notation 8066A
Adopted December 7, 2010

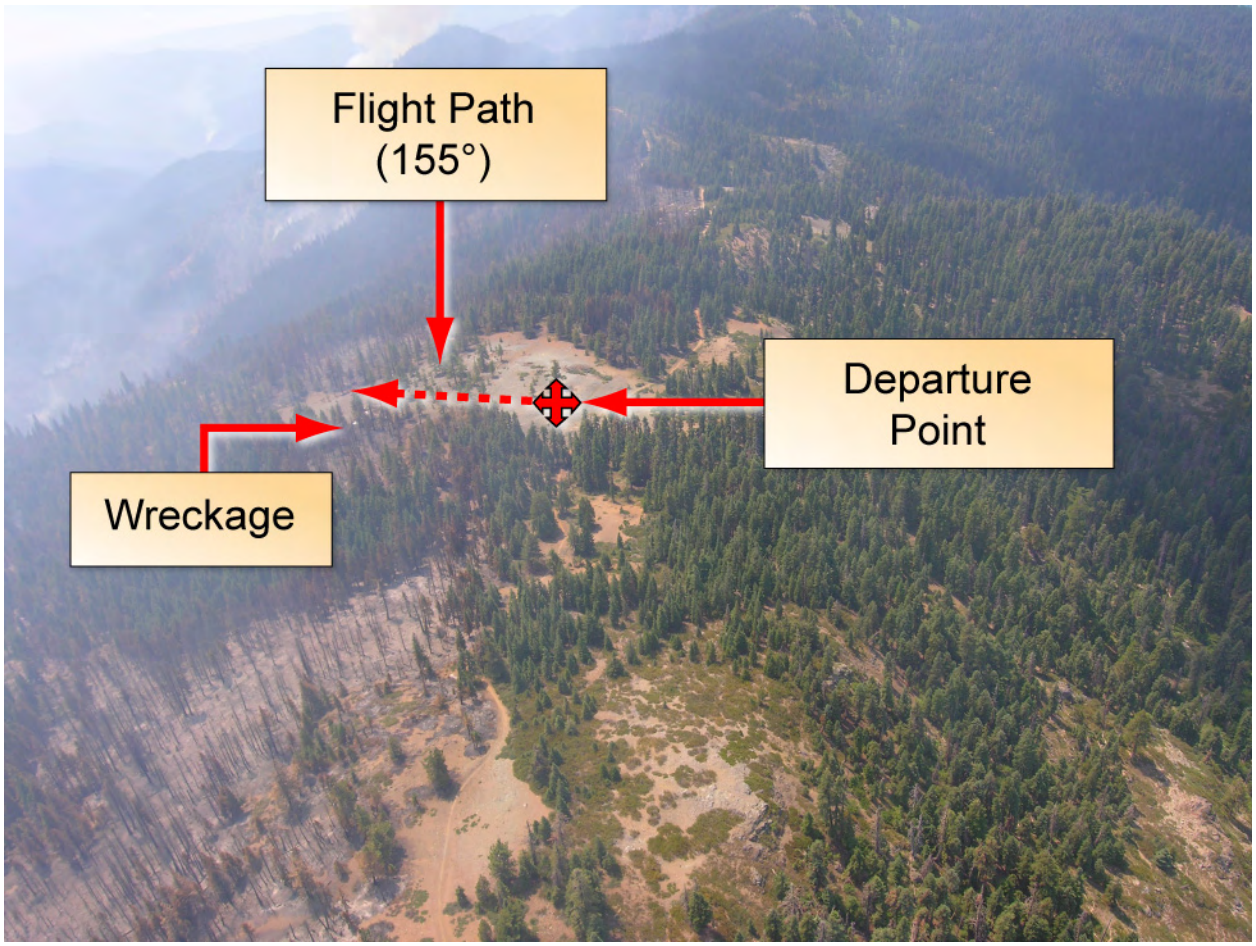
The helicopter collided with the trees and subsequently impacted the down sloping terrain, coming to rest on its left side. (See figure 2 for an aerial view of H-44 and N612AZ's departure path.) Almost immediately after the impact, witnesses saw smoke and fire coming from the wreckage. One witness reported that both engines continued to run for about 30 seconds after the helicopter impacted the ground.

Figure 2. Aerial photograph of H-44. Red dashed arrow shows approximate departure path of helicopter.

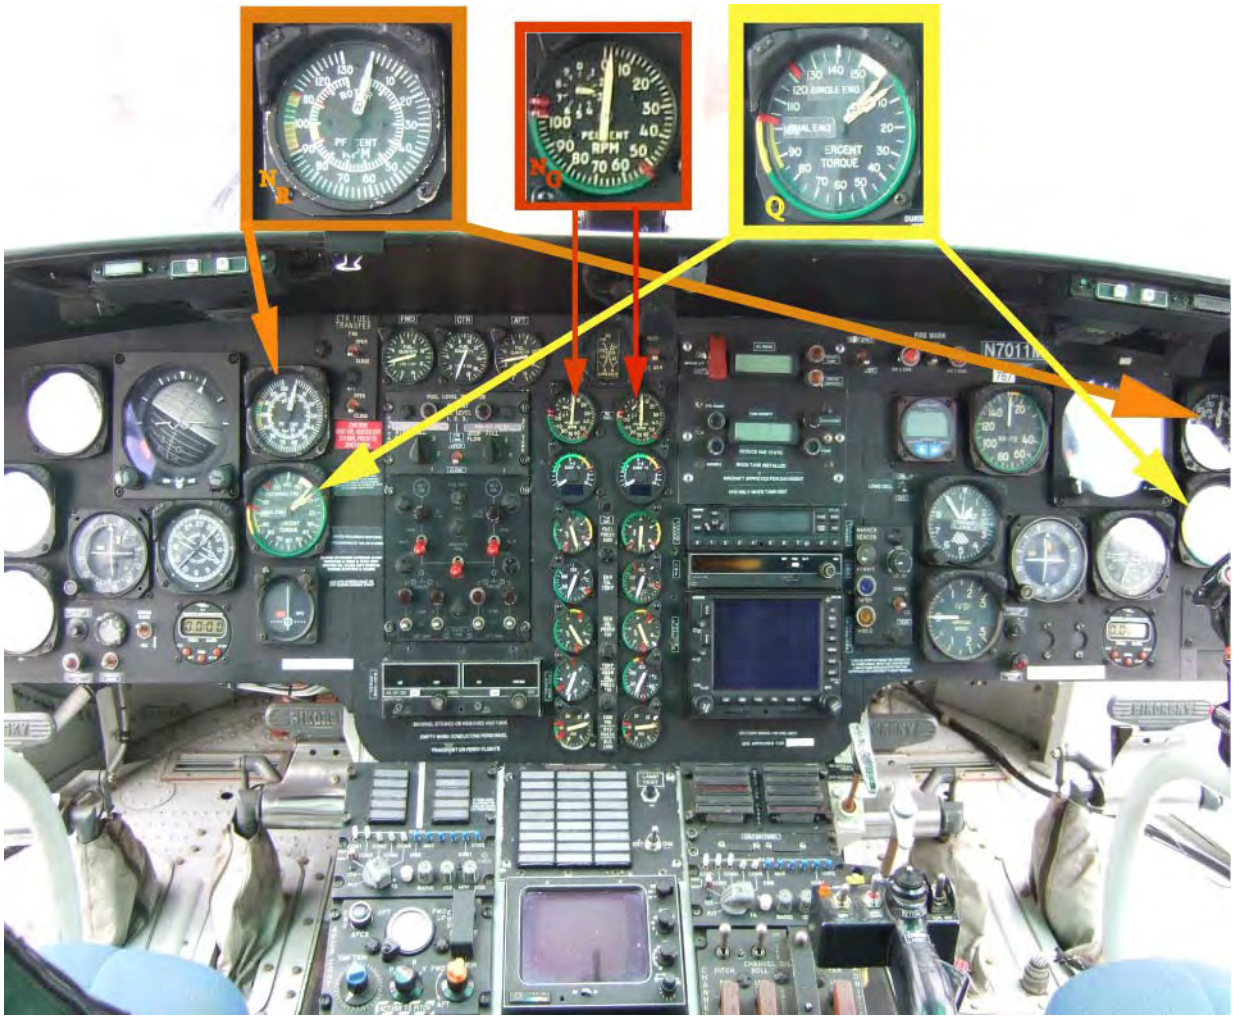
Various instruments were installed in the accident helicopter's cockpit to monitor engine performance. Dual-pointer engine torque gauges and triple-needle tachometers were installed in the pilot and copilot sections of the instrument panel. Each torque gauge (Q) had two needles labeled "1" and "2" for the No. 1 and No. 2 engine torque readings, respectively, and the markings on the gauges were incremented at 5-percent intervals. Each tachometer had three needles labeled "1," "2," and "R" for the No. 1 and No. 2 engine power turbine speed readings and the N_R in percent, respectively, and the markings on the gauges were incremented at 2-percent intervals (see figure 4). Additionally, the center section of the instrument panel housed two N_G gauges and two power turbine inlet temperature (T_5) indicators, one each for the No. 1 and No. 2 engines. The N_G gauges were marked with red lines at 100 percent and 102 percent for the 5-minute (takeoff) power limit and the 2.5-minute power limit, respectively.

Figure 4. Photograph of exemplar instrument panel, tachometer, N_G gauge, and torque gauge. The tachometer, N_G gauge, and torque gauge are labeled N_R, N_G, and Q, respectively.

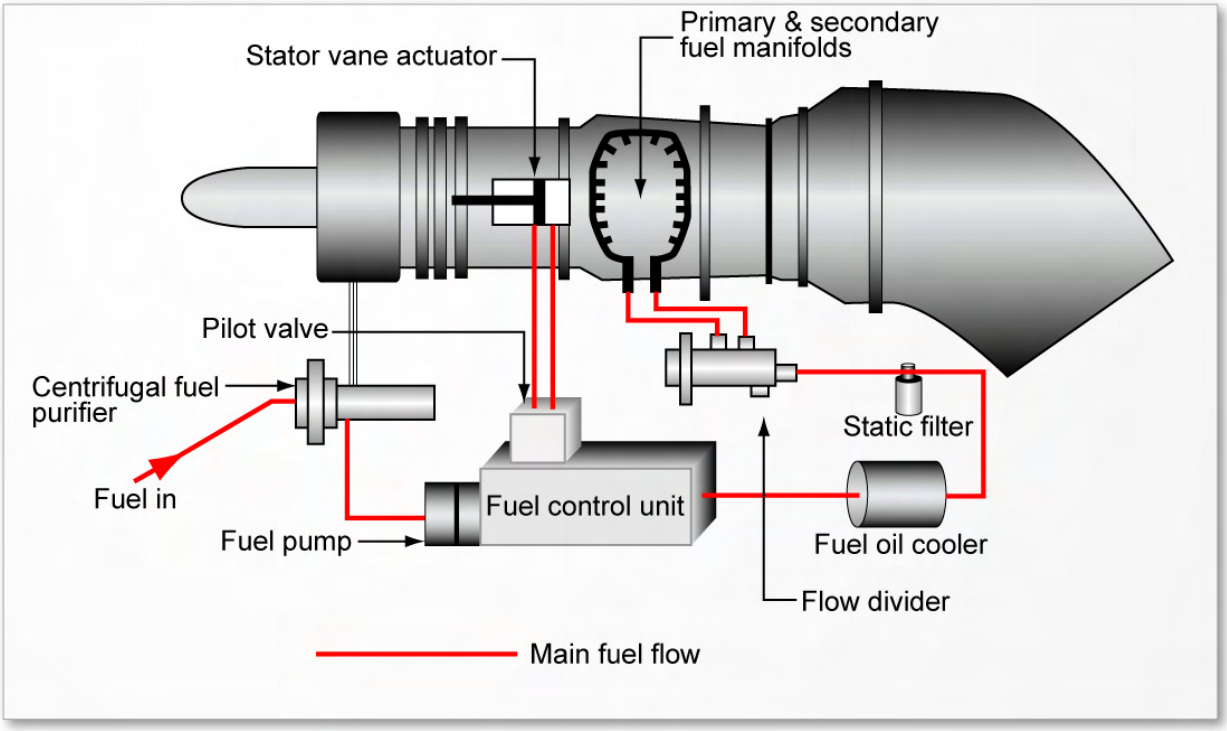
During engine operation, pressurized fuel from the airframe fuel system is supplied to the engine-driven centrifugal fuel purifier on each engine (see figure 5). This dynamic fuel filter purifies fuel by a centrifugal action rotating filter.[30] After leaving the centrifugal fuel purifier, the fuel enters the engine-driven fuel pump inlet. After the pump boosts its pressure, the fuel is supplied to the FCU and to the stator vane actuator (SVA). Fuel entering the FCU is routed through a screen-type filter assembly referred to as the main filter group. Metered fuel exits the FCU and is passed through the oil cooler, static filter,[31] and flow divider en route to the combustion chamber.

Figure 5. Diagram of the GE CT58-140 engine fuel system.

The centrifugal fuel purifiers installed on the helicopter's engines were both installed at an aircraft total time of 35,161.9 hours, or about 238 hours before the accident. According to the CHSI maintenance program, the centrifugal fuel purifiers were inspected and cleaned every 150 flight hours (Phase 2 inspection). The last Phase 2 inspection was accomplished on June 30, 2008, at an aircraft total time of 35,328.7 hours, or about 71 flight hours before the accident.

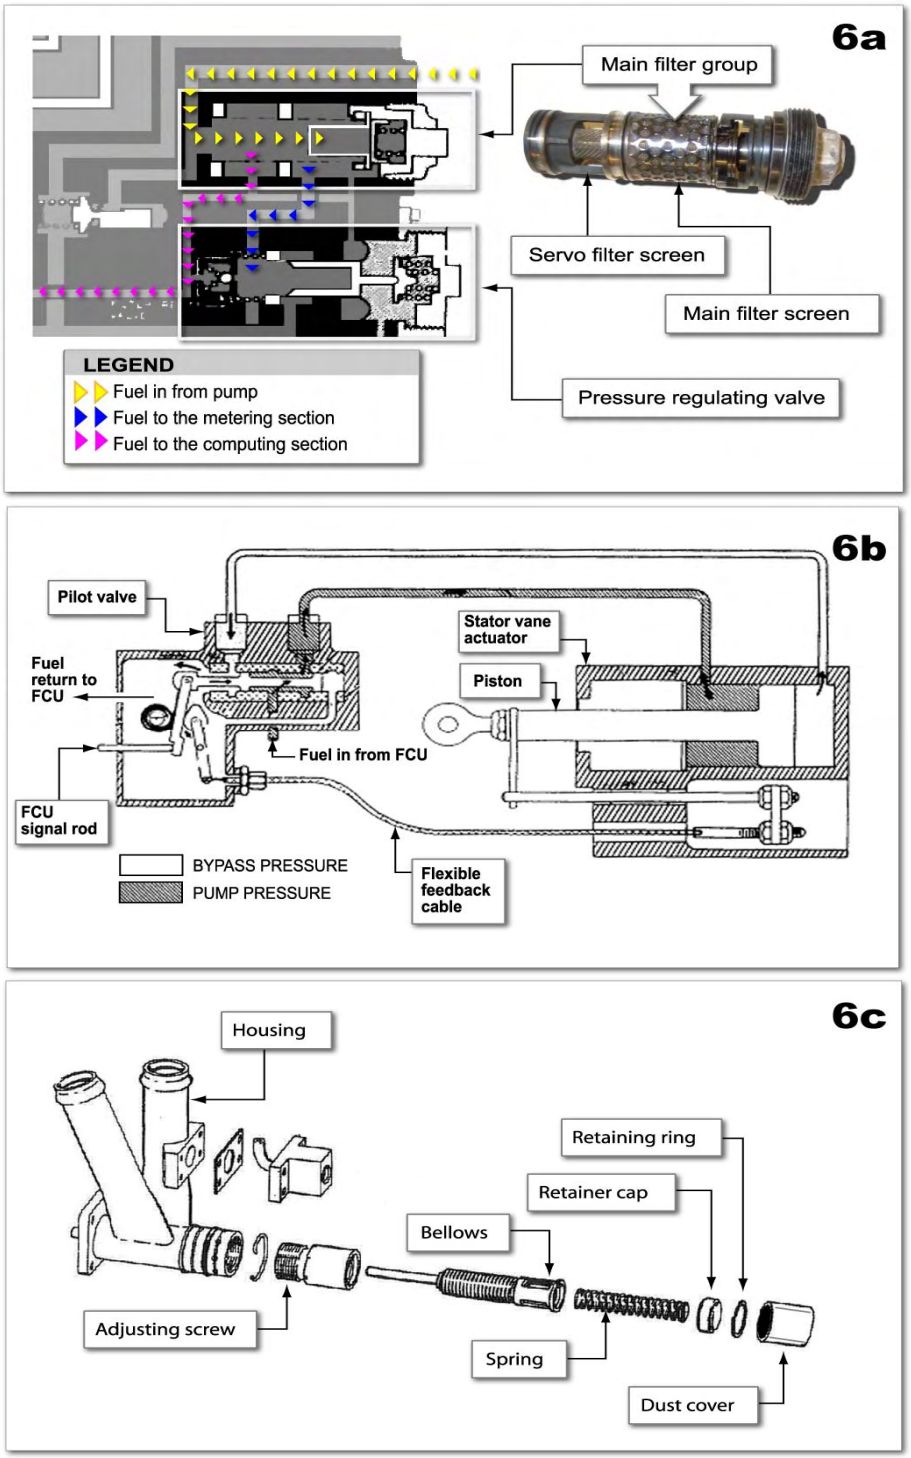
Figure 6. Engine component diagrams: a) FCU main filter group and PRV, b) stator vane actuating system, and c) FCU T_2 bellows group.

The stator vane actuating system comprises an SVA, a pilot valve assembly, a feedback cable, a signal actuating mechanism in the FCU, and multiple actuating levers (see figure 6b). The pilot valve receives engine speed commands via movement of the FCU signal actuating mechanism, which results in movement of the pilot valve piston. Depending on the direction of piston motion, the pilot valve ports high-pressure fuel to extend or retract the SVA, which results in corresponding movement of the actuating levers and repositioning of the feedback cable. Movement of the feedback cable results in the pilot valve's piston returning to its null position, shutting off the flow of fuel to the SVA when the desired position is reached.

The T_2 sensing system consists of the T_2 servo and the T_2 bellows group. The T_2 bellows group includes the following major components: bellows, bellows housing, override spring, position adjusting screw,[35] spring retainer cap, retaining ring, and dust cover (see figure 6c). The position adjusting screw is manufactured from aluminum tube stock. One end of the screw contains an external thread that attaches to the mating internal threads on the T_2 sensor housing, and the other end contains an internal circumferential groove. The screw is installed in the housing, and the bellows is inserted into the end of the position adjusting screw that contains the groove. The spring and spring retainer cap are then inserted, and the spring is compressed until the retaining ring can be inserted into the groove. In the installed condition, the retaining ring presses against the internal groove in the position adjusting screw and prevents the bellows, spring, and spring retainer cap from sliding out of the housing. The T_2 bellows is protected from the environment by the position adjusting cover, which is a dust cover manufactured from plastic or aluminum.

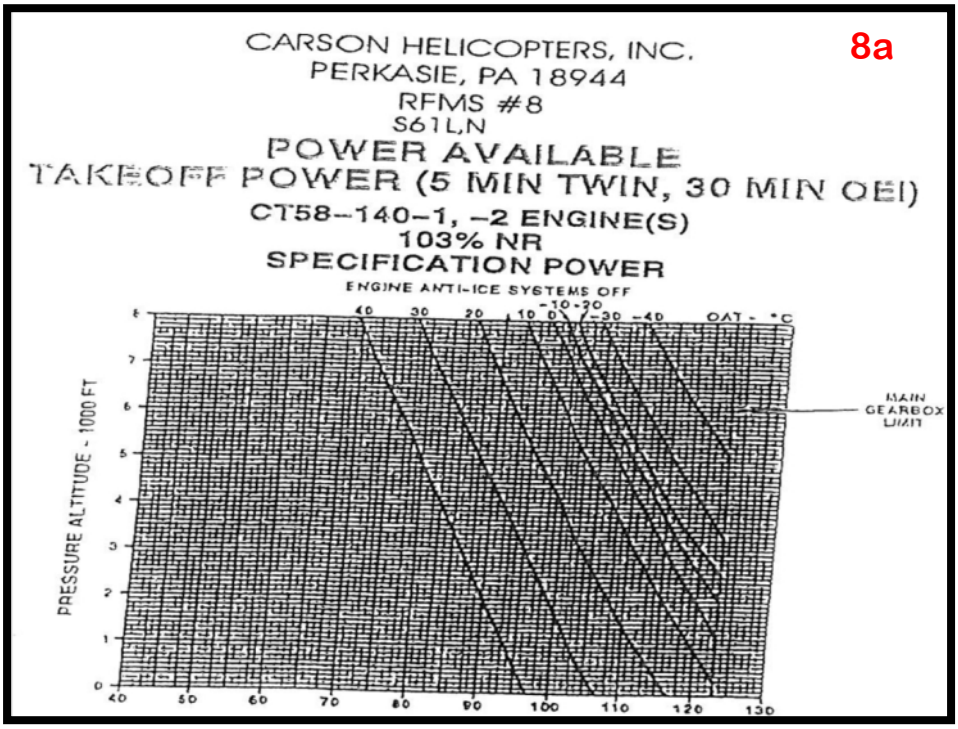
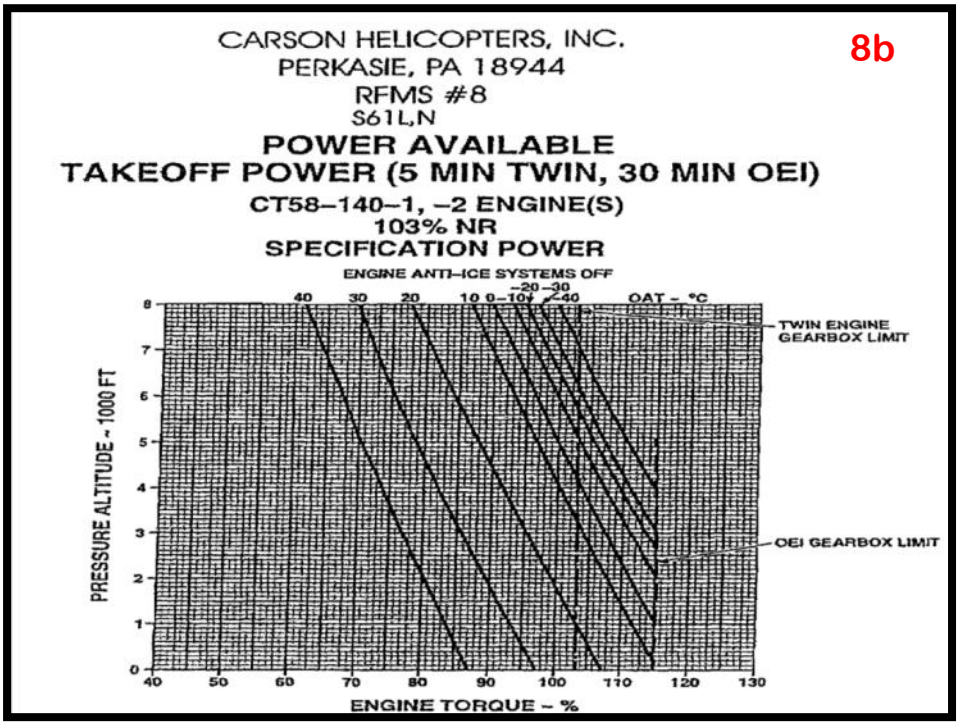
During its review of the CHSI-provided copy of RFMS #8 contained in the Trinity helibase binder for the helicopter, NTSB investigators noted that figure 4 was slightly askew on the page and had less crisp, distinct lines than the other charts in the RFMS (see figure 8a). Investigators also noted that the figure's graphical section had only a single reference line for the main gearbox limit, whereas this type of chart would typically include two reference lines: one each for the twin engine and OEI gearbox limits. NTSB investigators compared the graphical section of RFMS #8 Figure 4 with that of other figures in RFMS #8 and found that it appeared to be identical to the graphical section of RFMS #8 Figure 1, Power Available, 2.5 Minute Power, 100 percent N_R. No difference existed in the torque values given by the two graphical sections.

For example, at 6,000 feet PA and 32° C, the torque value from both figures was 82.5 percent. Typically, for a given PA and temperature, the torque value from a takeoff power available chart, commonly referred to as 5-minute power, would be less than the torque value from a 2.5-minute power available chart.

Figure 8. Figures from RFMS #8: a) CHSI-provided Figure 4 and b) FAA-provided Figure 4.

A copy of RFMS #8 was obtained from the FAA's New York Aircraft Certification Office (ACO) that had approved RFMS #8. The FAA-provided RFMS #8 Figure 4 looked identical in format to the CHSI-provided RFMS #8 Figure 4, with the same text at the top and bottom of the figures, and both figures were date-stamped as FAA-approved on February 7, 2008. The notable difference was that the graphical sections were not the same. The graphical section of the FAA-provided chart had crisp, distinct lines and two reference lines: one each for the twin engine and OEI gearbox limits (see figure 8b). The torque value from the FAA-provided figure at 6,000 feet PA and 32° C was 73 percent.

The altered RFMS #8 Figure 4 chart was distributed as an attachment to a July 7, 2008, email from the CHSI chief pilot to all of the company's pilots, including the accident pilots. The email's subject line read "New load Calc info" and stated, in part, to "take out the 5 min power 103%, page 15 of 19 in your aircraft's RFM hoist supplement and replace it with the new 5 min power chart in this email, both are dated 7 Feb 2008."

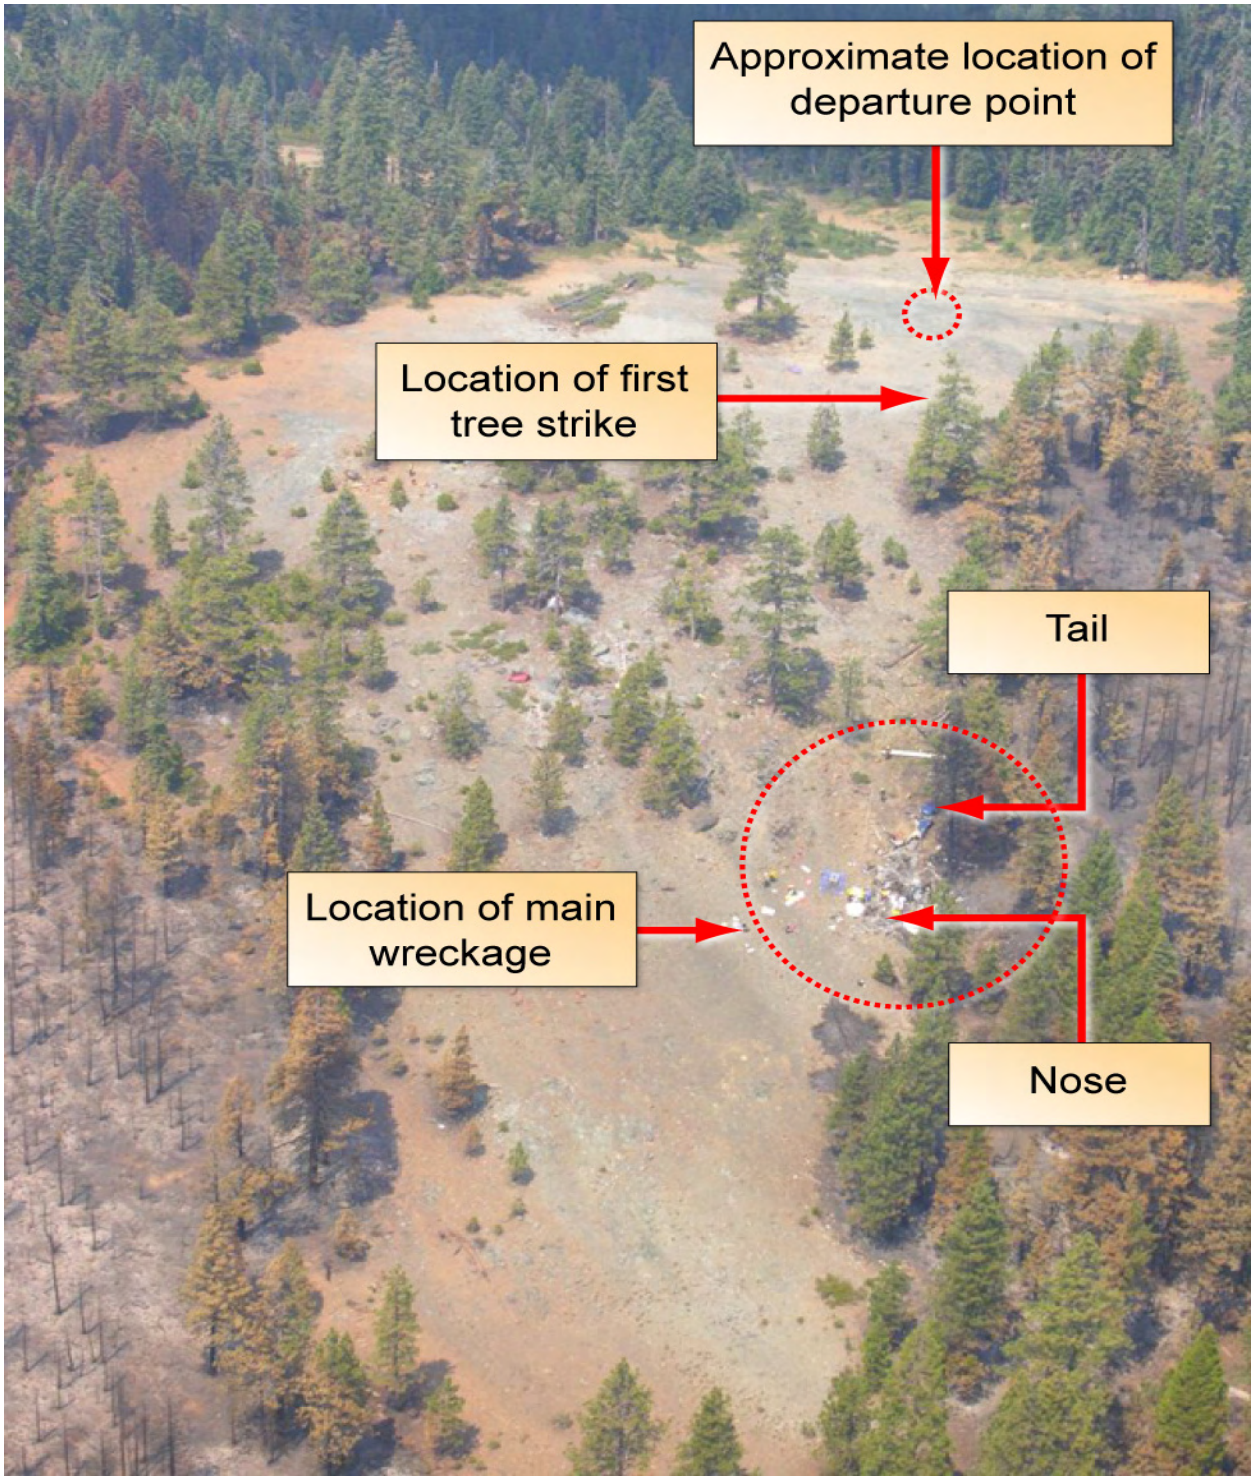
Figure 10. Aerial photograph of accident site.

An assessment of the surrounding trees revealed evidence of main rotor blades contacting several trees between the departure point and the main wreckage. Of these trees, the one closest to the departure point was a pine tree located about 65 yards south-southeast of the departure point. The ground elevation of the tree was 5,931.6 feet, and the height from the base of the tree

to the blade contact point was about 49.5 feet. To inspect the blade contact point, the tree was cut down. Examination showed that the tip of a retreating[65] main rotor blade contacted the tree, consistent with the fuselage being to the right of the tree at the time of contact.

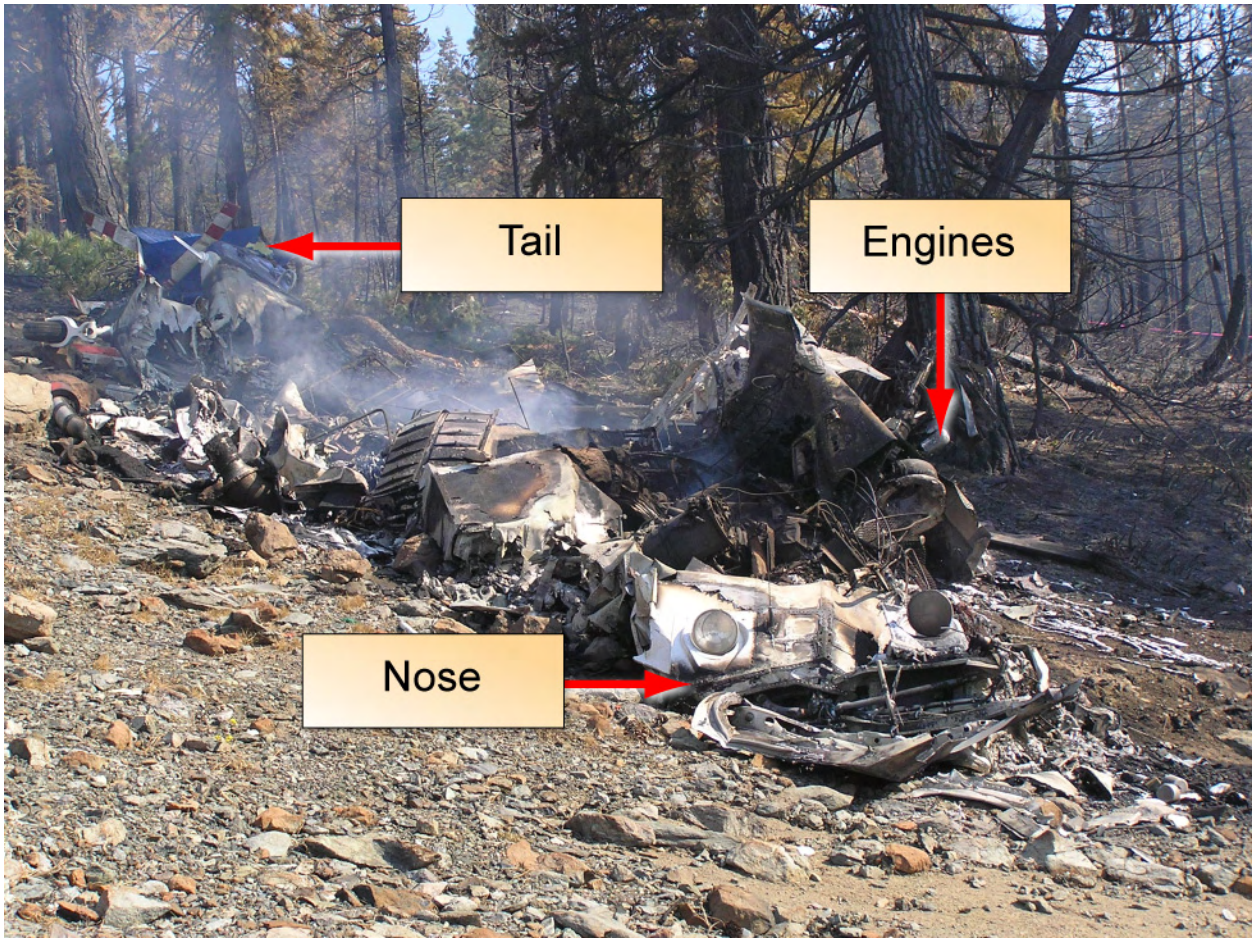
The helicopter was found on a downward slope of about 15° to 20°; it was resting on its left side with its nose down slope from its tail boom. The magnetic heading of the wreckage was about 155°. A postcrash fire had consumed most of the helicopter's airframe and structure forward of the tail boom. Solidified molten metal was noted in several areas of the wreckage and in the impact area. Sections of the helicopter's lower fuselage structure, including all fuel tank cells and the cabin flooring, were consumed by the postcrash fire. Most of the forward fuselage, including the cockpit and the electronics compartment, was inverted and consumed by fire (see figure 11).

Figure 11. Photograph of main wreckage.

Fragmented sections of all five main rotor blades were located in the immediate area around the main wreckage of the helicopter. A visual assessment of the main rotor blades revealed that all damage was consistent with multiple leading edge impacts with trees.

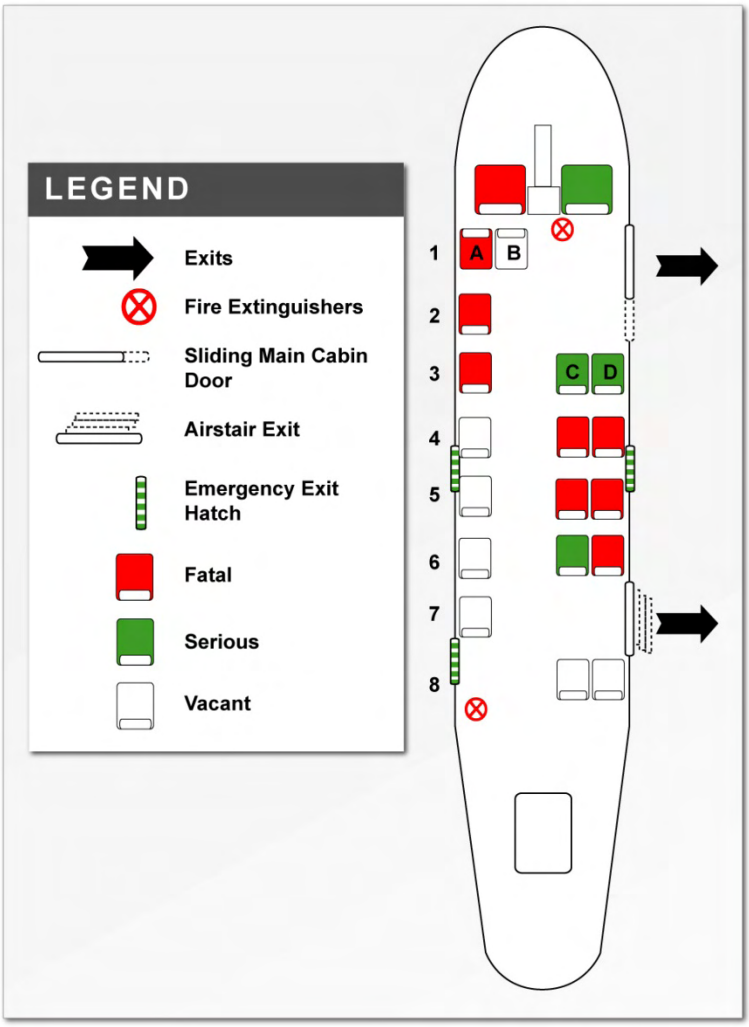
The helicopter was equipped with 2 pilot seats in the cockpit and 18 passenger seats in the cabin. As shown in figure 12, five rows of forward-facing double seats with non-locking folding seatbacks were on the right side of the cabin, and six rows of forward-facing single seats with non-locking folding seatbacks were on the left side of the cabin. A double seat faced aft on the forward left side of the cabin. The aft-facing double seat and the first forward-facing single seat on the left side of the cabin were designated for helicopter crewmembers. An aisle separated the passenger seats on either side of the cabin. For reference, NTSB investigators numbered the cabin seats from front to back by row (1 to 8) and from left to right by letter (A to D).

Figure 12. Cabin diagram for N612AZ.

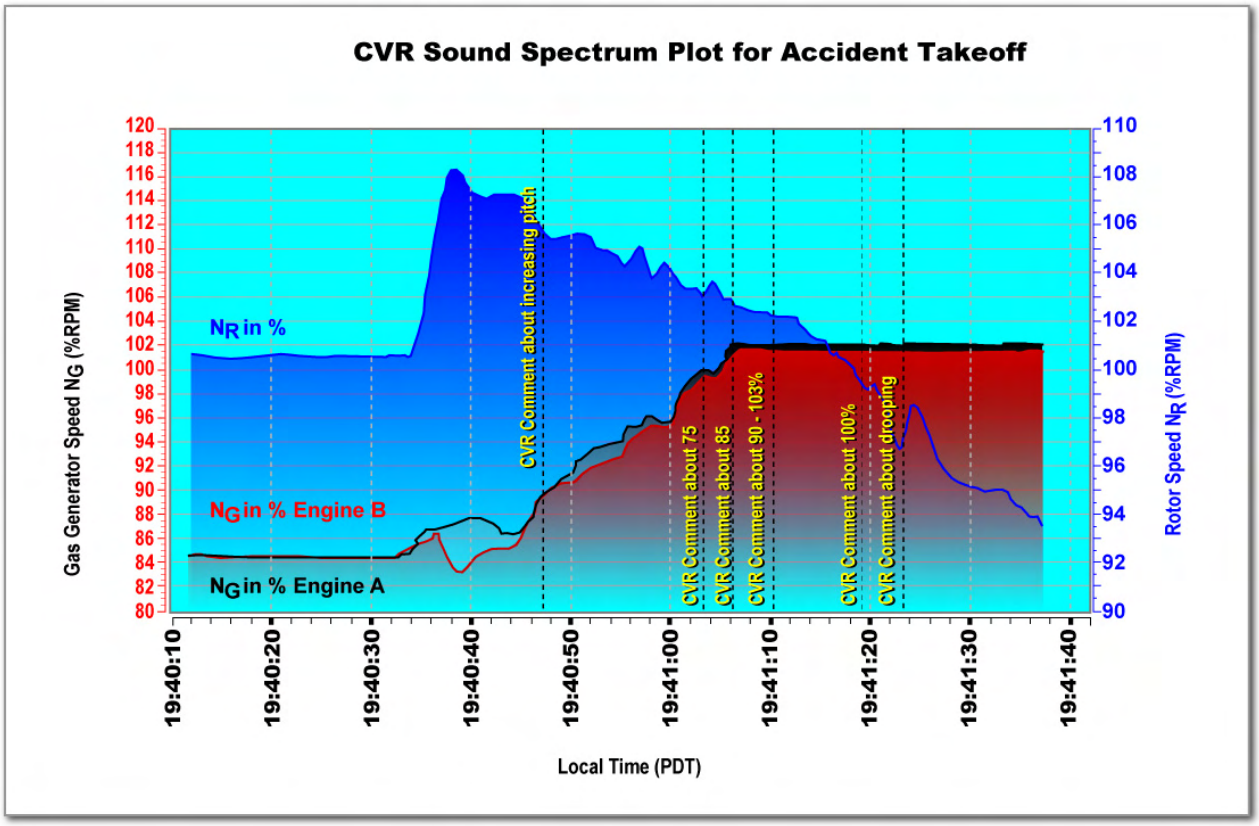
Figure 13. Plot of N_Gs and N_R versus time for accident takeoff.

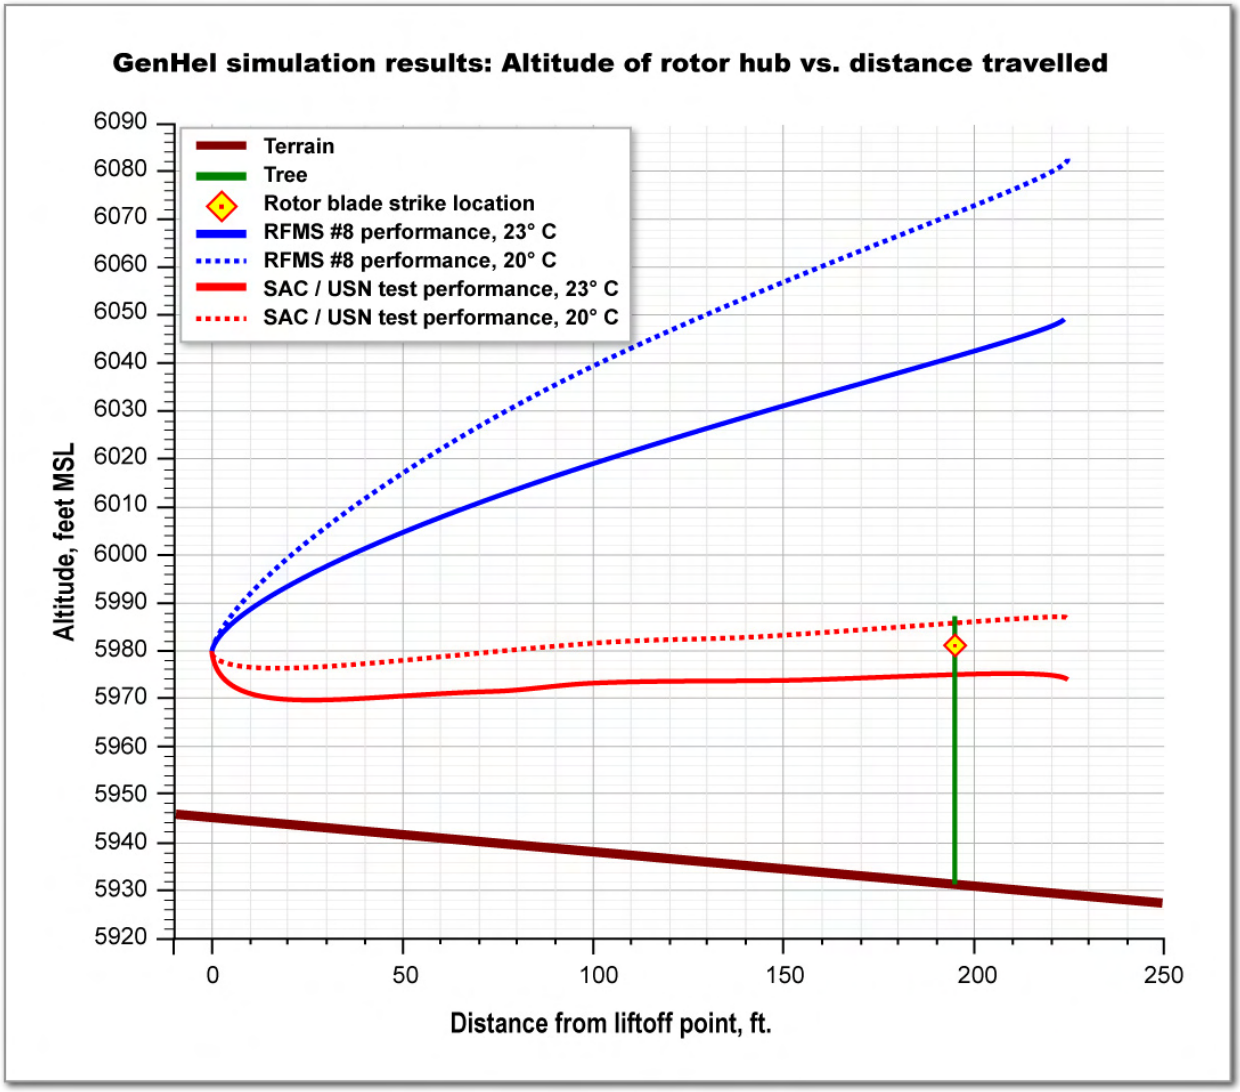
All simulations were performed using a helicopter gross weight of 19,008 lbs and no headwind. The results of the simulations are shown in figure 14.

Figure 14. GenHel simulation plots. In all the simulations, the helicopter is assumed to lift off and HIGE at a wheel height of about 20 ft before accelerating forward toward the tree.
