## Survival Factors

### Airbag Safety Study Factual

July 14, 2009

**Location:** Groton, Connecticut  
**Aircraft Type:** Cessna 172  
**Accident Date:** November 19, 2008  
**Accident Time:** 1833 EST  
**Accident Number:** ERA09LA064  
**Airbag Equipped:**

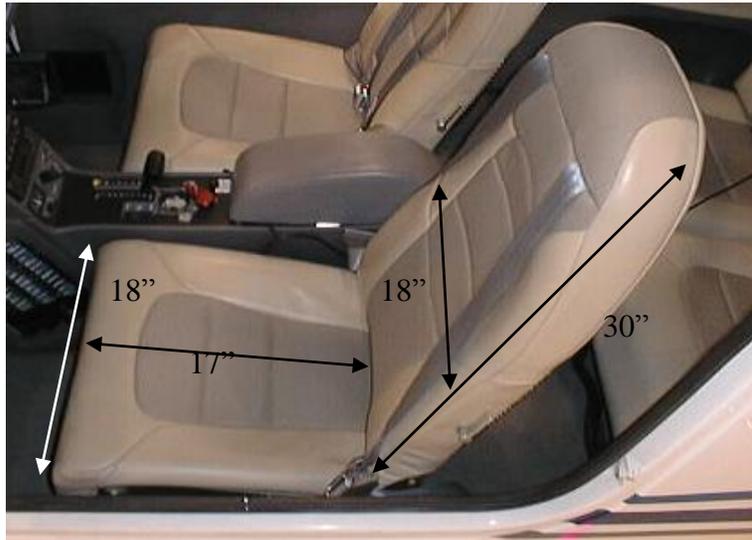
**Figure 5:** Dimensions of the seats.

The dimensions of the seats are documented in figure 5. Because the cabin seats are manufactured by Cessna and type certificated with the airplane, there is no unique part number or serial number for the seats. The cockpit seat and rear cabin seats were intact and no damage was observed to the seat covering or the seat frames. The left seat was adjusted to the 11<sup>th</sup> pin back from full forward and the right seat was adjusted to the 9<sup>th</sup> pin back from full forward. The cockpit seats were removed and no deformation of the seats was observed.

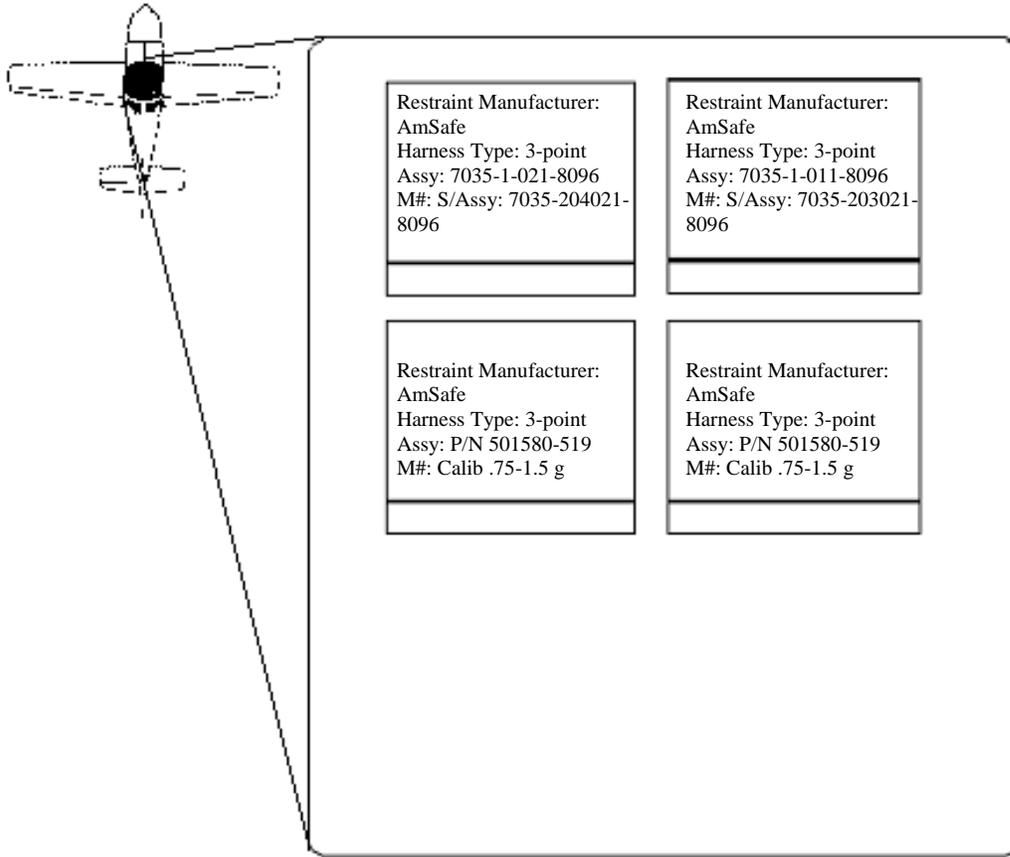
**Restraint Numbers:**

The three point AmSafe restraints were intact and the webbing showed no evidence of trauma. The webbing on each shoulder restraint showed a thin area of stress where the load bar for the connector tongue had been positioned for the left and right cockpit seat. The left shoulder restraint showed that the witness mark (load bar location during impact) was positioned 19.5 inches away from the edge of the airbag cover. For the right seat, the distance between the edge of the cover to the load bar mark was 12.25 inches.

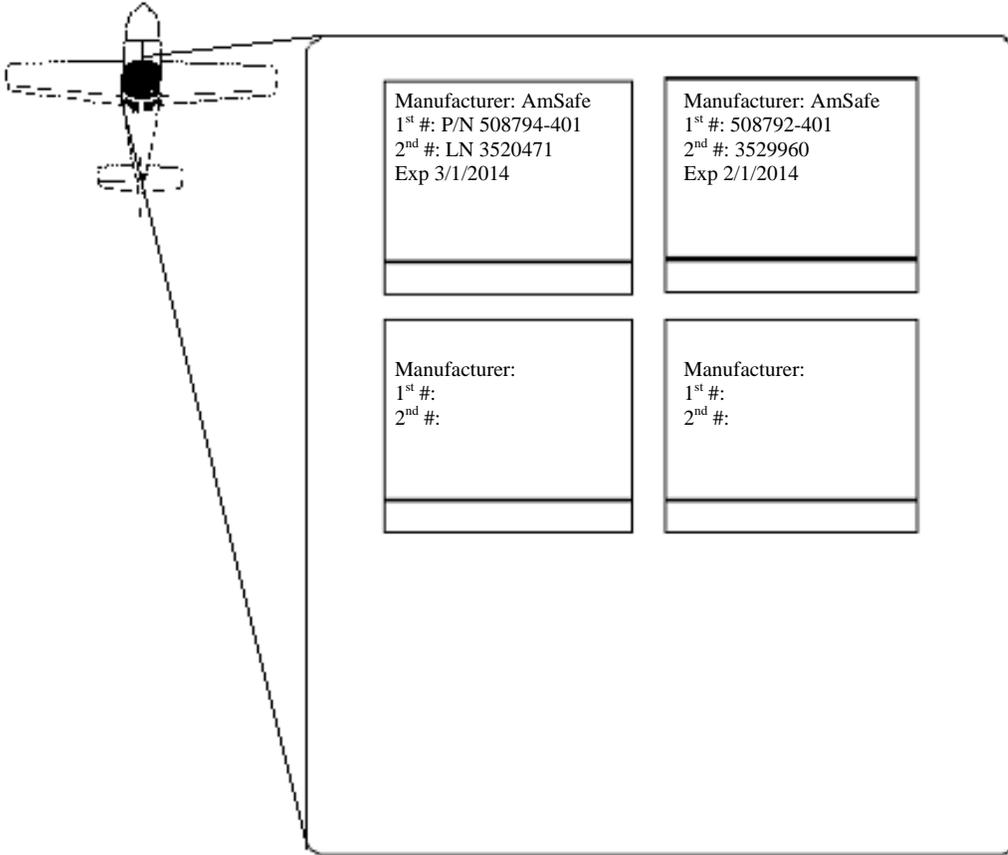
**Airbag Inflator Assemblies:**

Manufacturer: AmSafe 1 <sup>st</sup> #: P/N 508794-401 2 <sup>nd</sup> #: LN 3520471 Exp 3/1/2014	Manufacturer: AmSafe 1 <sup>st</sup> #: 508792-401 2 <sup>nd</sup> #: 3529960 Exp 2/1/2014
Manufacturer: 1 <sup>st</sup> #: 2 <sup>nd</sup> #:	Manufacturer: 1 <sup>st</sup> #: 2 <sup>nd</sup> #:
