# NATIONAL TRANSPORTATION SAFETY BOARD

## AIRCRAFT ACCIDENT REPORT

IN-FLIGHT ICING ENCOUNTER AND LOSS OF CONTROL  
SIMMONS AIRLINES, d.b.a. AMERICAN EAGLE FLIGHT 4184  
AVIONS de TRANSPORT REGIONAL (ATR)  
MODEL 72-212, N401AM  
ROSELAWN, INDIANA  
OCTOBER 31, 1994

VOLUME 1: SAFETY BOARD REPORT

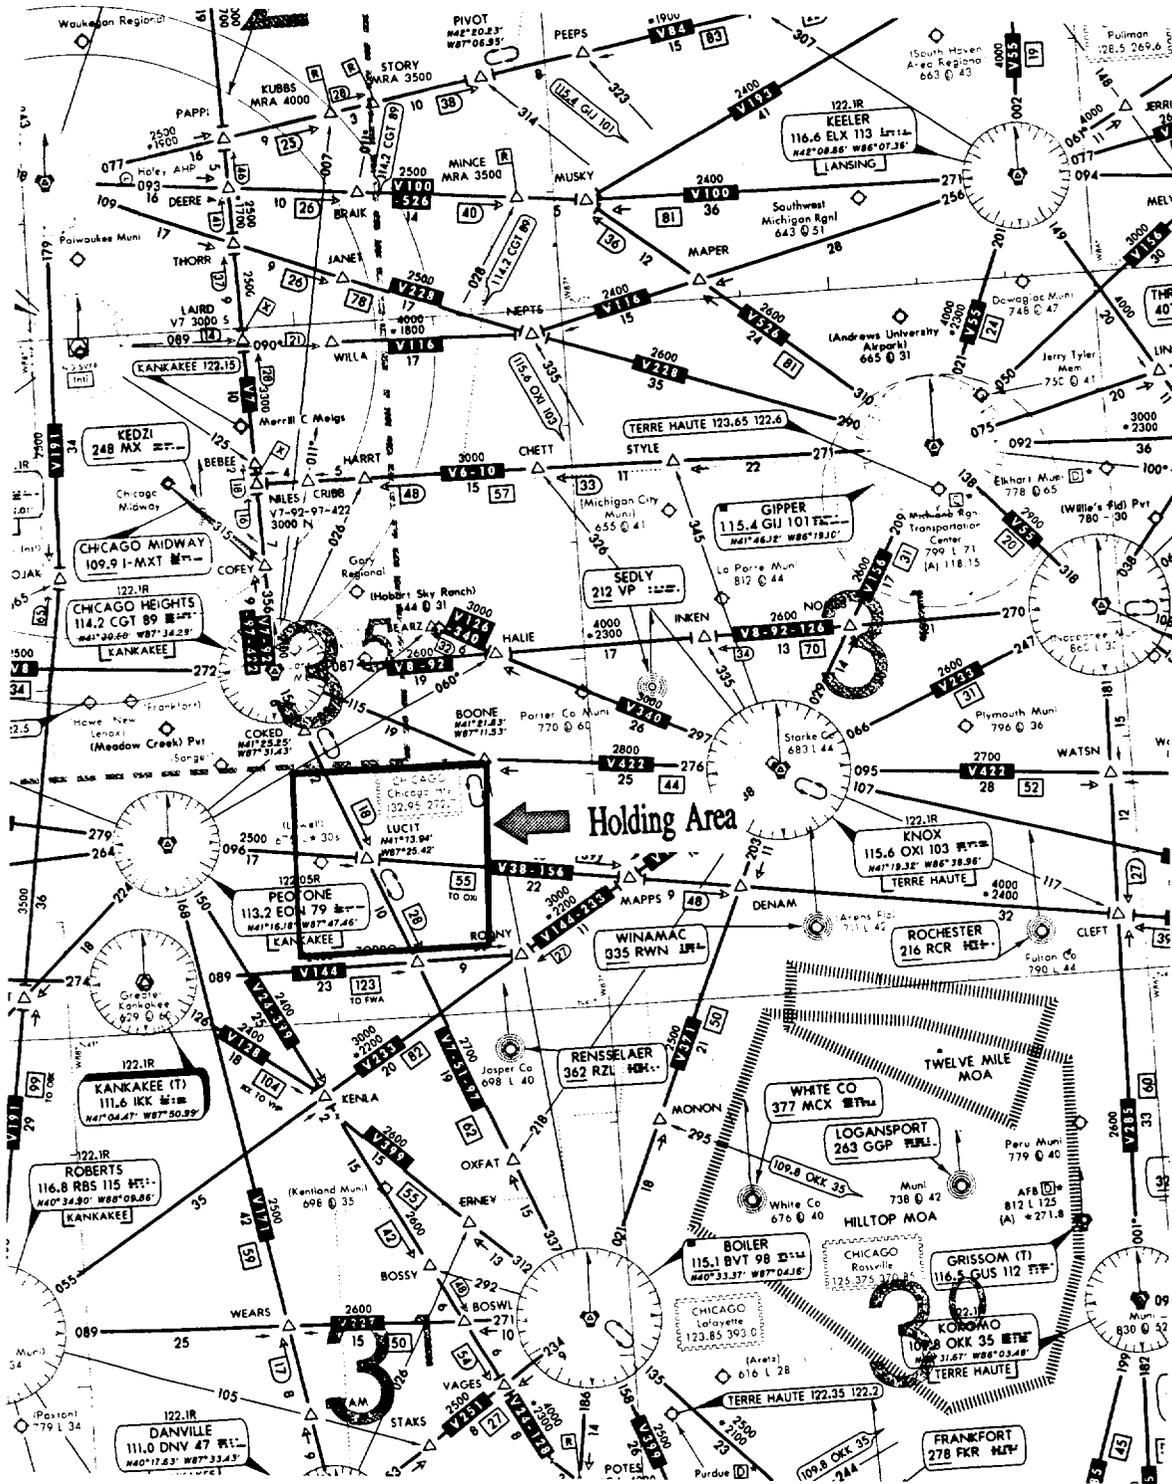
Figure 1.--Holding pattern location; box identifies LUCIT intersection.

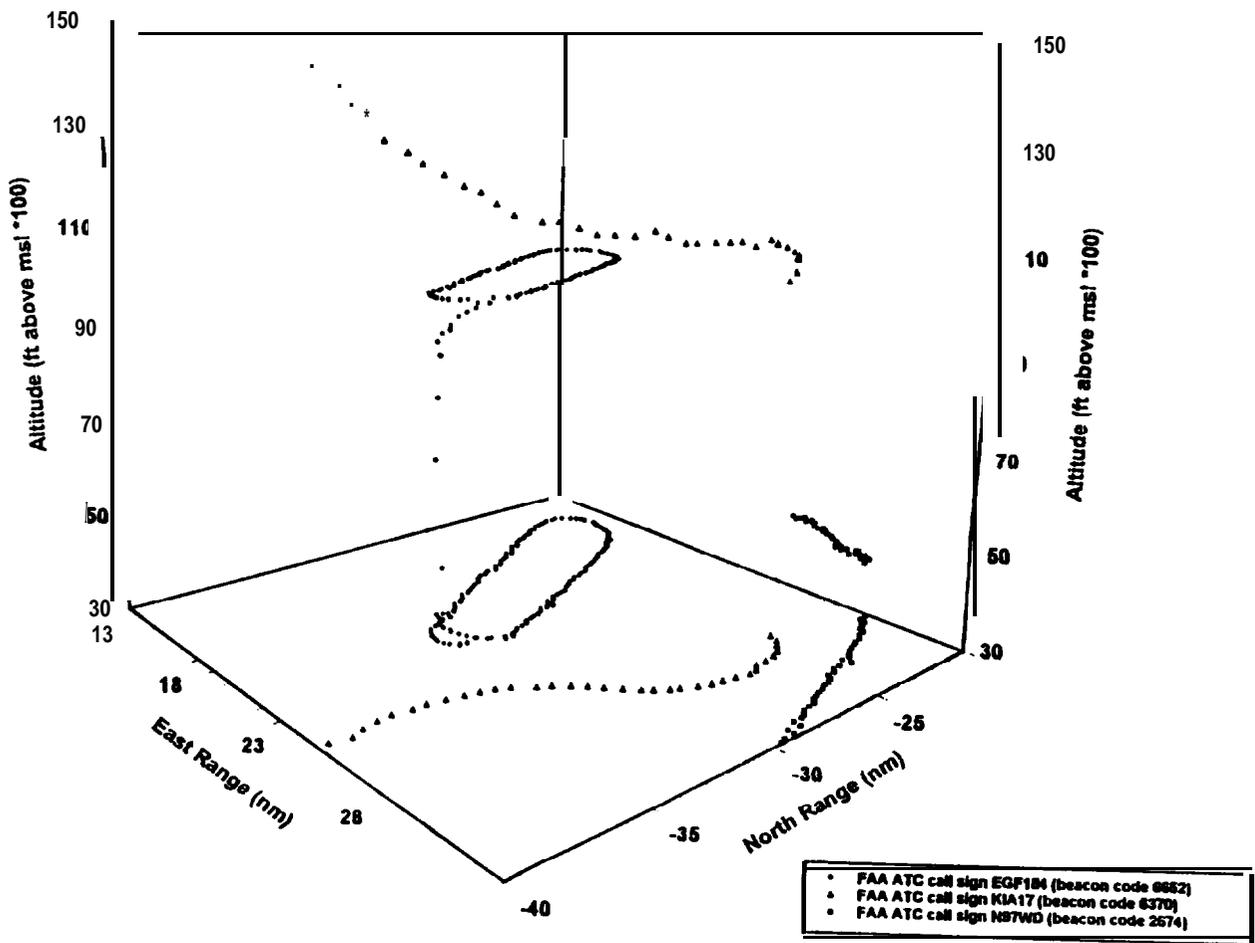
Figure 2.—Flightpath of airplane in holding pattern.

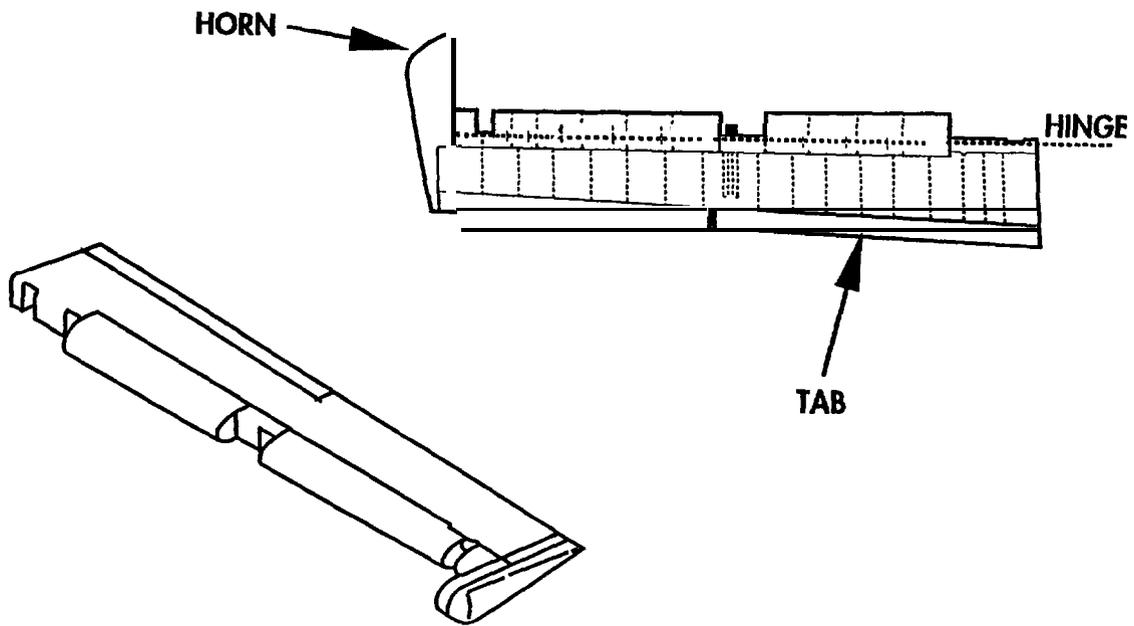
Figure 5.--Aileron assembly.

gearing between the aileron hinges and the cockpit control wheels. Aileron hinge moments are a function of the air pressure distribution on the surface of the aileron and associated balance devices, as well as the chordwise location of the aileron hinge line.

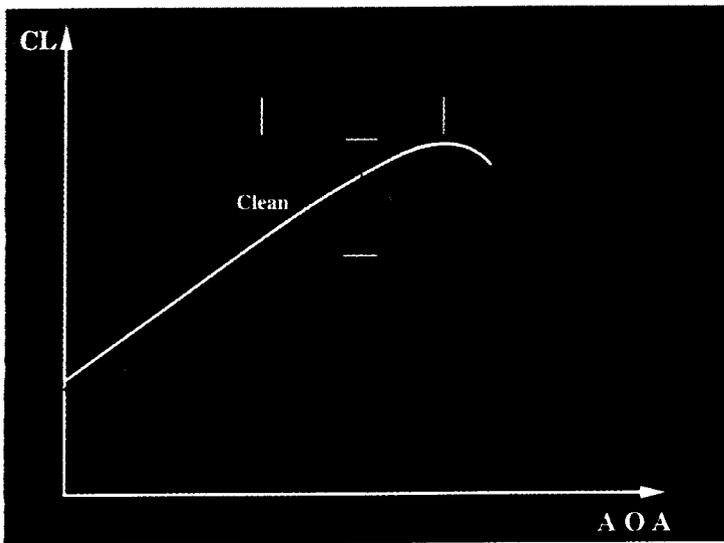
Fig. 3- Effect of certified ice shapes on lift curve - Flaps 30°, gear down standard de-icers

The lift curves are substantially modified compared to clean aircraft (fig. 3):

When the maximum lift capability of the wing decreases by 25%, the actual stall speed is 12% higher than the basic stall speed (aircraft clean). So an iced aircraft (fig. 3) flying at a given speed (and thus at a given CL) will have stall margin reduced either looking at angle of attack (6°5 less margin) or looking at stall speed (12% less margin).

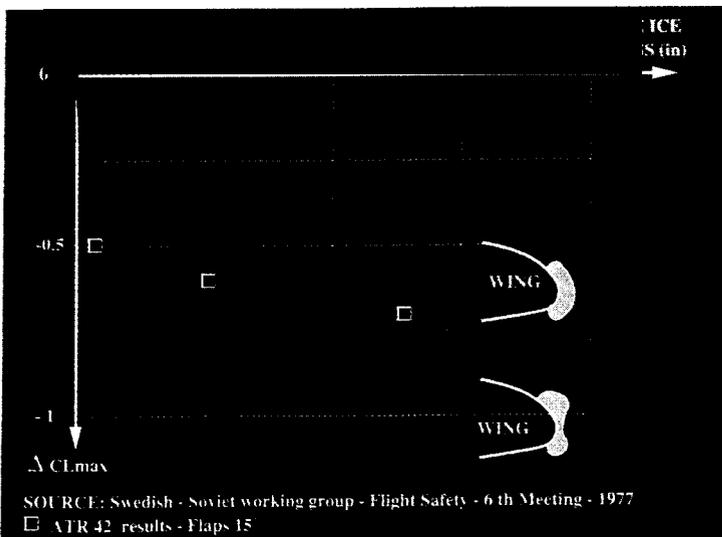
More surprising is the fact evidenced by fig. 4: the bulk of the maximum lift degradation is already there for accretions as small as a few millimeters.

Fig. 4 Effect of ice shape on  $CL_{max}$  - Wind tunnel tests - Flaps 15°

- Even small ice accretion is enough to destroy lift significantly (refer to fig. 4 page 4).
- Small ice accretions are most often difficult to observe and may even be missed by the ice detector,

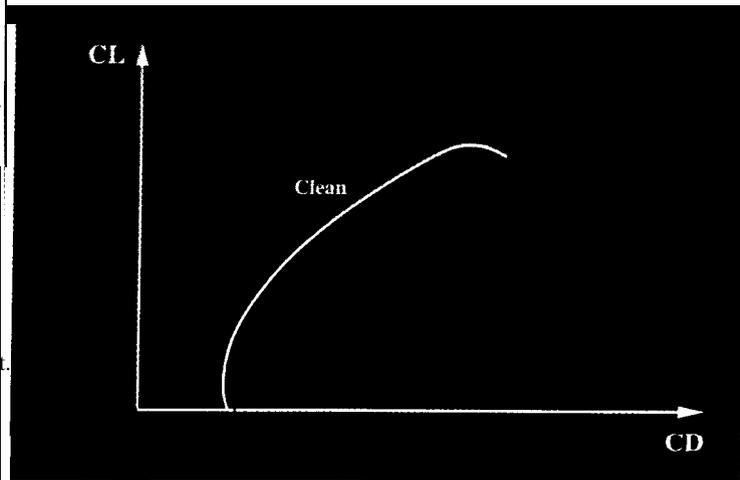
The drag polar is also heavily affected (fig. 5) € superior drag at a given angle of attack, € superior drag at a given lift, € best lift/ drag ratio at a lower lift coefficient.

Fig. 5- ATR 72- Effect of certified ice shapes on drag polar. Flaps 0°. Standard de-icers

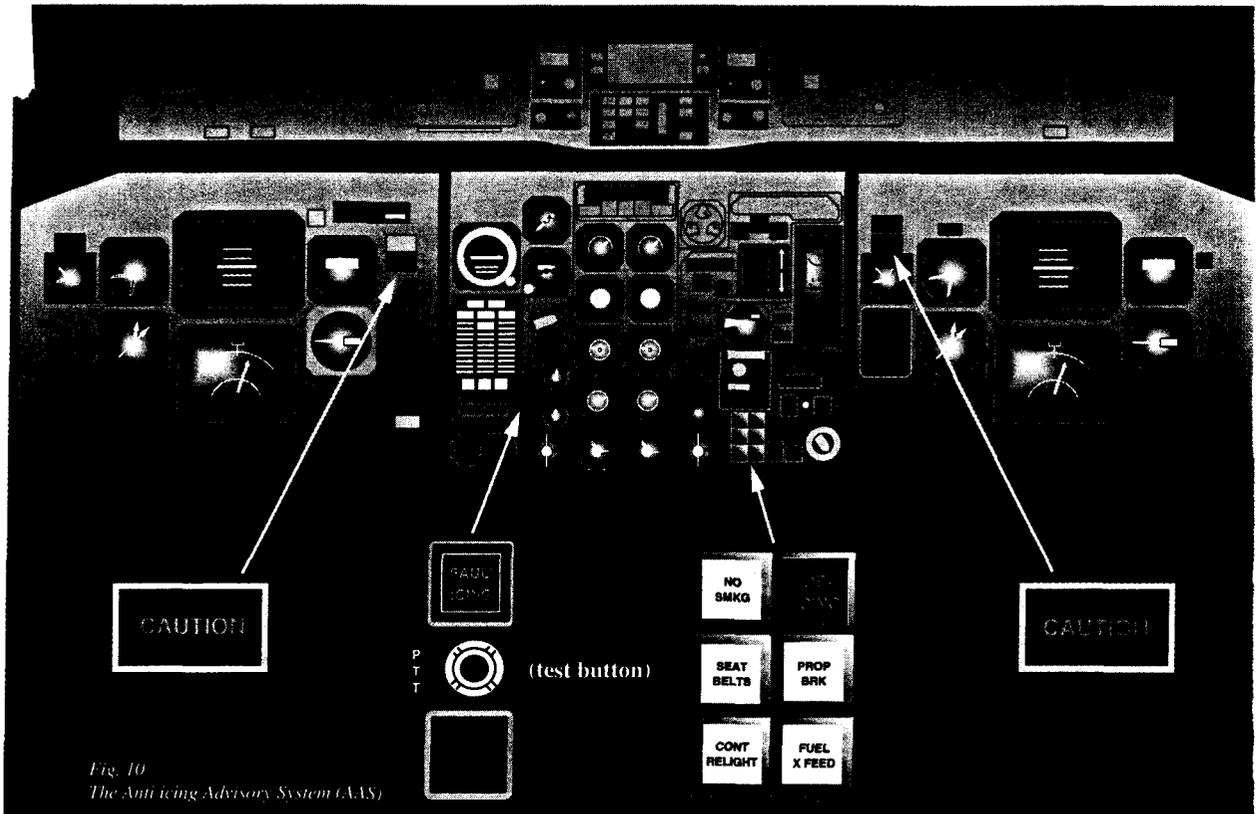
The electronic ice detector is located under the left wing and alerts the crew as soon as and as long as ice accretion develops on the probe. Aural and visual alerts are generated (amber ICING light on the central panel and single chime).

Fig. 10  
The Anti Icing Advisory System (AAIS)

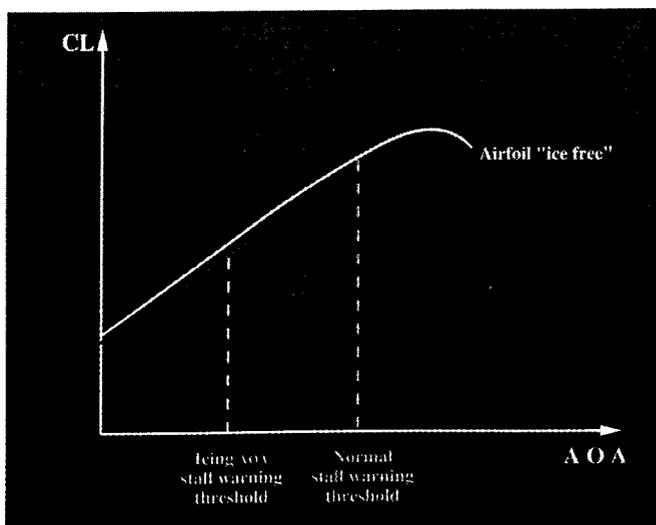
Fig. 12

Stall occurs at higher speeds (fig. 12) when ice accretion spoils the airfoil, therefore the stall warning threshold must be reset to a lower value of angle of attack.

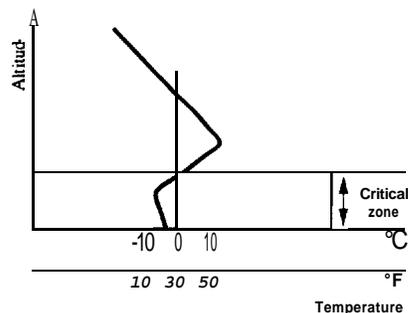
Freezing rain normally occurs as a result of weather conditions where temperature increases with altitude (temperature inversion, ref. fig. 13). Warm rain falls from or passes through this warm layer into a region of subfreezing temperature and typically becomes supercooled. These supercooled large rain drops will then freeze upon impact with an object.

Fig. 13- Temperature in inversion is a zone where temperature increases with altitude.
